Re: Site Visit – June 19<sup>th</sup>, 2017  
Old Longview Lake Dam and Spillway  
Lee's Summit, MO  
Olsson Project No. 017-0305

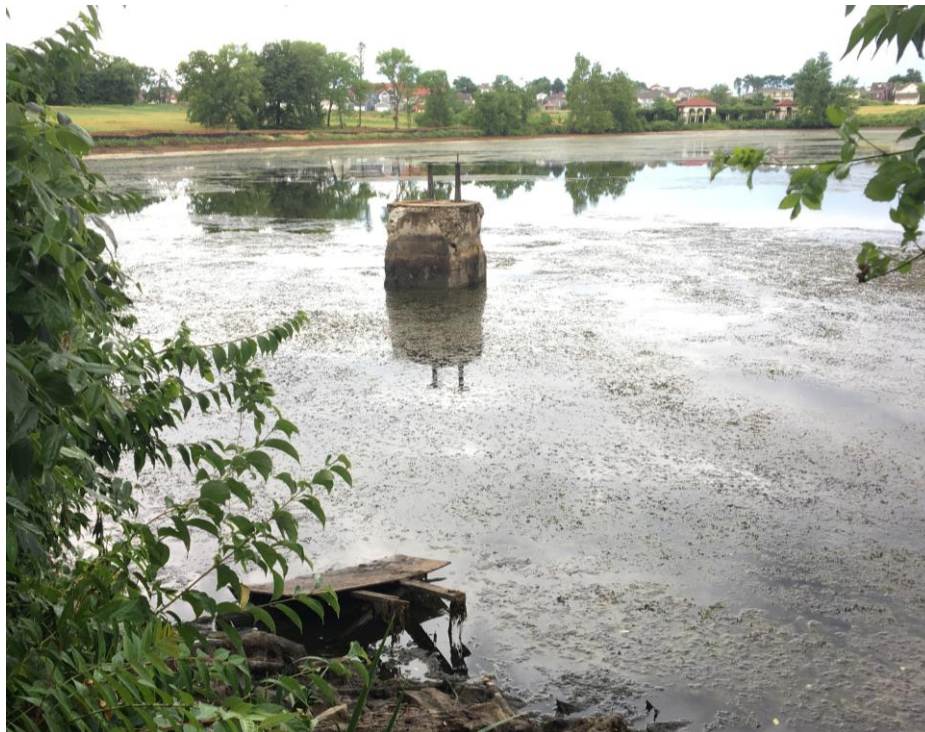
As requested, Olsson Associates (**Olsson**) visited the project site on June 19<sup>th</sup>, 2018 to observe the existing condition of the Old Longview Lake Dam and Spillway. Our previous observations noted a syphon pump in place to draw down the lake. At the time of our current observation, we observed the lake to be approximately one foot lower in elevation from the previous week as indicated by the staining on the structure shown in the Figure below.

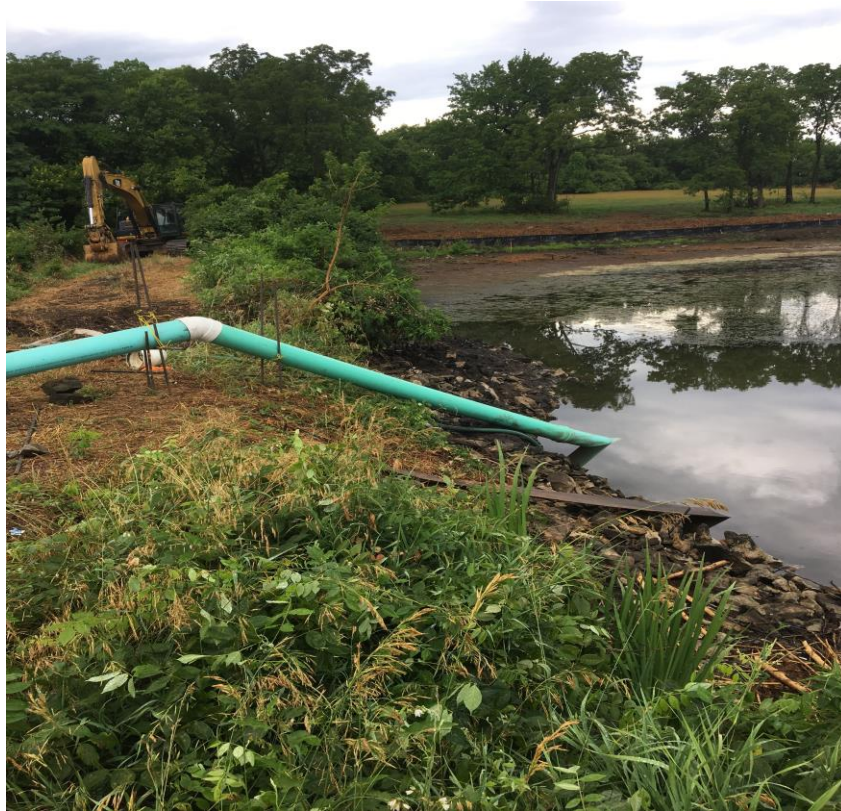
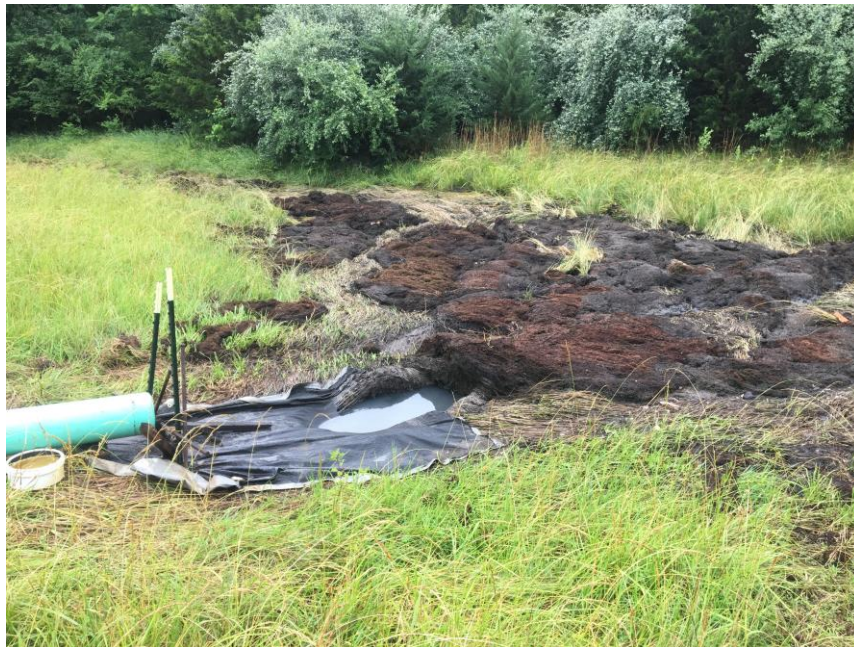
In addition, the pipe had been adjusted to a steeper angle in order to continue drawing the lake down if required. The pipe was not drawing water from the lake at the time of the observation. A larger moss pile is shown at the base of the hill where the pipe outlets. This is shown in the Figure below.

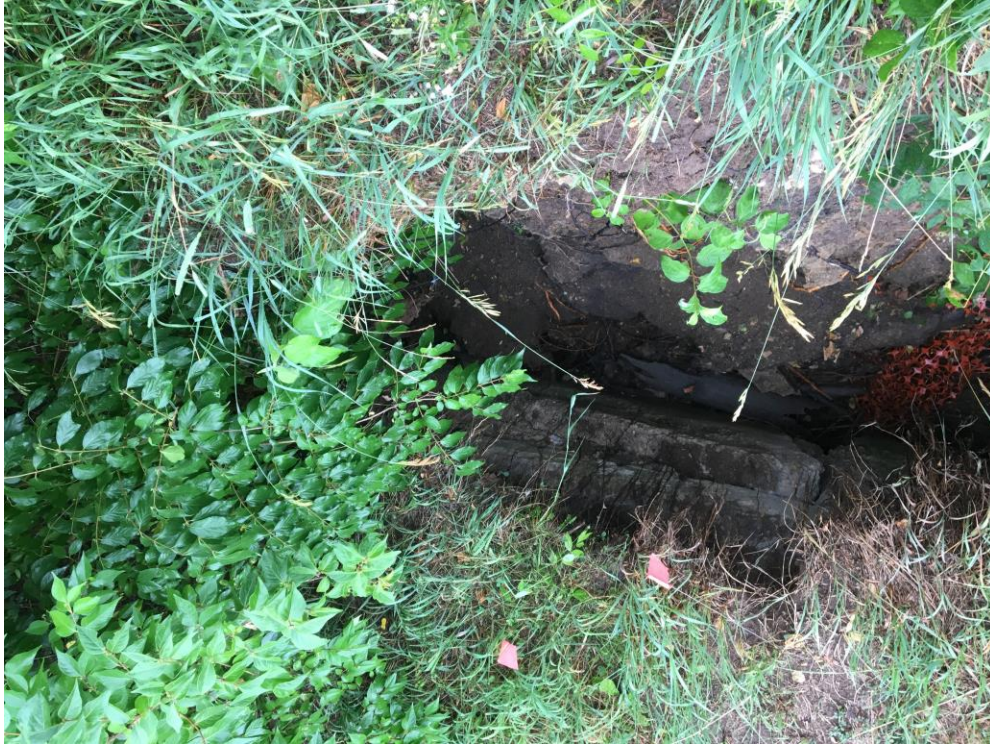
No water was observed flowing over the blanket of the spillway or through the eroded area on the west side of the spillway. Visually, the dam, spillway and erosion channel do not appear to have changed since our initial visit. We have included a current photograph of the area below.
