GEOTECHNICAL ENGINEERING REPORT

OLD LONGVIEW LAKE DAM AND SPILLWAY IMPROVEMENTS

LEE'S SUMMIT, MISSOURI

AUGUST 13, 2018

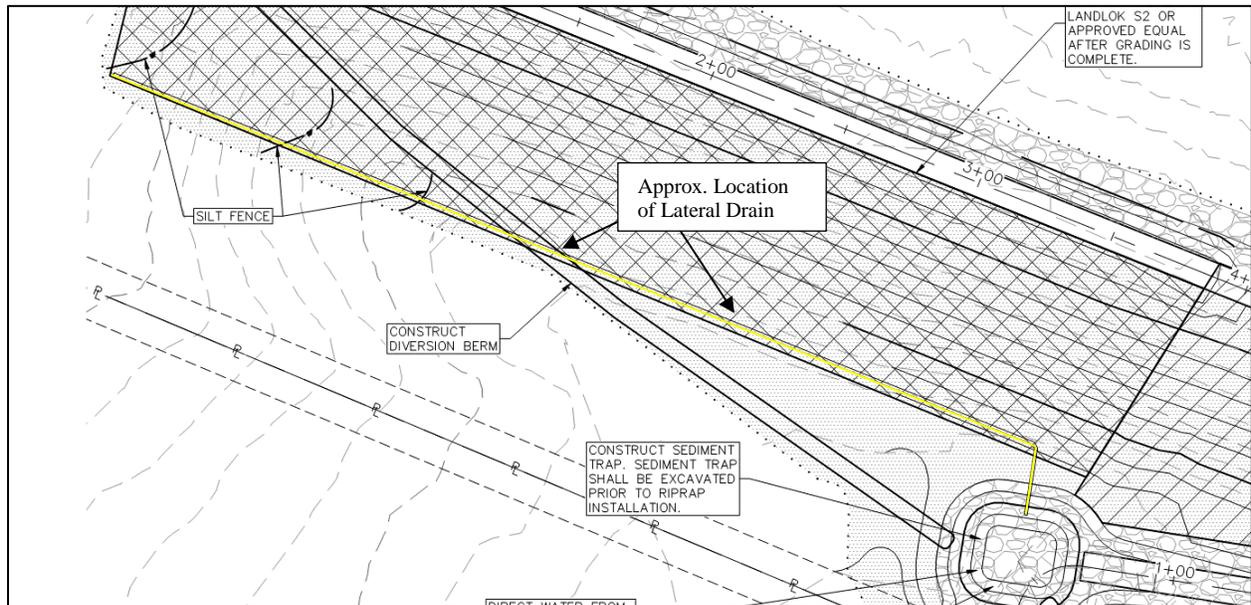
Figure 6: Lateral Drain Location

We recommend a lateral trench drain be installed near the toe of the slope on the west side of the embankment. As mentioned previously, water was observed seeping out of the ground in this area. The drain should be a minimum of three feet from the toe with at least 1 foot of clay cover. The location of the drain is shown in Figure 6 below.

The lateral drain should be three feet deep by three feet wide and consist of ¾ inch clean rock wrapped in Mirafi 140 N filter fabric. A four-inch diameter perforated pipe should be placed near the bottom of the drain and positioned to drain to the settling basin at a minimum slope of 2 percent. A typical detail of the drain is shown below.

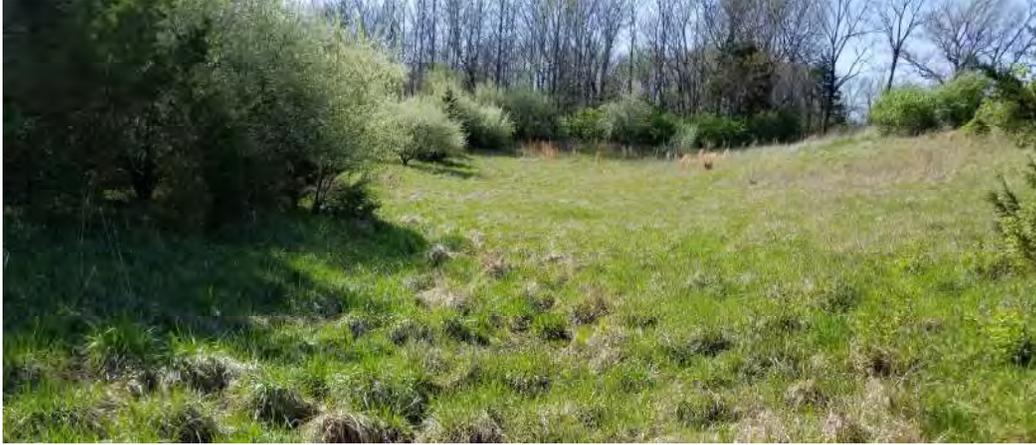
Figure 3: Photograph of West Portion of the Downstream Face of Dam

The west half of the downstream face of the dam slopes at an estimated 5H:1V and contains shallow rooted shrubs on the crest of the dam and shallow rooted grasses on the face of the slope. A photograph of the west portion of the dam is shown in Figure 3.

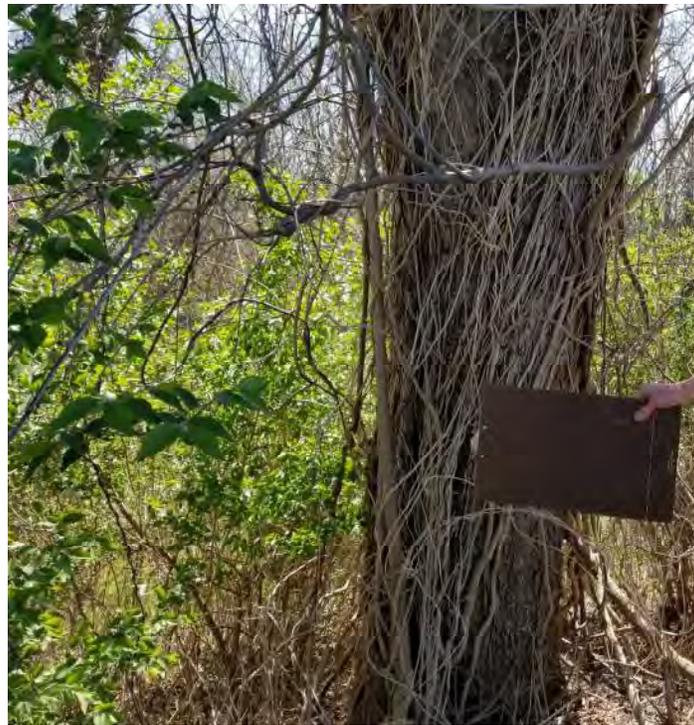
Figure 4: Photograph of Large Mature Tree on Crest of Dam

The center of the downstream face of the dam contains shallow rooted vegetation and two large mature trees on the crest of the dam (Figure 4). Smaller, less mature trees cover the remainder of the slope (Figure 5). The large trees appear to be around 24 inches in diameter and have canopies around 50 feet in diameter. The smaller trees are generally 6 inches in diameter or less. Additional vegetation, including shrubs and grasses, were observed in this area.

Removal of the large trees should be delayed until final construction plans are developed and the lake can be drawn down to a level that does not destabilize the dam during excavations. Repair of the toe seepage can also be delayed until final construction.

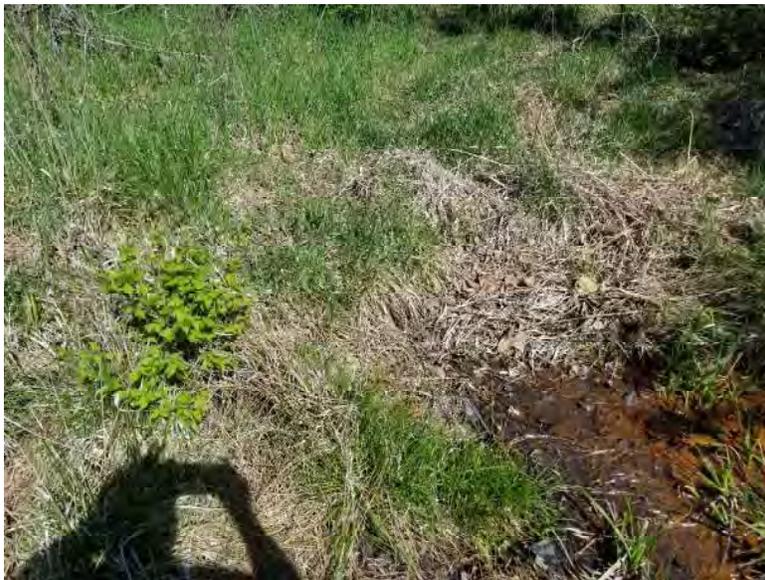
Figure 6: Photograph of Seepage at Toe of Dam

Seepage was observed at the toe of the slope in the central portion of the dam. In our opinion, the amount of seepage observed was relatively minor as erosion from the seepage or flowing water out of the toe was not observed. In addition, seepage was only encountered at the toe and not found along the slope. The pooling of seepage water at the toe of the slope is shown in Figure 6.

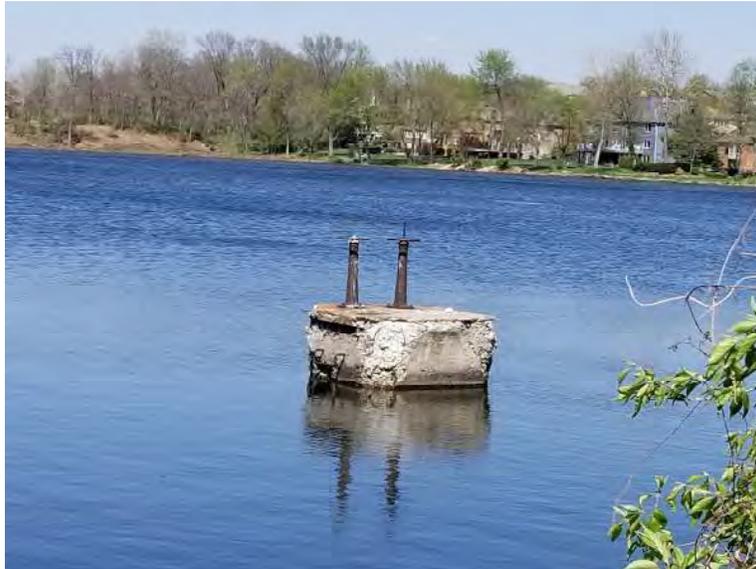
Figure 7: Drawdown Structure

What appears to be a drawdown structure with a set of valves is located within the lake approximately 50 feet north of the dam. We did not investigate the structure as access to the structure is only available by boat. However, it appears that this structure is no longer serviceable as we could not locate an outlet pipe downstream and the valves did not appear operable from our vantage point. In addition, the concrete foundation for the valve structure is in very poor condition. The structure is shown in Figure 7. We do not anticipate this structure will be reused.

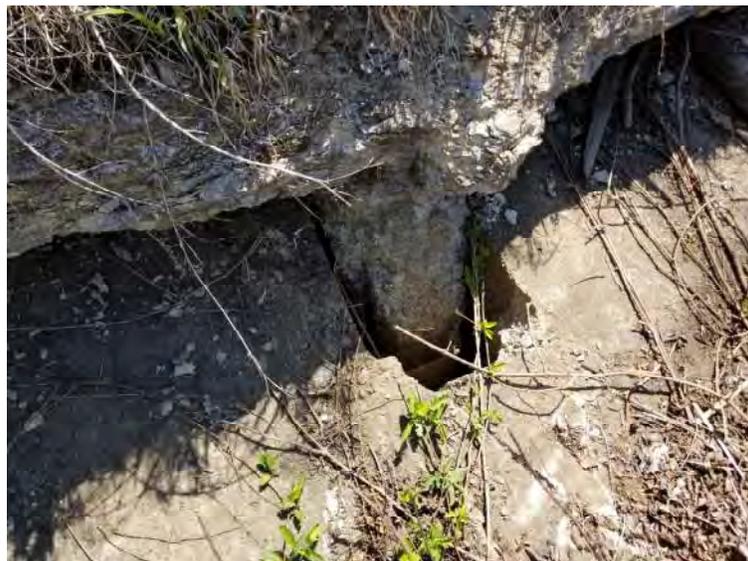
Figure 8: Photograph of Spillway Puncture

The primary spillway for the lake is located on the far east side of the dam. The spillway consists of a reinforced concrete double box with wingwalls downstream. The concrete is in very poor condition. Weathering has resulted in the exposure of the reinforcing elements. At the time of our site visit, the top portion of the box had punctured the concrete apron below (Figure 8).

The puncture appears to be due to loss of support from erosion below the bottom of the apron (Figure 9). In addition, the wingwalls appear to have been pushed into the channel from the growth of large vegetation (Figure 10).

We recommend the top portion of the double box spillway that has punctured the apron be removed to provide improved drainage along the spillway. From our observations, this portion of the spillway appears to only have been constructed to level the dam crest. Once the upper portion is removed, we recommend the holes in the concrete apron of the spillway be filled with non-shrink cement grout, flowable fill or Portland cement concrete. Any other noticeable seepage paths should also be grouted, including the erosion around the west side of the spillway. Once all the seepage paths are grouted, a minimum of 3 feet of rip-rap should be placed in front of the spillway extending 10 feet to either side of the spillway to help protect the spillway from additional erosion. The rip-rap should appropriately sized. Rip-rap should also be placed on the downstream side of the spillway to prevent any movement that could occur during high water events.

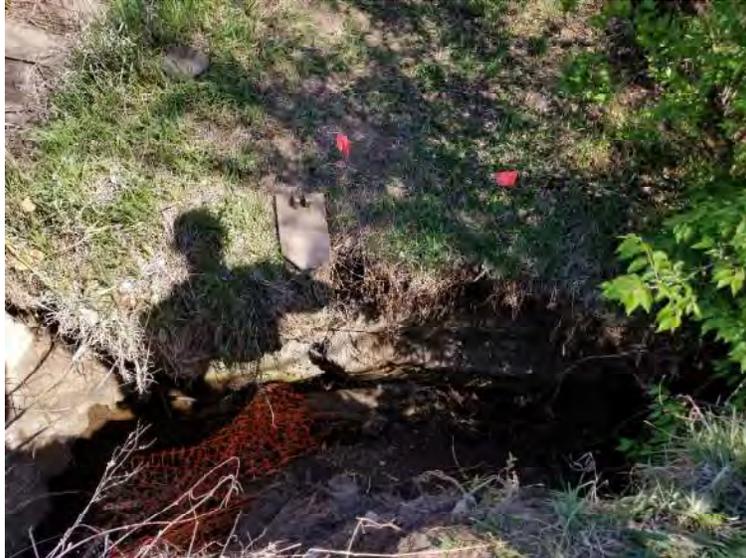
Figure 11: Photograph of Erosion Around West Side of Spillway

In addition to erosion below the spillway, we also observed erosion around the west side of the spillway (Figure 11). Erosion around the west side was around 3 to 4 feet deep and around 3 feet wide. At the time of our observations, the majority of water loss from the lake is directed through this area of erosion, however, the water level of the lake during our site visit did not reach the height of the spillway apron. It appears that during high water events, water would be directed over the spillway as normal. The areas downstream of the spillway appear consistent with most streams in the area. Some erosion is present, but erosion is limited by the thick vegetation and shallow rock elevation.

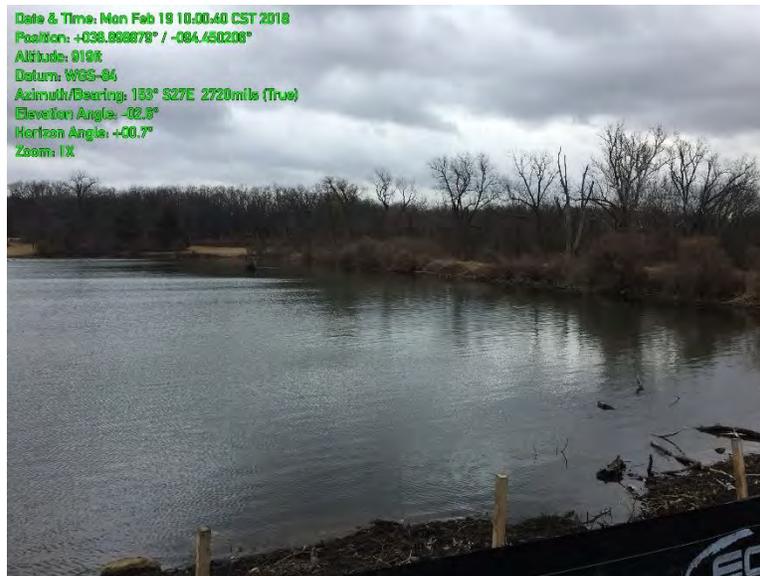
The dam is covered with grass along the downstream face, with heavy brush along the crest, and heavy brush and trees growing on the crest and downstream face of the eastern half of the dam. We did not observe any signs of seepage at the toe of the dam, which may be due to the ground still being frozen.

Photo 1- Looking at dam from western shore to the southeast

Vegetation on the dam crest and face- Clearing these trees and brush should be accomplished as soon as possible. It is important to have the geotechnical engineer provide recommendations for removal of root balls and replacement of the resulting excavations with proper engineered fill material.

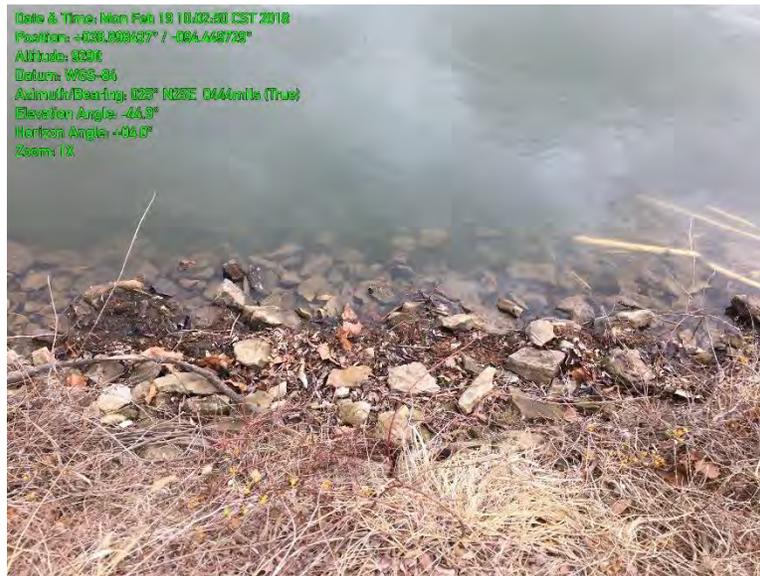
The upstream face appears to have rock fragments placed on it to control erosion (Photo 2). The freeboard area over the water surface does not appear to have any rock on its face and has experienced significant erosion (Photo 3).

Photo 2- Upstream face rock "erosion control"

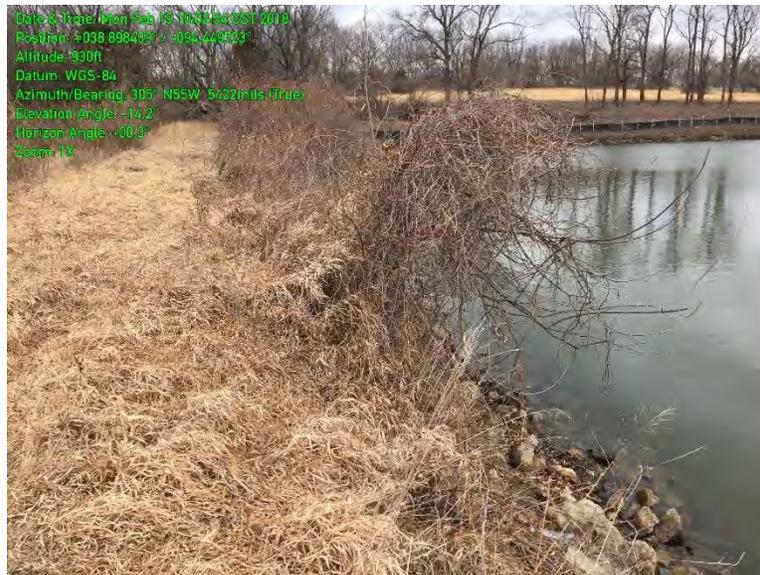
Photo 3- Looking west at freeboard erosion of embankment

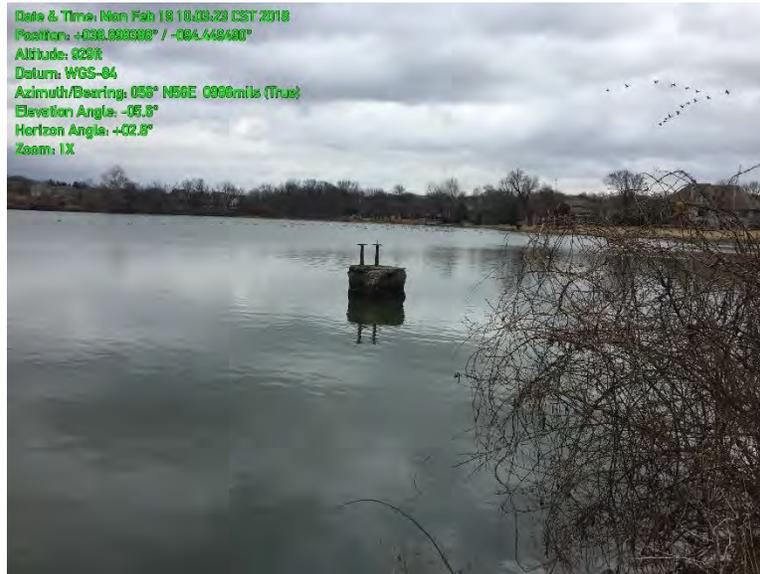
The primary spillway and outlets works appear to be in very poor condition, and is only accessible by boat, as there is no access walkway from the crest (Photo 4). The Terra Technologies report states that the outlet works valves and the spillway are inoperable. They could not find the outlet for this system, and Terracon could not locate the outlet during our site visits.

Photo 4- Primary spillway and outlet works

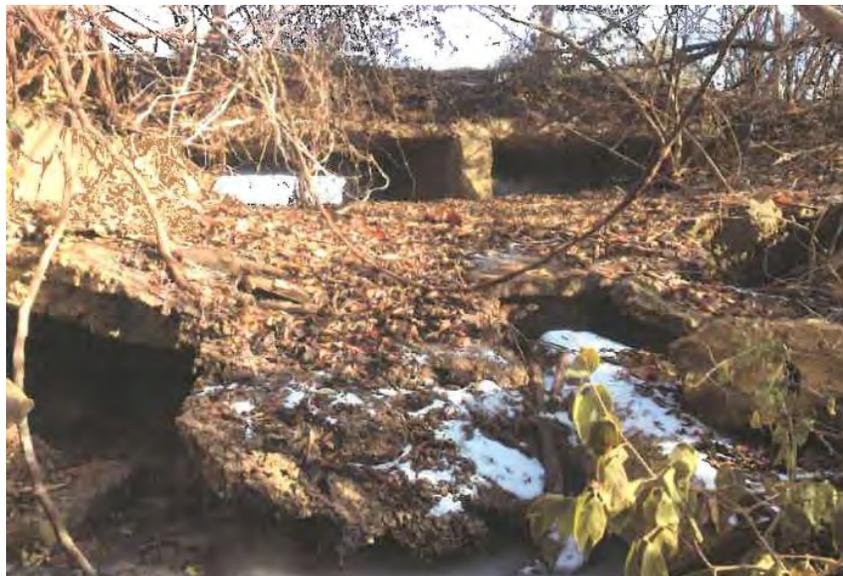
The emergency spillway was intact, but experiencing erosion that was undermining it when it was observed by KCTE (Photo 5). It has since collapsed (Photo 6) and we observed a steady flow of water (Photo 7) in the erosion channel coming from the lake.

Photo 5- Emergency spillway in late 2016/early 2017 (from Reference 2, Photo 5)

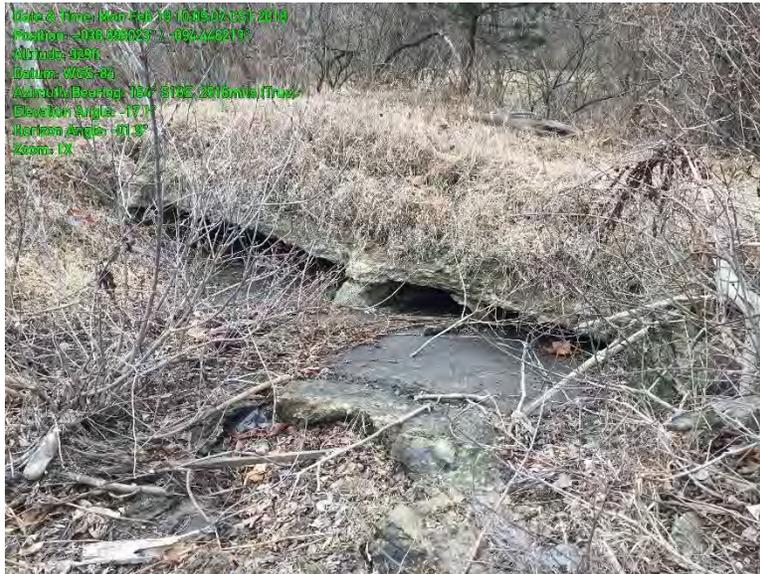
Photo 6- Emergency spillway February 19, 2018)

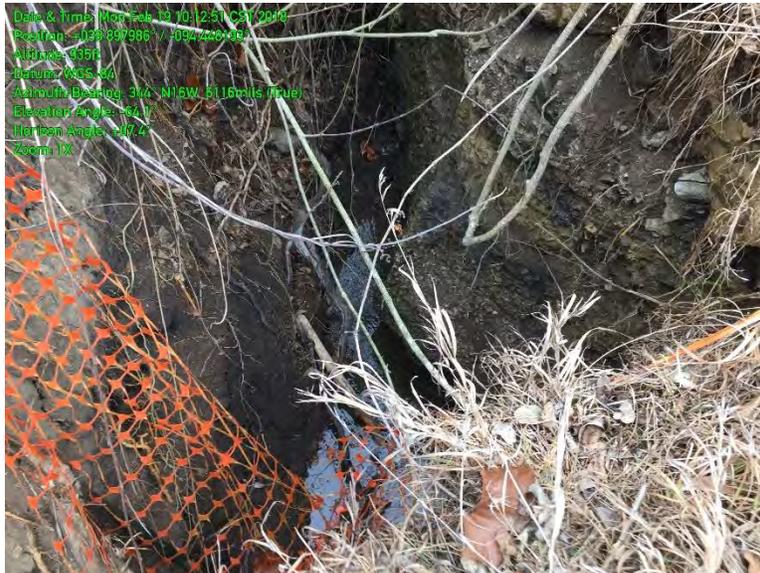
Photo 7- Seepage under emergency spillway

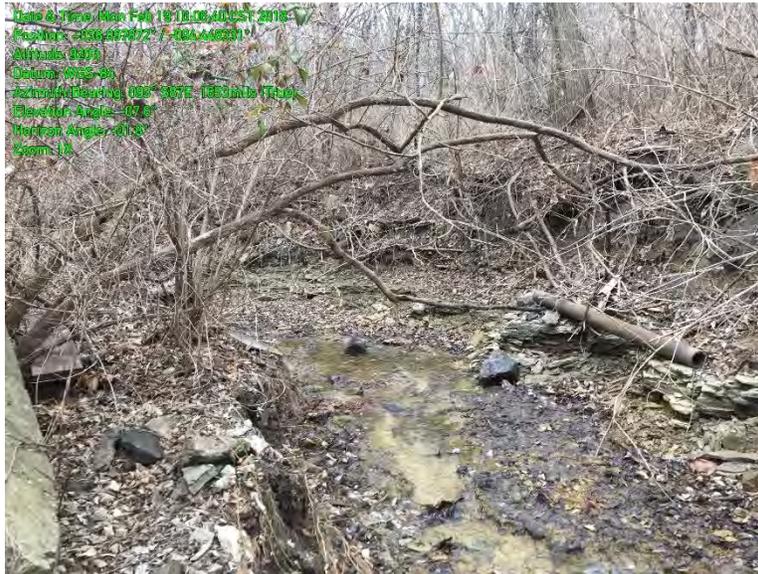
Downstream of the emergency spillway, significant erosion of the stream banks was observed during our visit (Photos 8 and 9).

Photo 8- Looking southwest from downstream side of emergency spillway

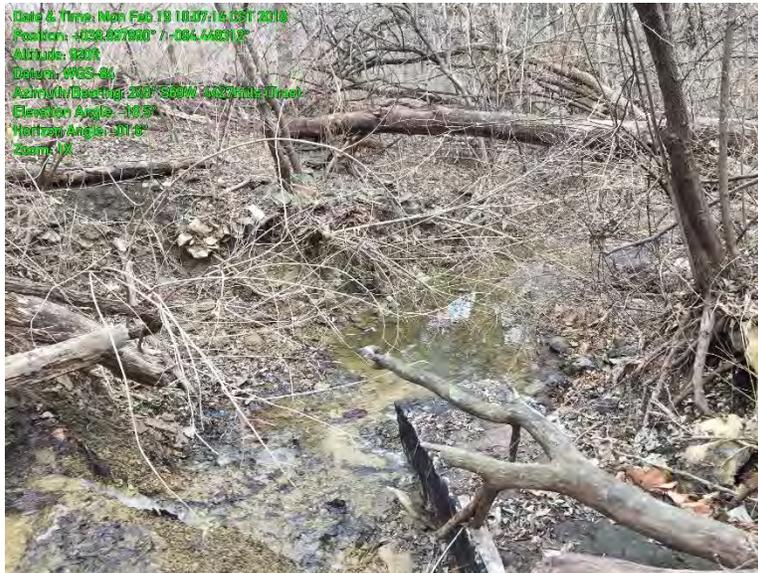
Photo 9- Looking south approximately 100 feet downstream from emergency spillway

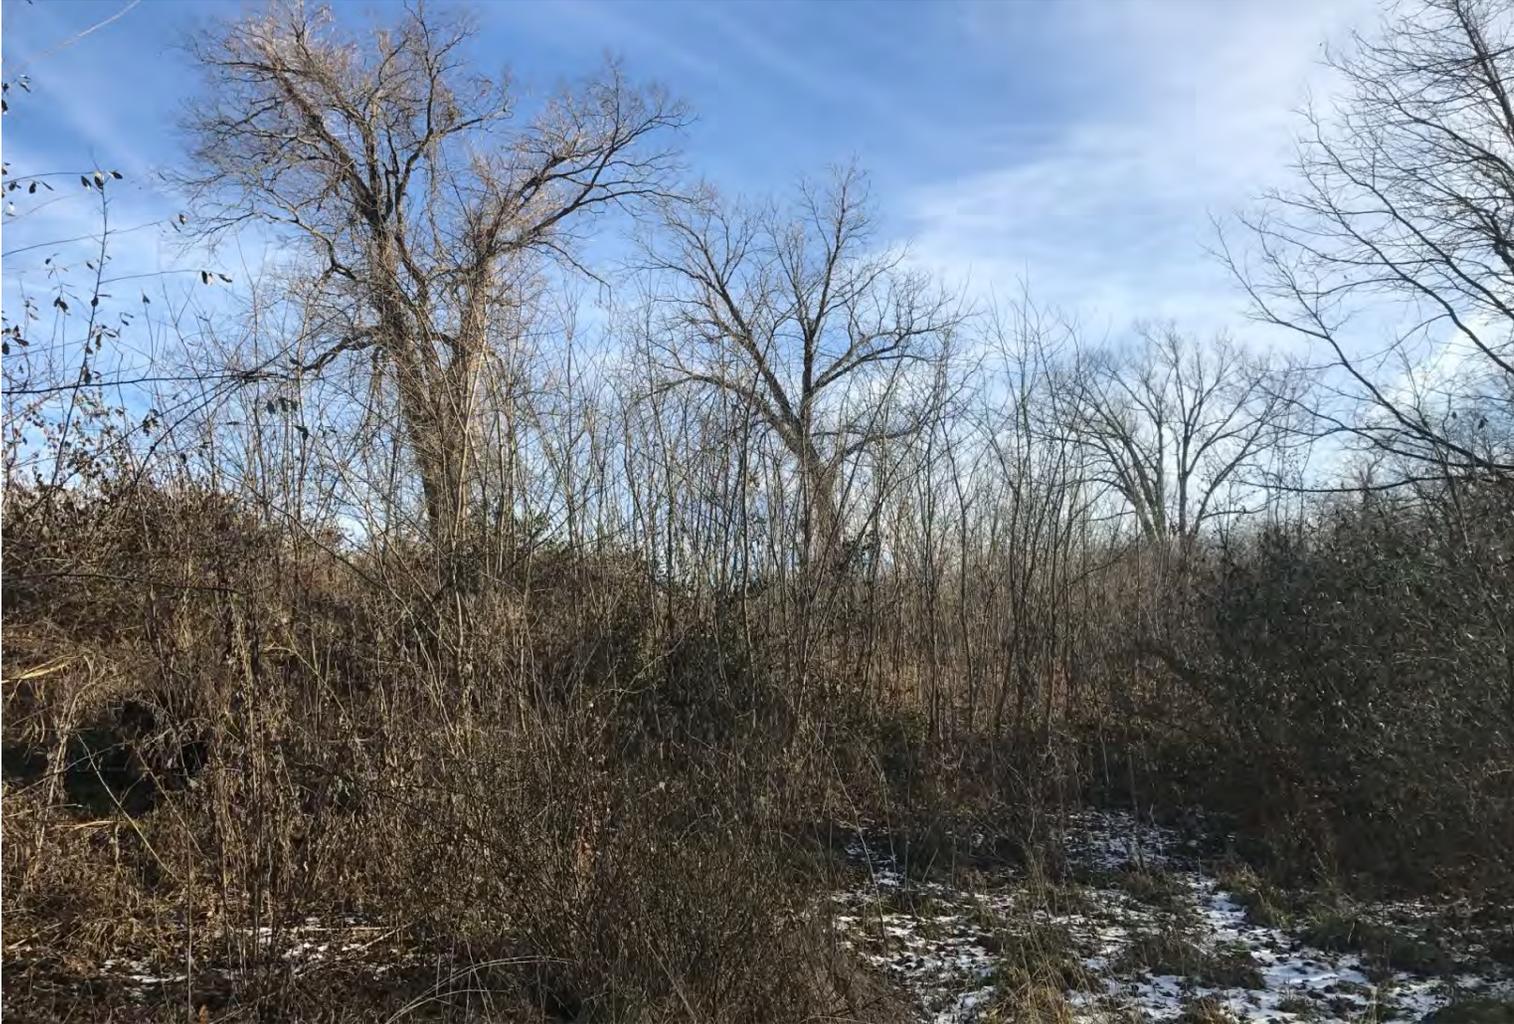
Typical view of woody growth on downstream face of eastern portion of dam.

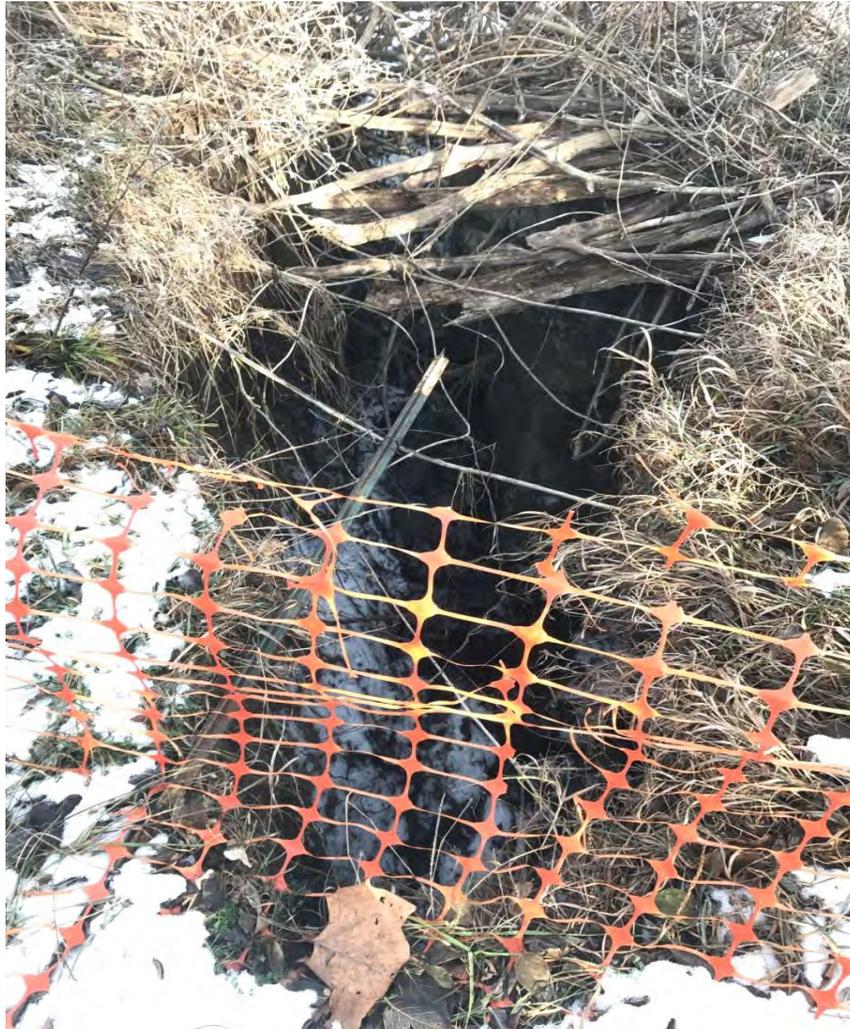
Typical view of erosional channel adjacent to spillway structure.

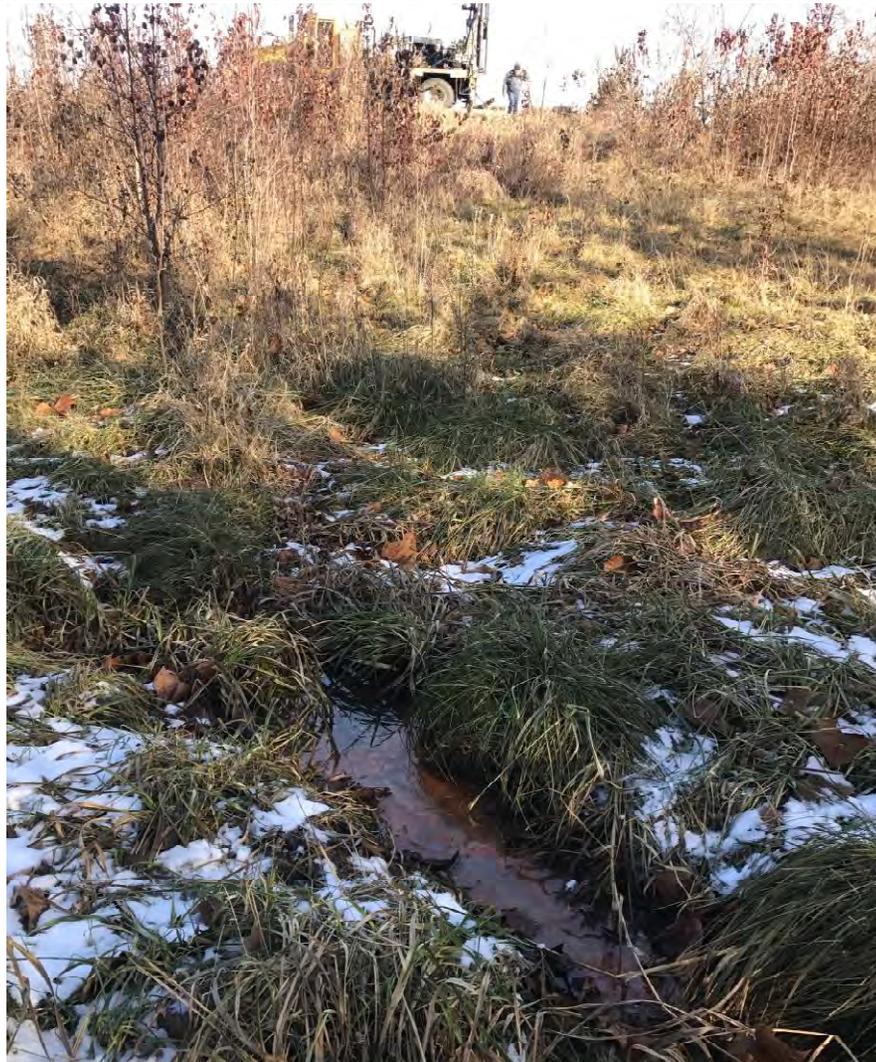
Typical view of water seepage at toe of dam.
