Subject: Maintenance and Condition Assessment Report

AT&T/Black & Veatch Designation:	Site Name:	Green
	Site Number:	KS4130
Engineering Firm Designation:	TEP Project Number:	75971-66325
Site Data:	202 E. Third St. Lee's Summit, Jackson County, MO 64063 Latitude N 38° 54' 49.97", Longitude W 94° 22' 26.77" 145± Foot – Monopole Tower

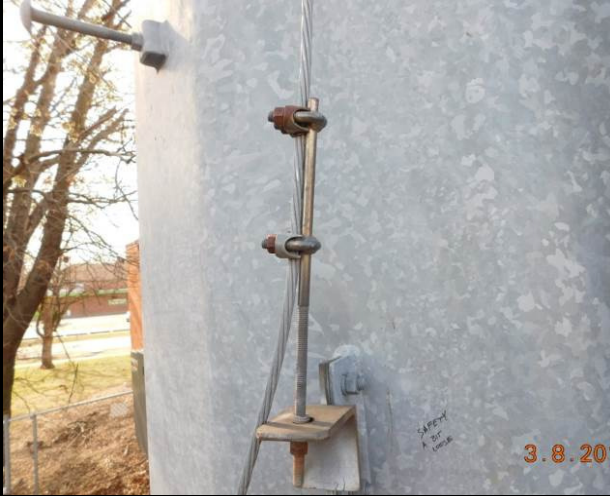
<p><u>A.4. Climbing facilities, platforms, catwalks – all secure</u></p> <p>Observation: The mounting hardware at the base of the safety climb cable was observed to be loose and had corrosion.</p> <p>Recommendation: The mounting hardware should be replaced with new material of the same size and strength, and tightened to a “snug-tight” condition.</p>
 	<p><u>A.4. Climbing facilities, platforms, catwalks – all secure</u></p> <p>Observation: The safety climb cable was observed to be slightly loose.</p> <p>Recommendation: The safety cable should be tightened so that there is no slack in the cable throughout the tower elevation.</p>

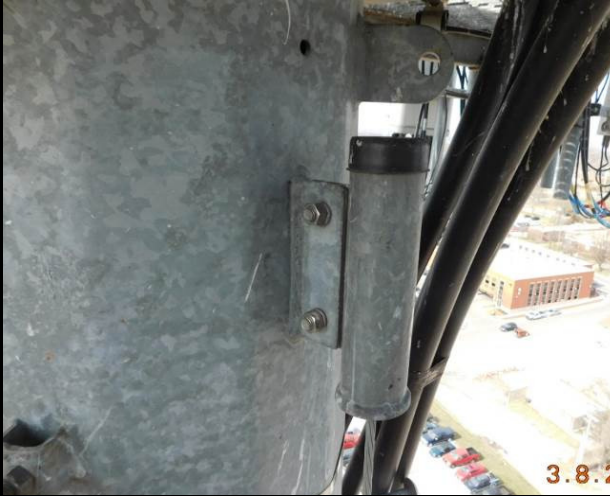
<p>3.8.2</p>	<p><u>A.4. Climbing facilities, platforms, catwalks – all secure</u></p> <p>Observation: The tail of the top of the safety climb cable was observed to be projecting from the sleeve assembly less than the 1" minimum recommended by the manufacturer.</p> <p>Recommendation: Consult the safety cable manufacturer for corrective actions. Reduced projection may indicate a fall or force may have occurred to the safety cable system. The safety cable manufacturer appears to be 3M / DBI Sala.</p>

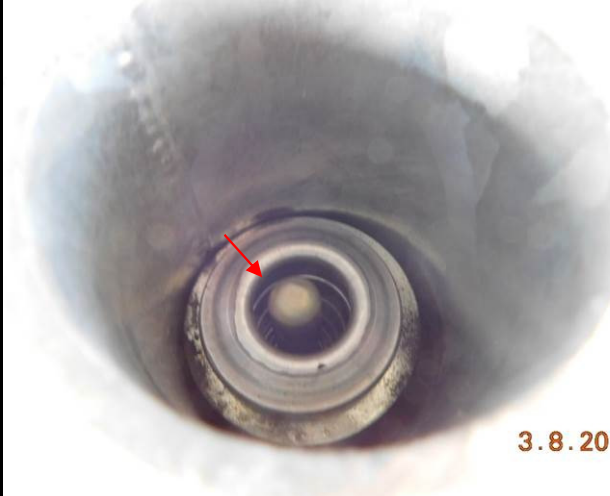
<p>3.8.20</p>	<p><u>A.4. Climbing facilities, platforms, catwalks – all secure</u></p> <p>Observation: Chipped galvanizing and corrosion was observed on the safety climb cable from elevations 120'± to 122'±.</p> <p>Recommendation: All corrosion should be cleaned with a wire brush and coated with two coats of approved galvanizing compound. Ensure a safety climb device runs smooth along the safety climb cable after galvanizing. Monitor the safety cable in future maintenance cycles for any additional deterioration at this location.</p>

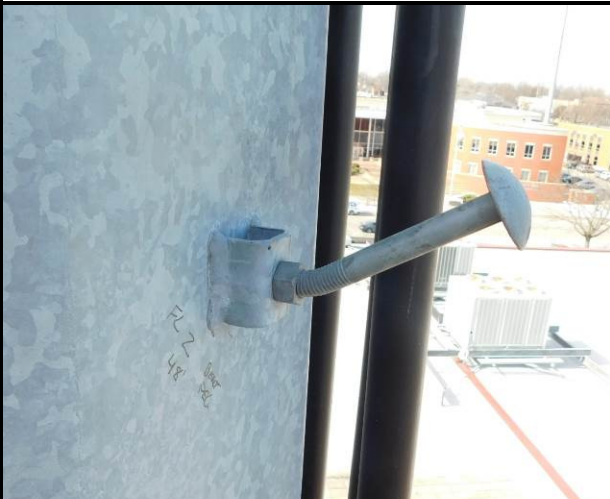
<p><u>A.4. Climbing facilities, platforms, catwalks – all secure</u></p> <p>Observation: A bent step peg was observed on flat 2 at elevation 48'±.</p> <p>Recommendation: The step peg should be replaced with a new step peg of the same size and strength.</p>

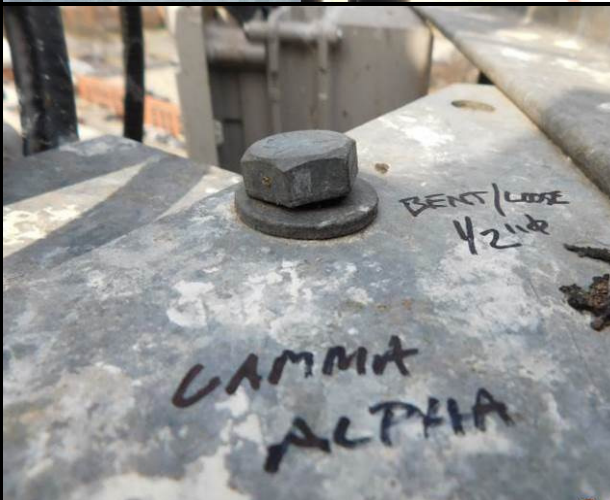
<p><u>A.5. Loose and/or missing bolts and/or nut locking devices</u></p> <p>Observation: One 1/2"Ø bolt located on the platform mount near the Alpha/Gamma corner was observed to be loose. Proper fit-up between the bolt and the plate was not achieved.</p> <p>Recommendation: The bolt should be replaced with a new bolt of the same size and strength and tightened per the "Turn-of-the-Nut" method.</p>

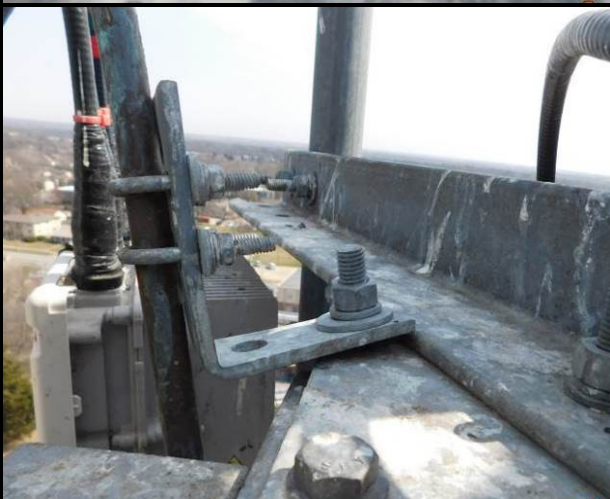
<p><u>A.5. Loose and/or missing bolts and/or nut locking devices</u></p> <p>Observation: Improper fit-up was observed on the connection from the existing lightning rod to the tower platform.</p> <p>Recommendation: The position of the connection should be adjusted so that proper fit-up between all members is achieved. The connection should be tightened to a "snug-tight" condition.</p>

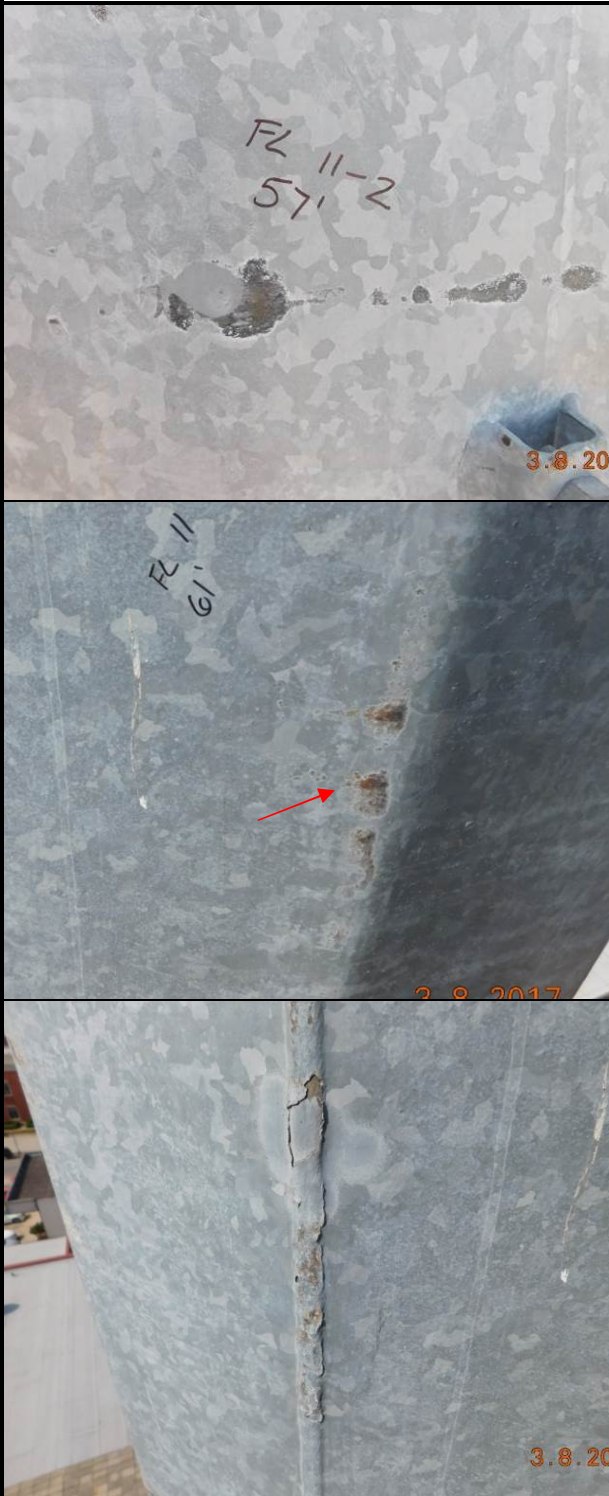
<p><u>B.1. Paint and/or galvanizing condition</u></p> <p>Observation: Chipped galvanizing was observed on the monopole shaft on flat 11 at elevations 57'±, 61'± and 66'±.</p> <p>Recommendation: The chipped galvanizing should be cleaned with a wire brush and painted with two coats of approved galvanizing compound.</p>

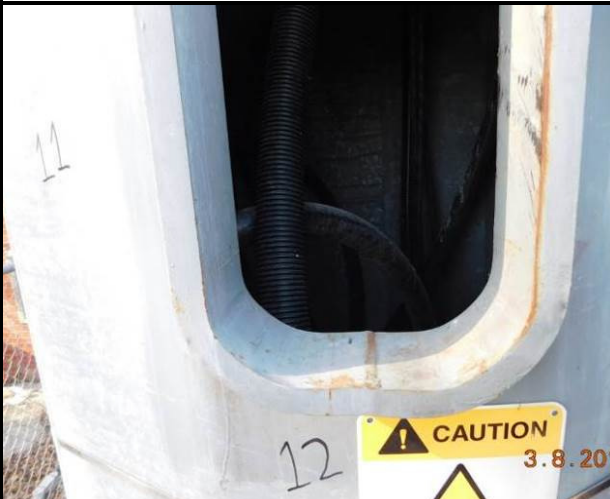
<p><u>B.2. Rust and/or corrosion condition including mounts and accessories</u></p> <p>Observation: Corrosion was observed on the outside of the porthole installed on flat 12 at elevation 6'-6".</p> <p>Recommendation: All corrosion should be cleaned with a wire brush and painted with two coats of approved galvanizing compound.</p>

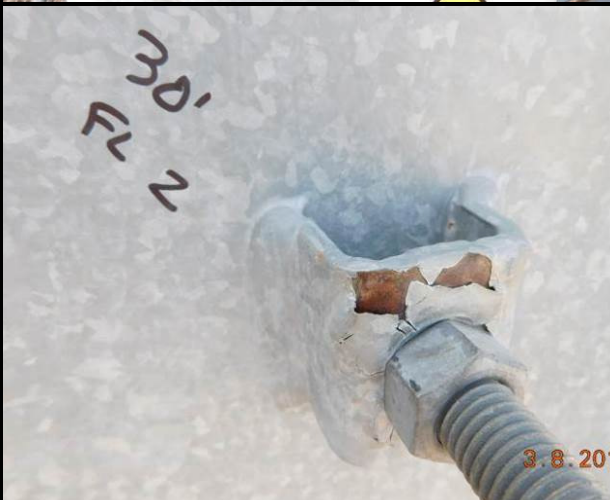
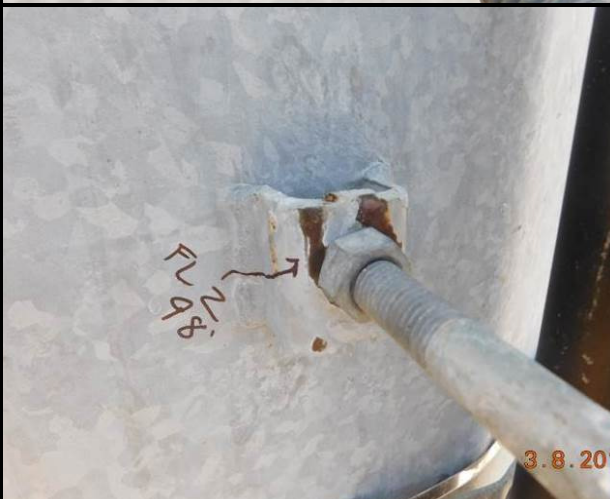
<p><u>B.2. Rust and/or corrosion condition including mounts and accessories</u></p> <p>Observation: Corrosion and chipped galvanization was observed at the following locations:</p> <ul style="list-style-type: none"> • The step peg on flat 2 at elevation 30'±. • The step peg on flat 2 at elevation 98'±. <p>Recommendation: All corrosion should be cleaned with a wire brush and painted with two coats of approved galvanizing compound.</p>

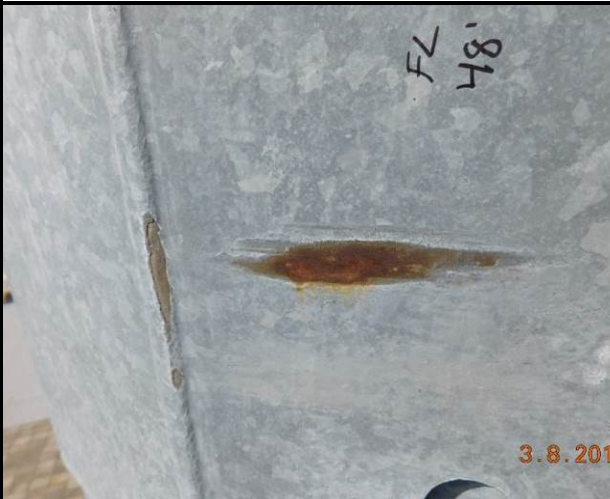
<p><u>B.2. Rust and/or corrosion condition including mounts and accessories</u></p> <p>Observation: Corrosion was observed on the monopole shaft in the following locations:</p> <ul style="list-style-type: none"> • Flat 11 at elevation 48'. • Flat 11 at elevation 121'-6"±. <p>Recommendation: All corrosion should be cleaned with a wire brush and painted with two coats of approved galvanizing compound.</p>

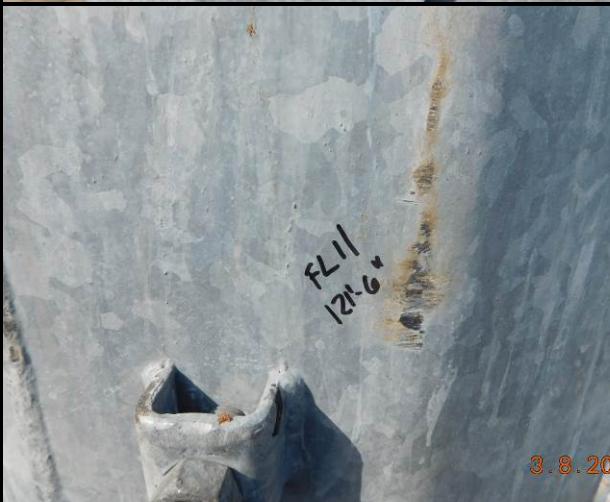
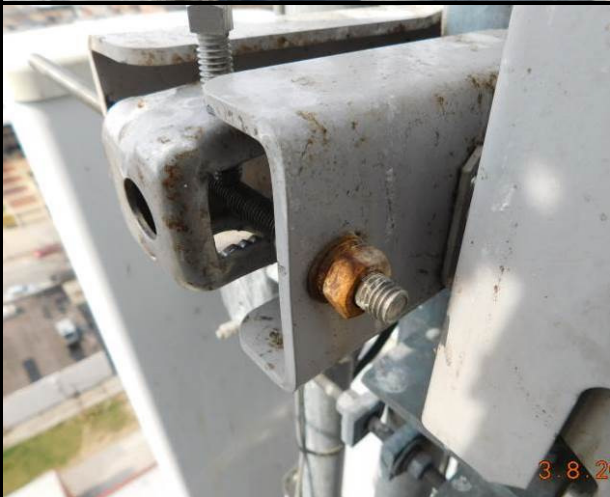
<p><u>B.2. Rust and/or corrosion condition including mounts and accessories</u></p> <p>Observation: Corrosion was observed on the nuts installed on the RRH mounting hardware in position 2 of the Alpha sector, position 3 of the Beta sector, and position 3 of the Gamma sector.</p> <p>Recommendation: The mounting hardware should be replaced with new members of the same size and strength.</p>

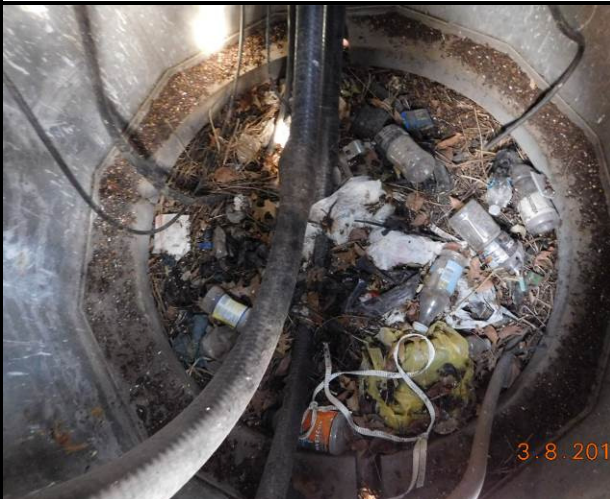
<input type="checkbox"/> Okay	<input type="checkbox"/> Possible Improvement	<input checked="" type="checkbox"/> Needs Repair	<input type="checkbox"/> Not Applicable
Notes: Trash/debris was observed inside the monopole base. See the executive summary for further details.

<p><u>B.4. Water collection in members (to be remedied, e.g., unplug drain holes, etc.)</u></p> <p>Observation: The base of the monopole is clogged with trash/debris.</p> <p>Recommendation: Ensure that the monopole base is clear and free flowing to prevent corrosion from occurring inside the monopole shaft.</p>

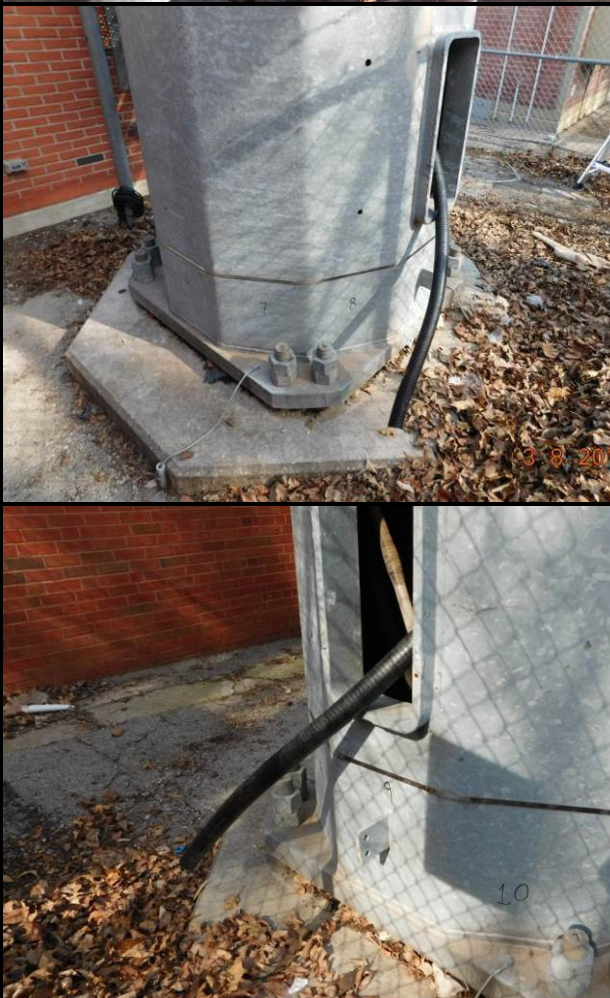
<p><u>E.3. Feed line condition (flanges, seals, dents, jacket damage, grounding, etc.)</u></p> <p>Observation: A coax exiting out of the porthole on flat 9 at elevation 2'-0" was observed to have been cut.</p> <p>Recommendation: The carrier or tower owner should remove the abandoned coax.</p>

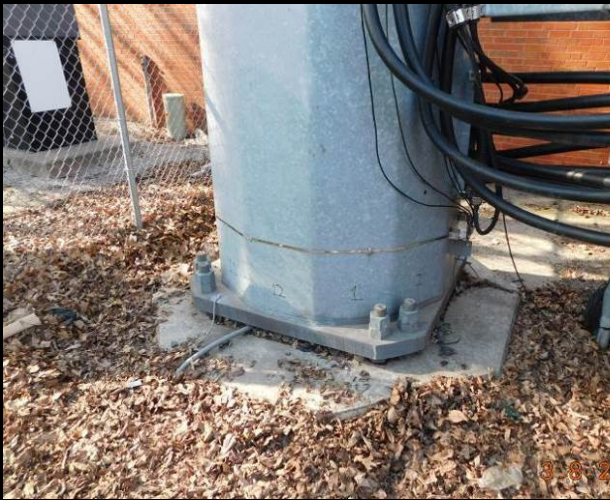
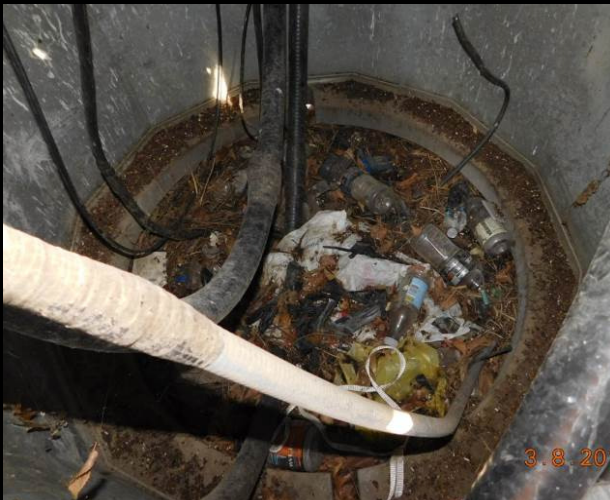
<p><u>I.1.c. Ground condition (Site condition (standing water, drainage, trees, etc.))</u></p> <p>Observation: Vegetation and trash/debris was observed throughout the compound and inside the monopole base.</p> <p>Recommendation: All vegetation and trash/debris should be removed from the site.</p>
