Subject: Maintenance and Condition Assessment Report

T-Mobile Designation: **Site Number:** A5C0335A
Site Name: Longview Farm Tank

Inspection Firm Designation: **TEP Project Number:** 591422.305839

Site Data: **499 Southwest Tower Park Drive**
Lee's Summit, MO 64081
Latitude N 38° 54' 33.00", Longitude W 94° 26' 53.99"
98± Foot – Water Tank

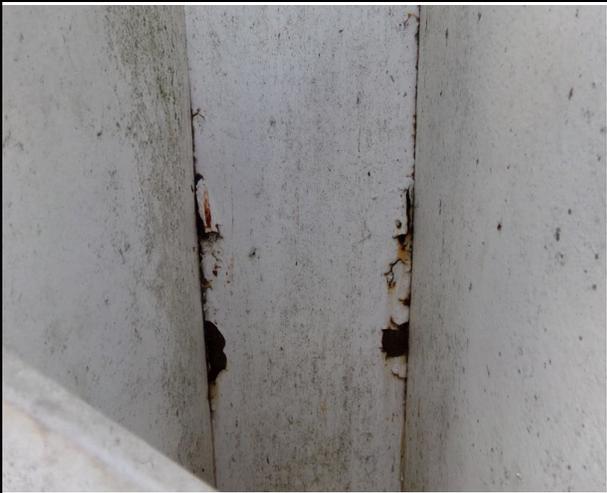
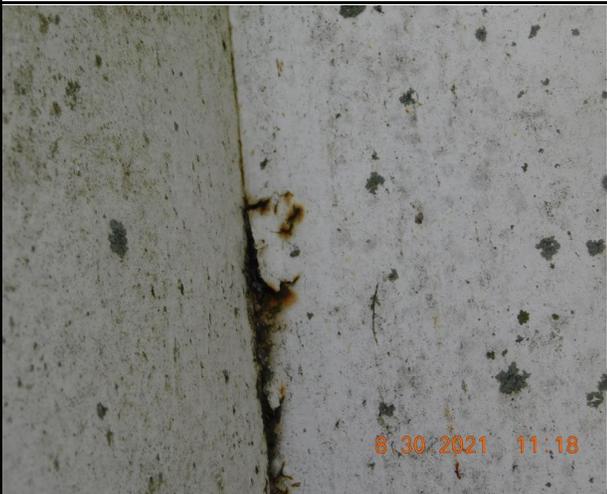
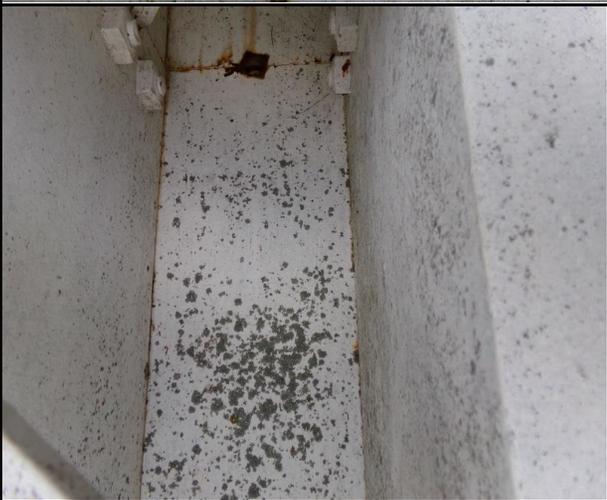
<p>Observation: Minor corrosion was observed throughout the inside of every tower leg.</p> <p>Recommendation: Monitor condition of the inside of each leg to ensure no material loss occurs. AWWA recommends regularly scheduled maintenance inspections every five years.</p>

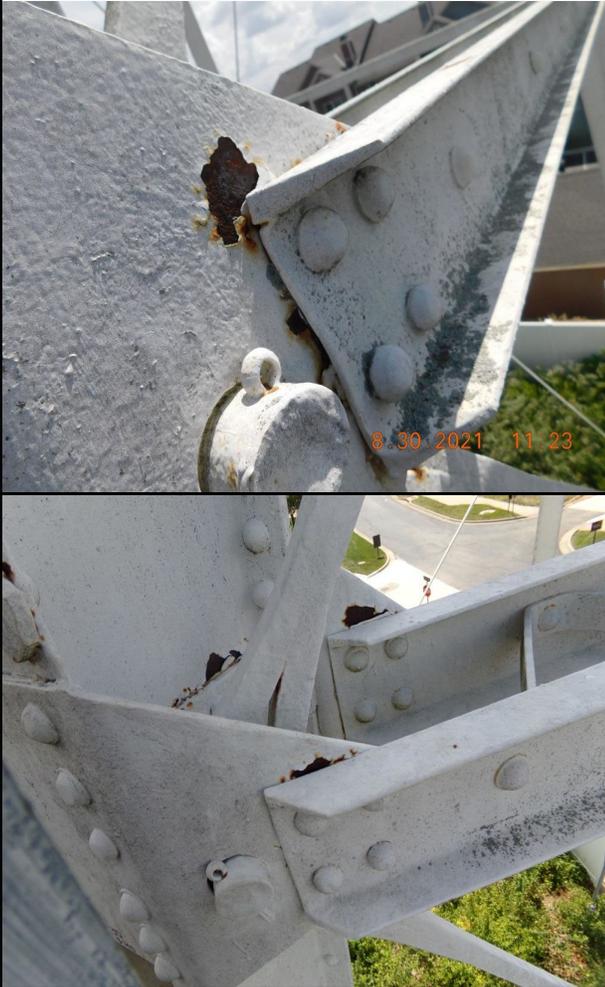
<p>Observation: Corrosion was observed on the water tank horizontal bracings on legs A and B at elevation 30’.</p> <p>Recommendation: Use a wire brush to remove existing paint from vicinity of visible corrosion. Then thoroughly clean and apply two coats of a brush on cold galvanizing compound containing at least 95% zinc if corrosion is observed. If during this process any section loss is observed, contact TEP immediately. Repaint to match.</p>

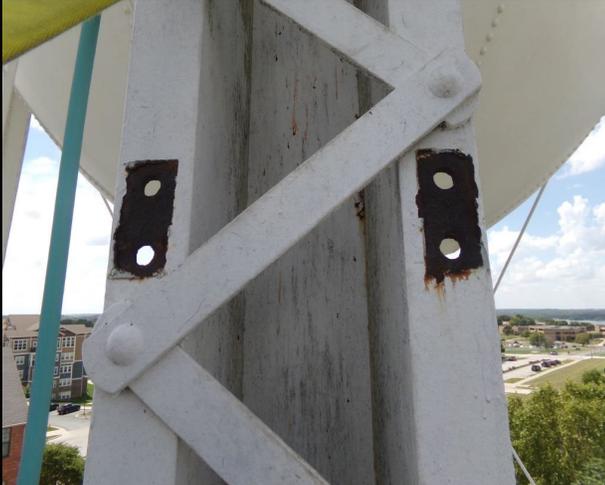
<p>Observation: Corrosion was observed on B leg at elevation 45’.</p> <p>Recommendation: Use a wire brush to remove existing paint from vicinity of visible corrosion. Then thoroughly clean and apply two coats of a brush on cold galvanizing compound containing at least 95% zinc if corrosion is observed. If during this process any section loss is observed, contact TEP immediately. Repaint to match.</p>

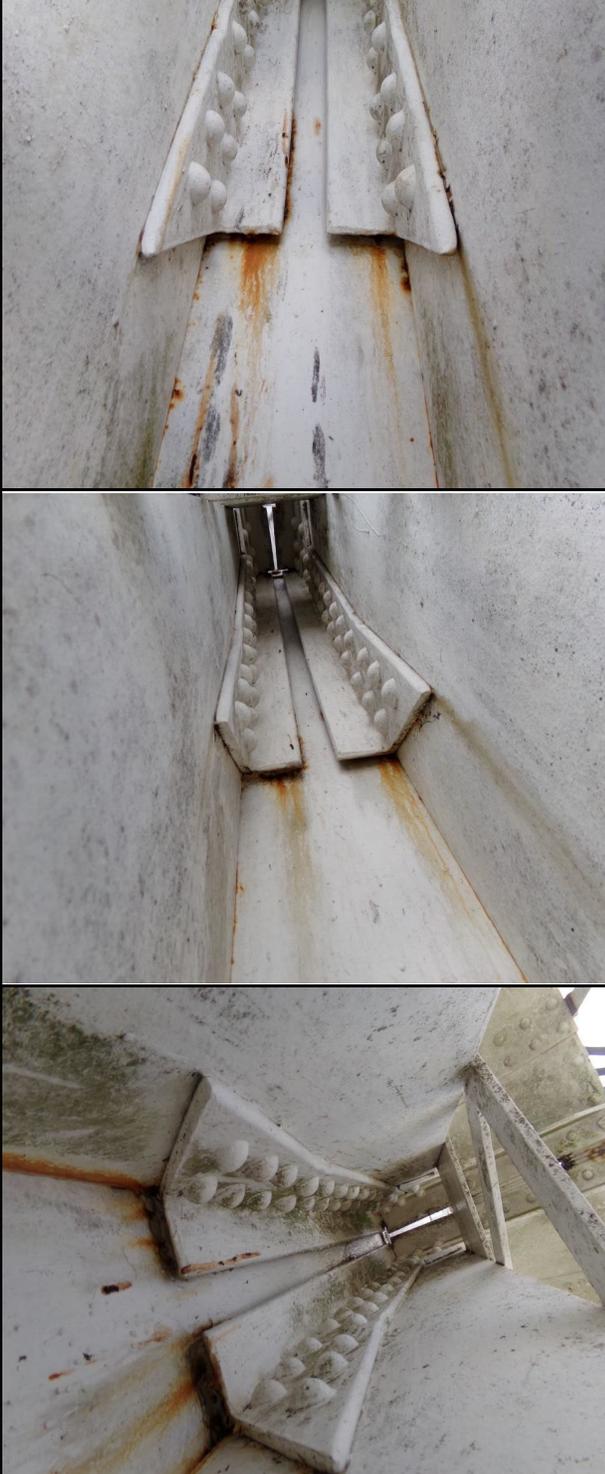
<p>Observation: Minor corrosion was observed on the bottom of the inside connection of the tower leg to the water tank on all legs.</p> <p>Recommendation: Monitor condition of the inside of each leg to ensure no material loss occurs. AWWA recommends regularly scheduled maintenance inspections every five years.</p>

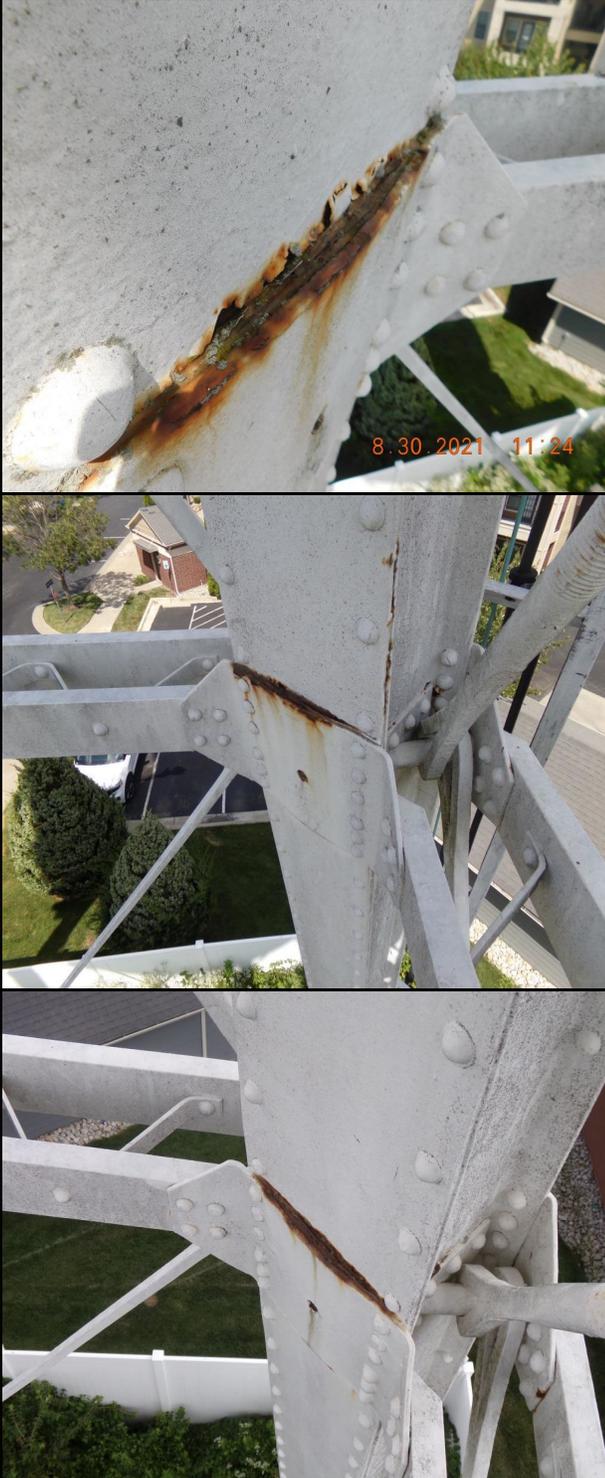
<p>Observation: Corrosion was observed on the back of every tower leg at elevation 30'.</p> <p>Recommendation: Use a wire brush to remove existing paint from vicinity of visible corrosion. Then thoroughly clean and apply two coats of a brush on cold galvanizing compound containing at least 95% zinc if corrosion is observed. If during this process any section loss is observed, contact TEP immediately. Repaint to match.</p>

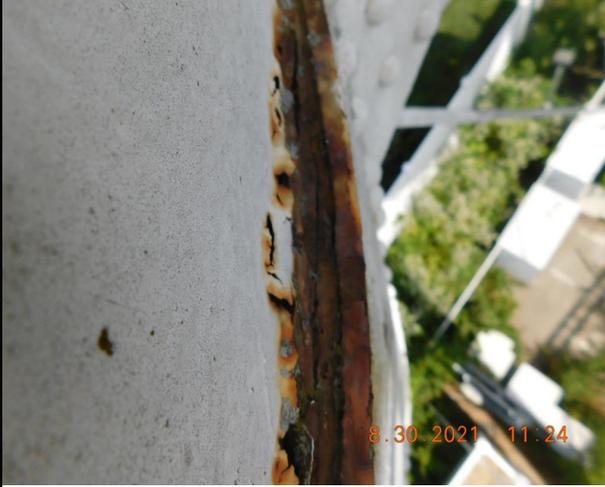
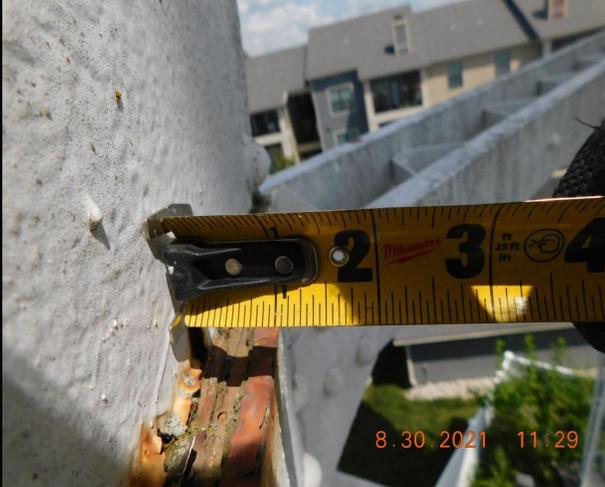
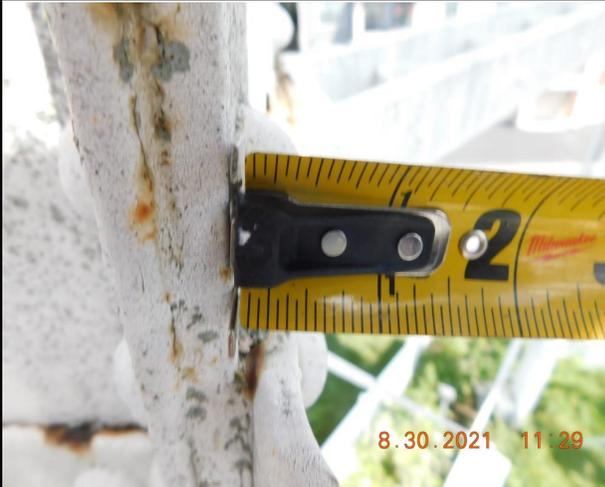
<p>Observation: (4) bent PL 15''x14''x3/8'' were observed on the back of every tower leg at elevation 30'.</p> <p>Recommendation: An Engineer licensed in the state of Missouri should review the current condition and determine an appropriate course of action.</p>

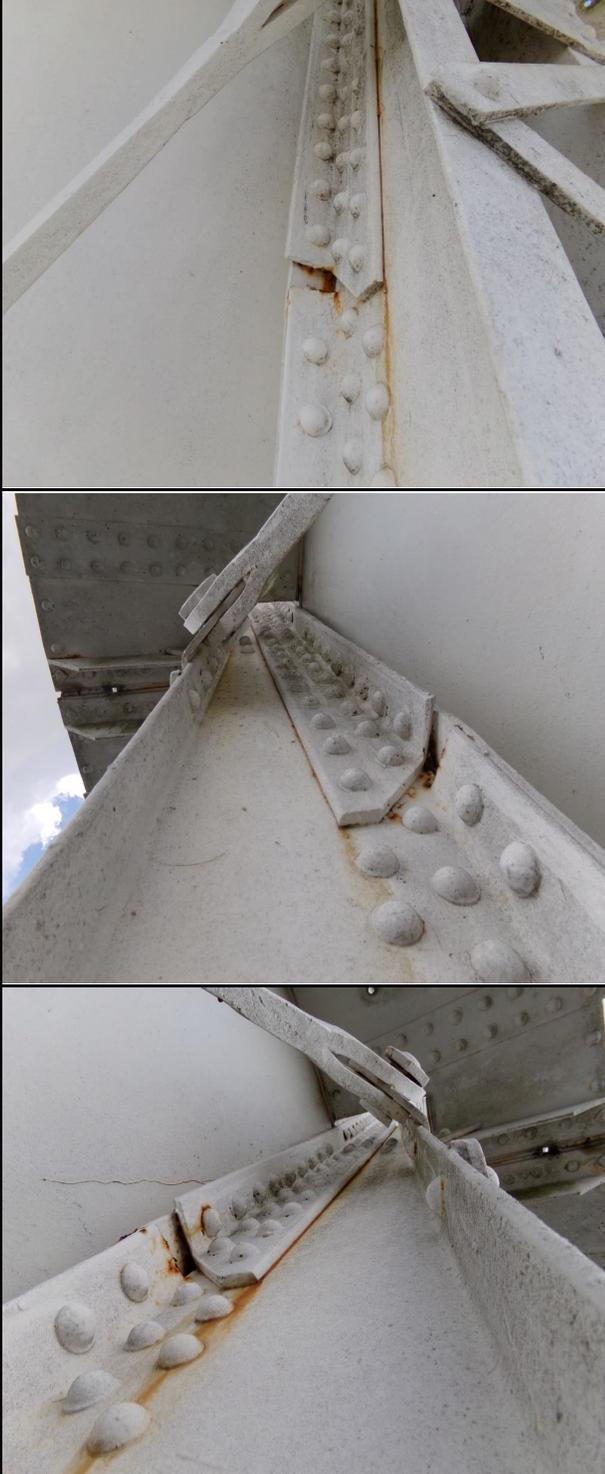
The photographs show the interior of a water tower leg, focusing on the connection points between the legs. The metal surfaces are painted white, and there are visible signs of minor corrosion, particularly at the joints and along the edges of the legs. The corrosion appears as brownish-orange staining and pitting. The legs are supported by a network of steel beams, and the overall structure is well-maintained but shows signs of age and wear.	<p>Observation: Minor corrosion was observed on the outside of every tower leg connection to the water tank at elevation 60'.</p> <p>Recommendation: Monitor condition of the inside of each leg to ensure no material loss occurs. AWWA recommends regularly scheduled maintenance inspections every five years.</p>

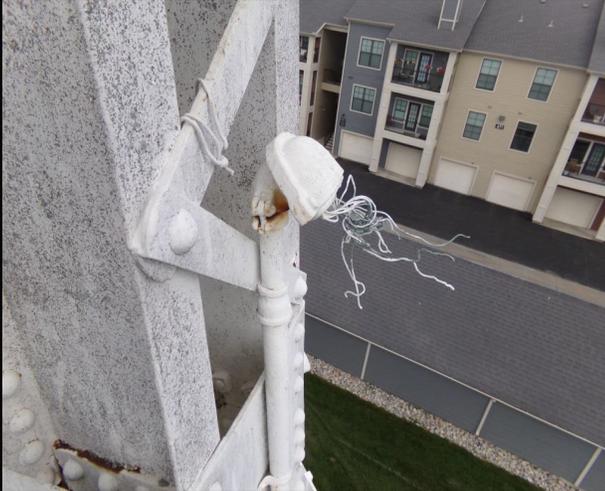
<p>Observation: Loose electrical wires and unused conduit were observed on C leg at elevation 32'.</p> <p>Recommendation: Remove the loose wires and unused conduits from the tower leg.</p>

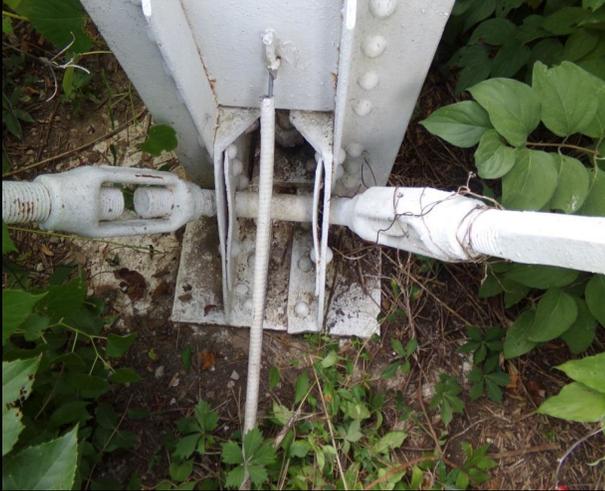
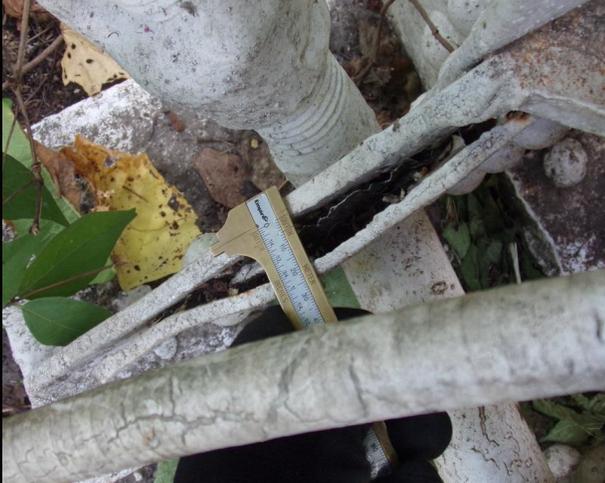
<p>Observation: (2) bent PL 1/4" thick with 3/4" deflection were observed on the baseplate of the D leg.</p> <p>Recommendation: An Engineer licensed in the state of Missouri should review the current condition and determine an appropriate course of action.</p>

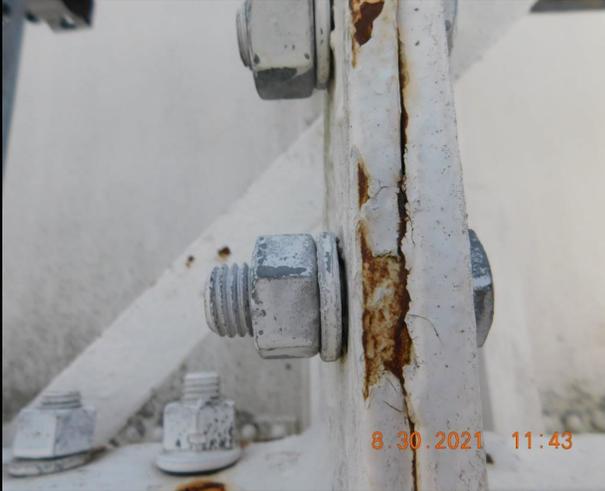
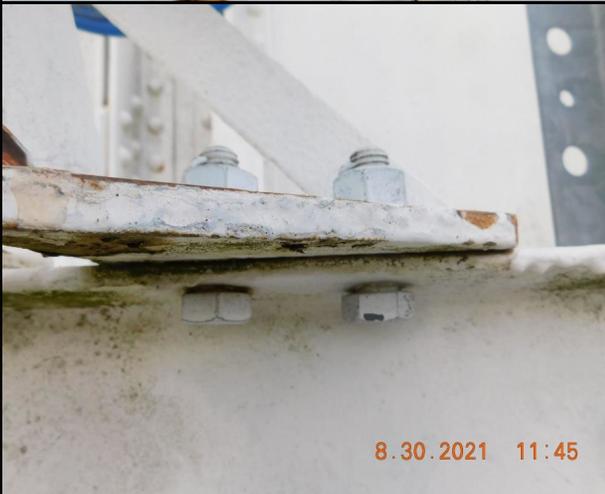
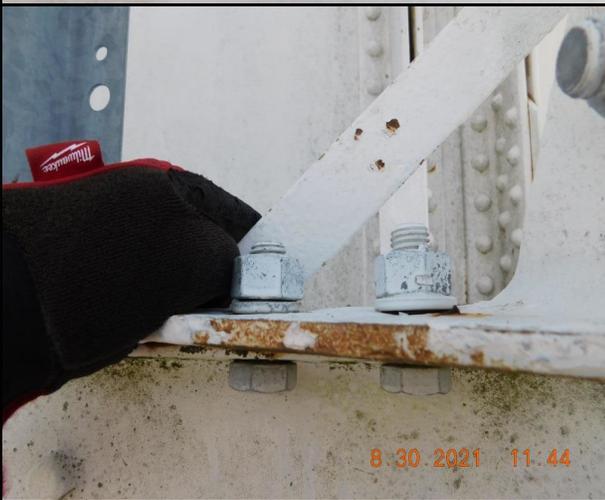
<p>Observation: (6) 5/8"Ø bolts were loose at the top of the ladder connection at elevation 60'.</p> <p>Recommendation: Tighten the bolt per AISC "turn-of-the-nut" method.</p>

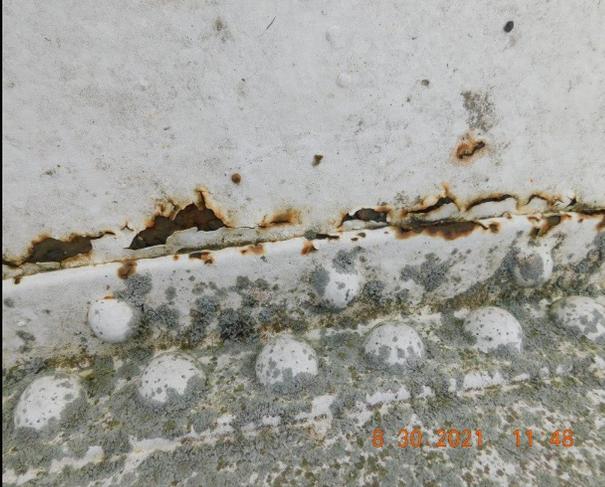
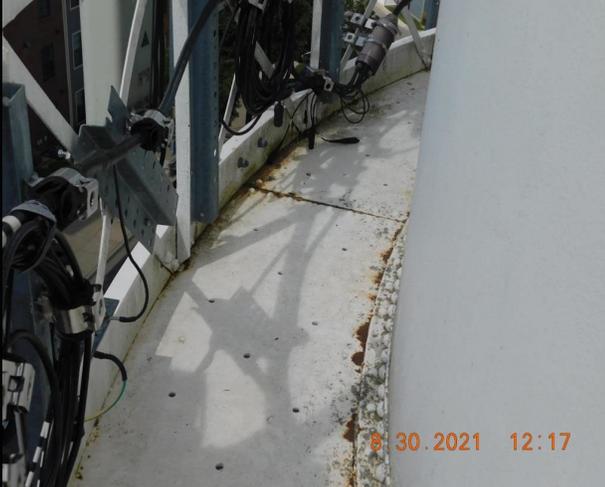
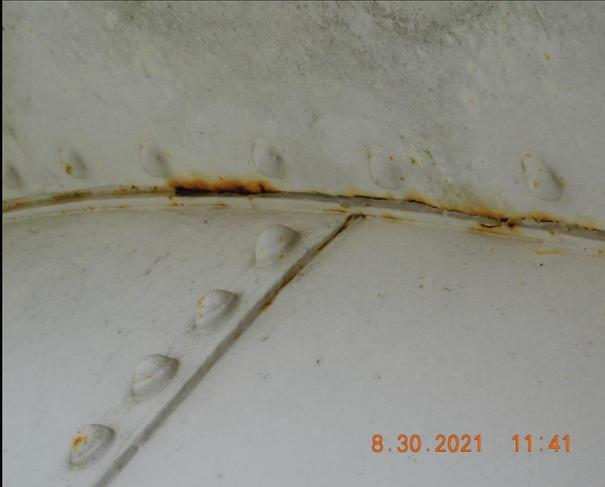
<p>Observation: Corrosion was observed platform connection to the water tank at elevation 62’.</p> <p>Recommendation: Use a wire brush to remove existing paint from vicinity of visible corrosion. Then thoroughly clean and apply two coats of a brush on cold galvanizing compound containing at least 95% zinc if corrosion is observed. If during this process any section loss is observed, contact TEP immediately. Repaint to match.</p>

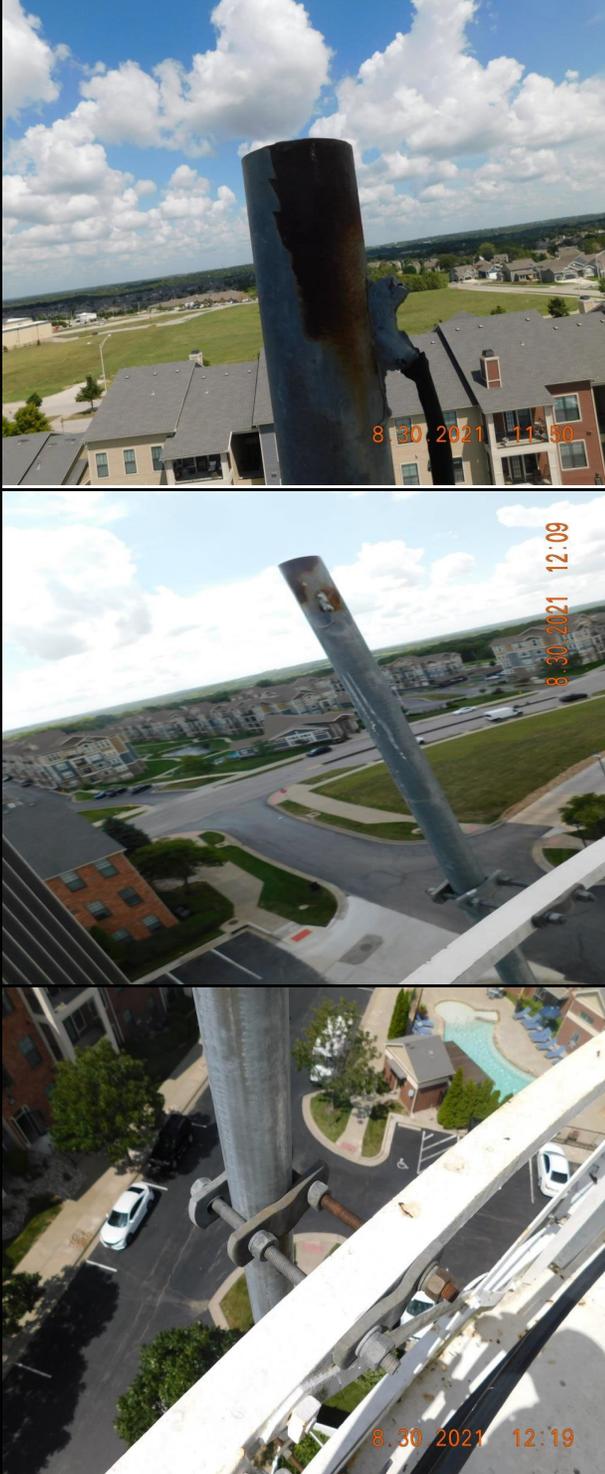
<p>Observation: Corrosion was observed on the empty mount pipe on the alpha, beta, and gamma sector and the mount pipe hardware on the gamma sector at elevation 65’.</p> <p>Recommendation: If possible remove empty mounts to reduce wind loading on handrail. If mounts must stay in place for future use replace pipe mounts and hardware.</p>

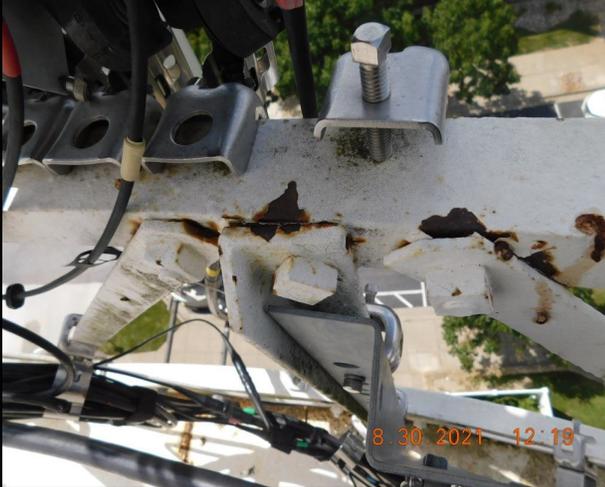
<p>Observation: Corrosion was observed throughout the handrail connections at elevation 65’.</p> <p>Recommendation: Use a wire brush to remove existing paint from vicinity of visible corrosion. Then thoroughly clean and apply two coats of a brush on cold galvanizing compound containing at least 95% zinc if corrosion is observed. If during this process any section loss is observed, contact TEP immediately. Repaint to match.</p>

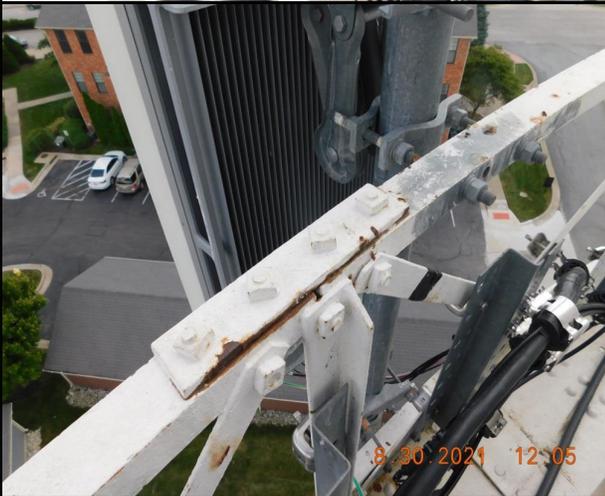
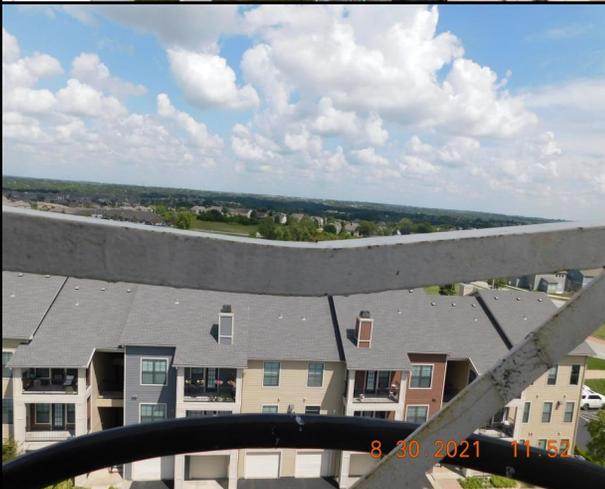
<p>Observation: (1) Bent L 2”x2”x1/4” was observed on the platform handrail and elevation 65’ near B leg.</p> <p>Recommendation: An Engineer licensed in the state of Missouri should review the current condition and determine an appropriate course of action.</p>

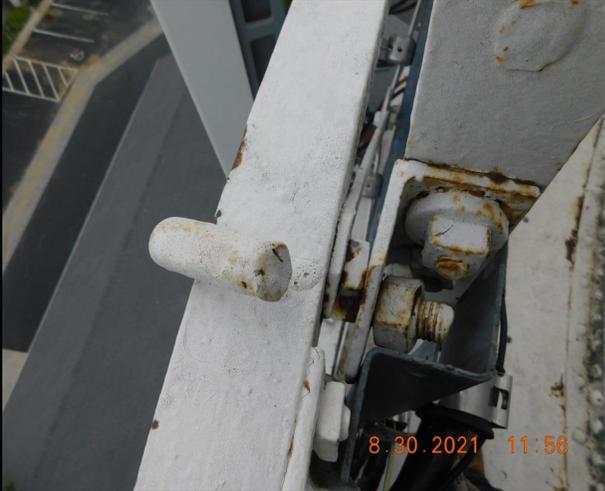
<p>Observation: (2) loose 3/4"Ø J-bolts were observed at the bottom of the platform ladder at elevation 65'.</p> <p>Recommendation: Tighten the bolt per AISC "turn-of-the-nut" method.</p>

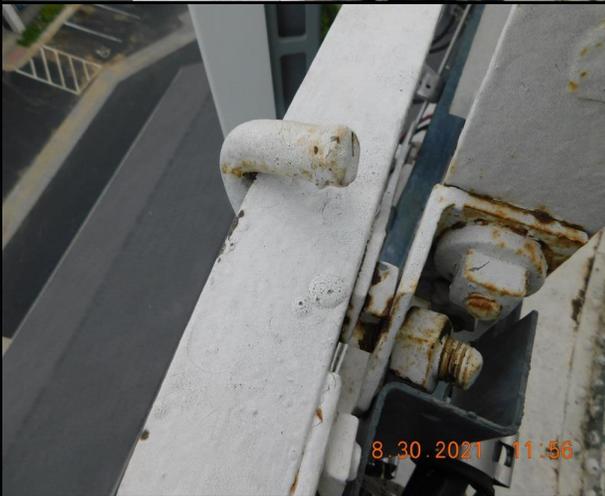
<p>Observation: (2) loose 5/8"Ø bolts were observed at the bottom of the platform ladder at elevation 65'.</p> <p>Recommendation: Tighten the bolt per AISC "turn-of-the-nut" method.</p>

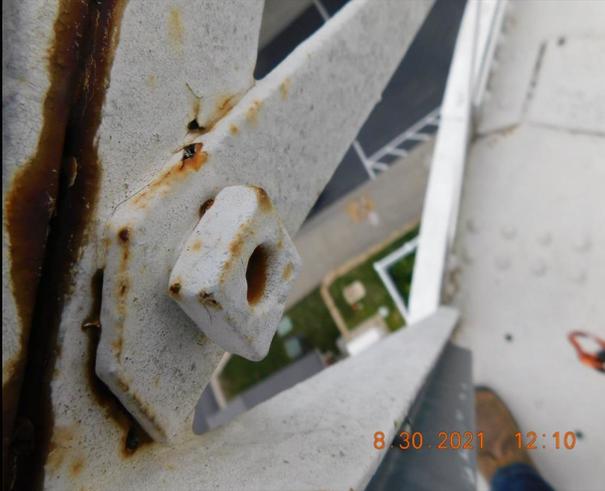
<p>Observation: (1) recessed 1/2"Ø bolt was observed on the platform bracing at elevation 65' D leg.</p> <p>Recommendation: Replace recessed bolt with new 1/2"Ø bolt of sufficient length.</p>

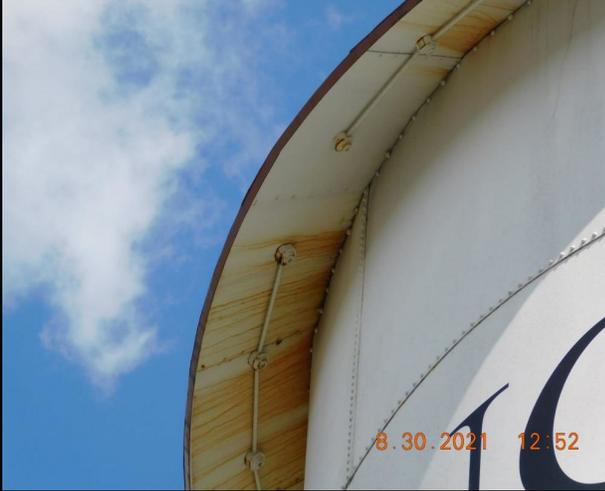
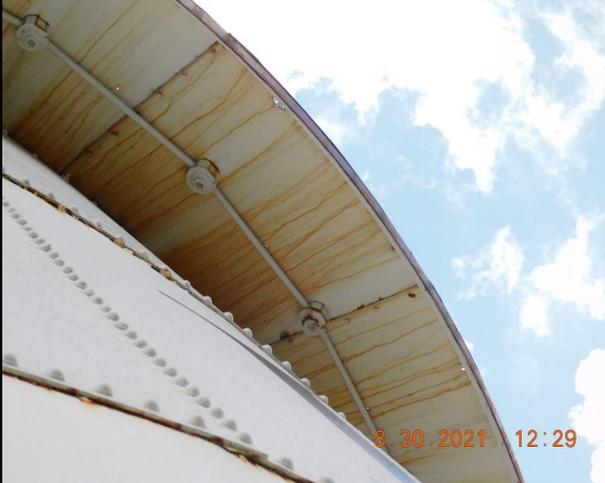
<p>Observation: Minor corrosion was observed throughout the top cap of the water tank at elevation 100'.</p> <p>Recommendation: Monitor condition of the inside of each leg to ensure no material loss occurs. AWWA recommends regularly scheduled maintenance inspections every five years.</p>

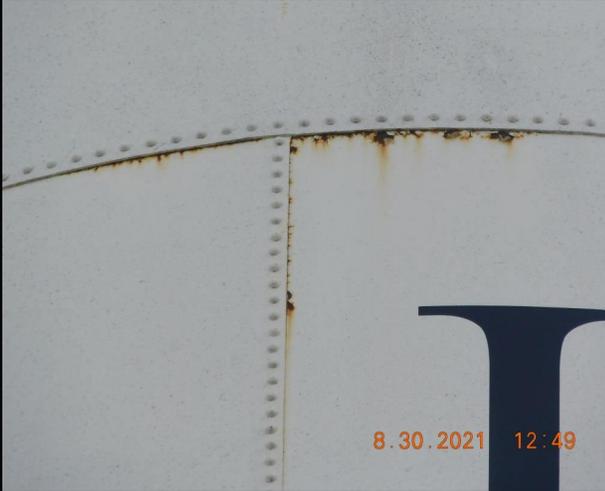
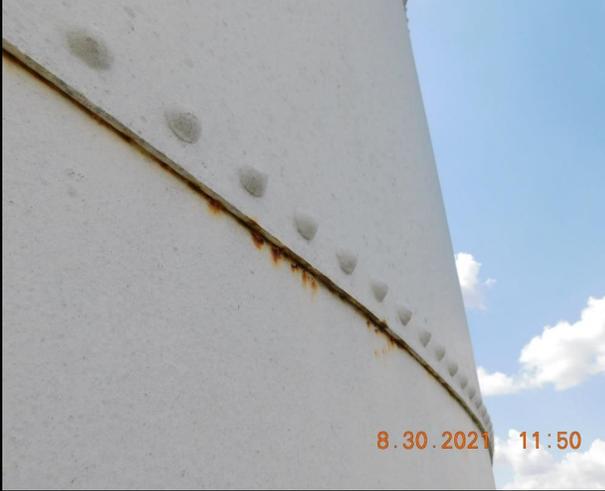
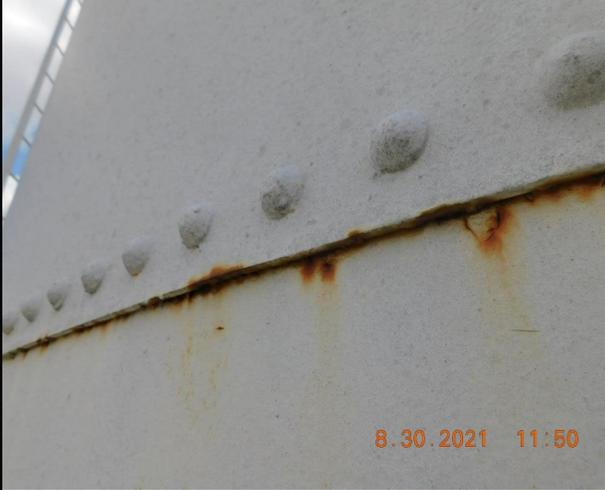
<p>Observation: Corrosion was observed on the water tank sections throughout the tower.</p> <p>Recommendation: Use a wire brush to remove existing paint from vicinity of visible corrosion. Then thoroughly clean and apply two coats of a brush on cold galvanizing compound containing at least 95% zinc if corrosion is observed. If during this process any section loss is observed, contact TEP immediately. Repaint to match.</p>

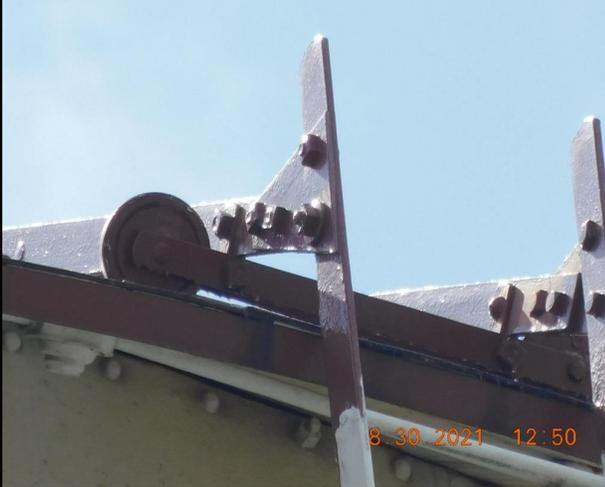
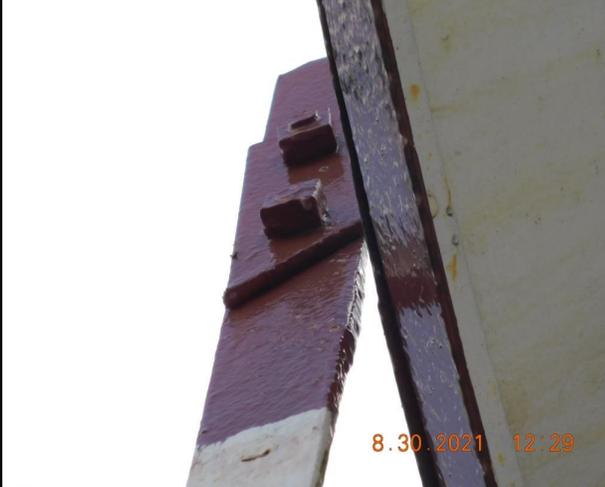
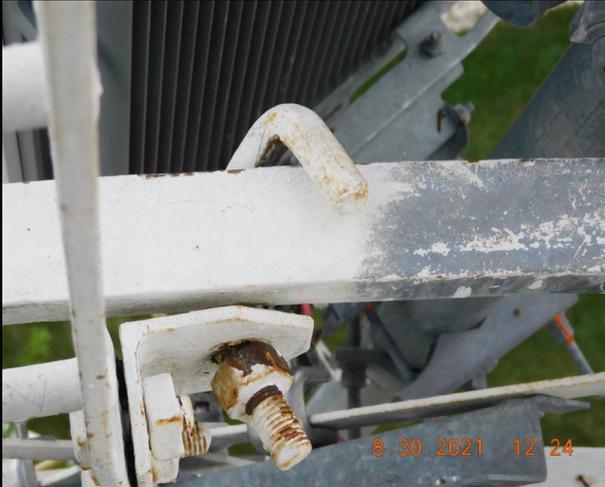
<p>A photograph showing a close-up of a metal platform ladder's attachment point to a structure. Several bolts are visible, some appearing loose or missing. A timestamp '8.30.2021 12:50' is overlaid in orange at the bottom.</p>	<p>Observation: Loose bolts at the bottom of the platform ladder caused the ladder to be unstable and unsafe to climb. The top of the water tank was unable to be inspected.</p> <p>Recommendation: Tighten loose bolts at the bottom of the ladder to make ladder stable.</p>

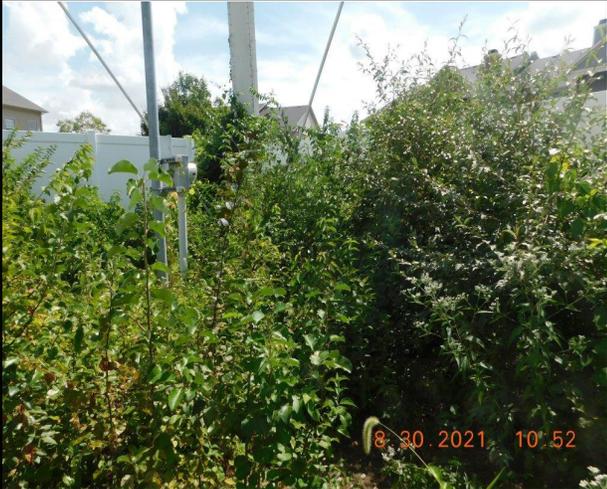
A photograph showing dense green bushes and trees inside a fenced area. A timestamp in the bottom right corner reads "8.30.2021 10:52".	<p>Observation: Overgrown vegetation was observed inside the compound.</p> <p>Recommendation: Remove overgrown vegetation inside the compound.</p>

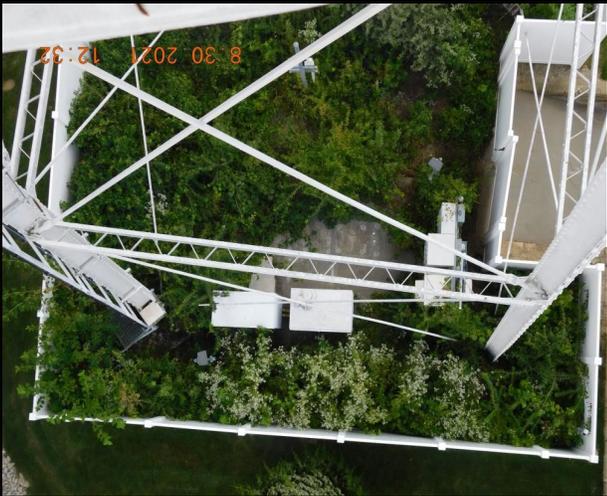
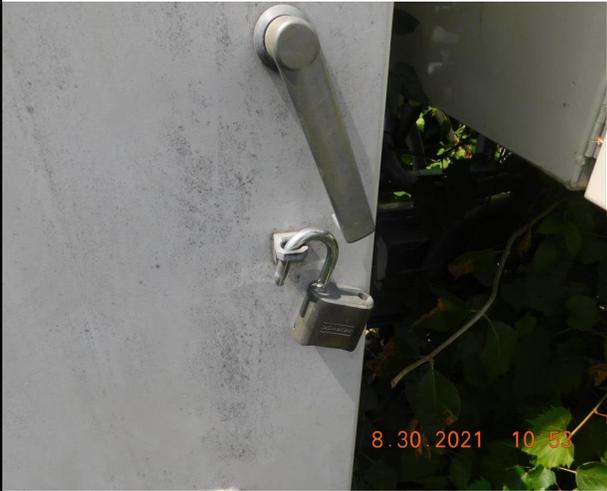
An aerial photograph of a white metal water tower structure. The tower is surrounded by dense green vegetation. A timestamp in the top left corner reads "8.30.2021 12:32".	<p>Observation: Equipment cabinets were found unlocked at the time of the inspection.</p> <p>Recommendation: Lock all equipment cabinets.</p>
