Review of Tower Inspection and Summary of Remediation

ATC Site Number & Name	306035 Unity Village MO 2, MO	Reviewed By:

Ins Mod Closeout

TOWER REMEDIATION SCOPE OF WORK

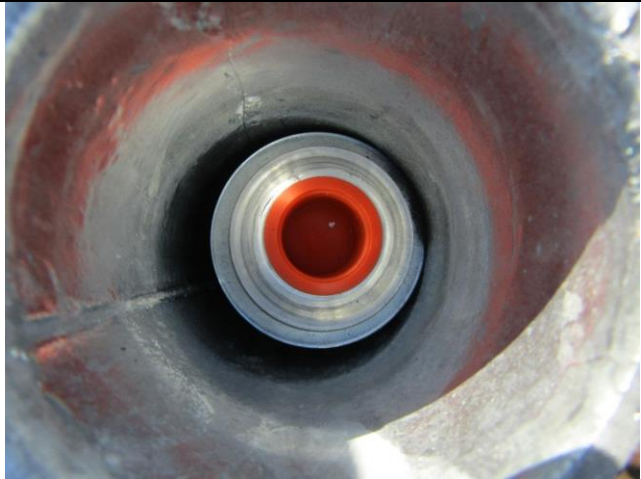
Bid Item	1		
Deficiency Photo		Description of Work	As-Built Photo

- The DBI Sala (Strandvise) safety climb system installed to 189', on AB Face is recommended for replacement due to the following reason(s): Improper/Unsafe Installation.

This has been corrected per ATC Project 13101469_N3_01.

<p>2</p> <p>Ensure safety climb assembly is properly installed. Adjust safety climb cable to extend at least 1" past the carrier clamp (top washer).</p>
