Sinnott Gering and Schmitt Towers, Inc.  
315 W. Huron St, STE 120  
Ann Arbor, MI 48103  
(844) 886-9377  
[Inspections@sgstowers.com](mailto:Inspections@sgstowers.com)

TOWER INFORMATION	
Site ID Number:	HTMO1589
Site Name:	Green
Site Data:	272-200 Southeast 3rd Street Lee\'s Summit, MO
Tower Height:	145
Overall Tower Height (Structure+Foundation+HAP):	155.69

INSPECTION SUMMARY	
SGS Job Number:	2109914
Date of Inspection:	11/5/21
Inspection Crew:	John Ordonez, Marc Ngo

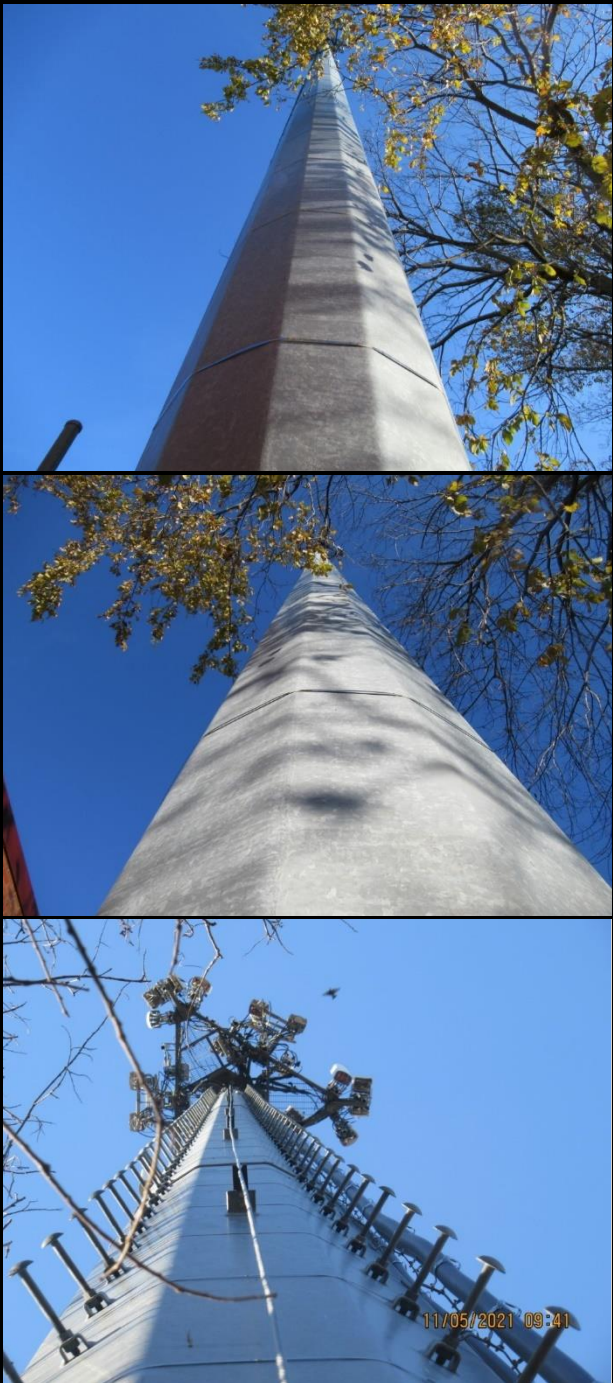
ITEM 1M	
Photograph(s)	Discrepancy Details and Recommendation

<p><b>Discrepancy:</b> Tree Interfering with Tower &amp; Safety Cable</p> <p><b>Description:</b> Tree observed to interfere with tower from 0'-30'. Tree observed to interfere with Safety Cable at 20'.</p> <p><b>Recommendation:</b> Trim tree limbs from contact with tower.</p>

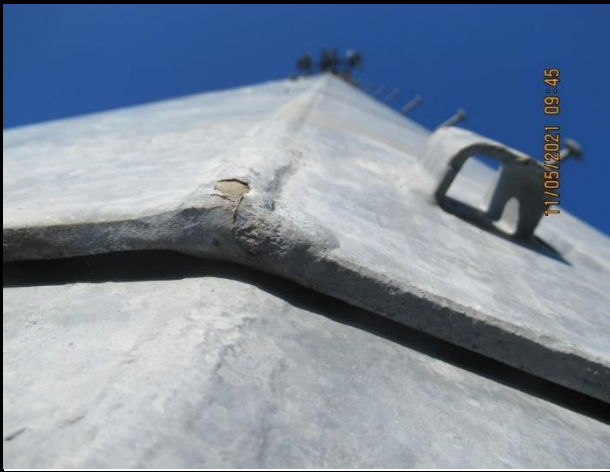
ITEM 2M	
Photograph(s)	Discrepancy Details and Recommendation

<p><b>Discrepancy:</b> Galvanization Coating Chipping</p> <p><b>Description:</b> Galvanization coating observed chipping at 45'.</p> <p><b>Recommendation:</b> Clean chipped area with a wire brush and apply two coats of an approved brush on galvanizing compound.</p>
N/A	
N/A

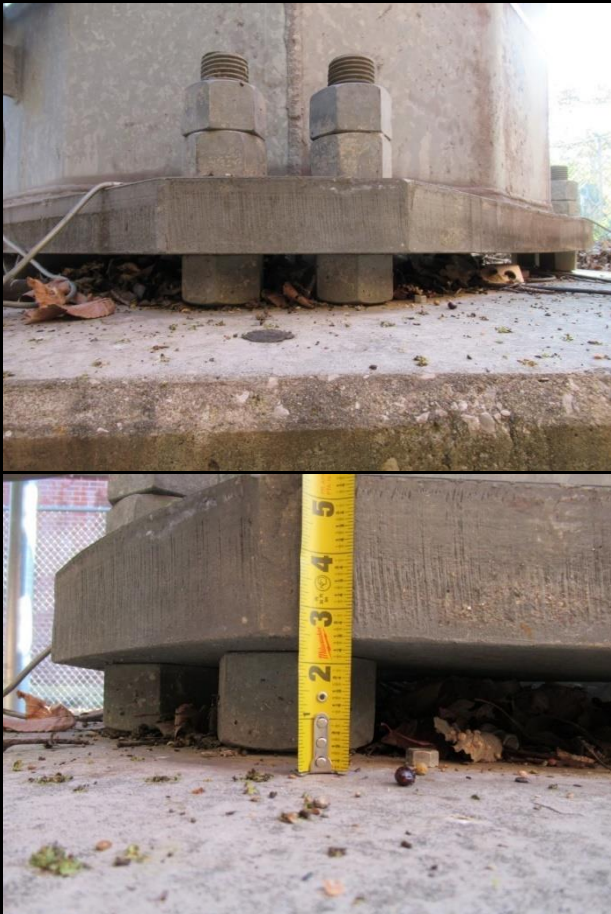
ITEM 3M	
Photograph(s)	Discrepancy Details and Recommendation

<p><b>Discrepancy:</b> Debris Below Baseplate</p> <p><b>Description:</b> Debris observed below baseplate.</p> <p><b>Recommendation:</b> Remove debris from under the Baseplate.</p>
N/A
