# LEE'S SUMMIT MISSOURI

## CODE MODIFICATION REQUEST (COMMERCIAL)

BUILDING/STRUCTURE NAME: Lee's Summit Downtown Market Green Street

PREMISE ADDRESS: 220 SE Green Street, Lee's Summit, MO 64063

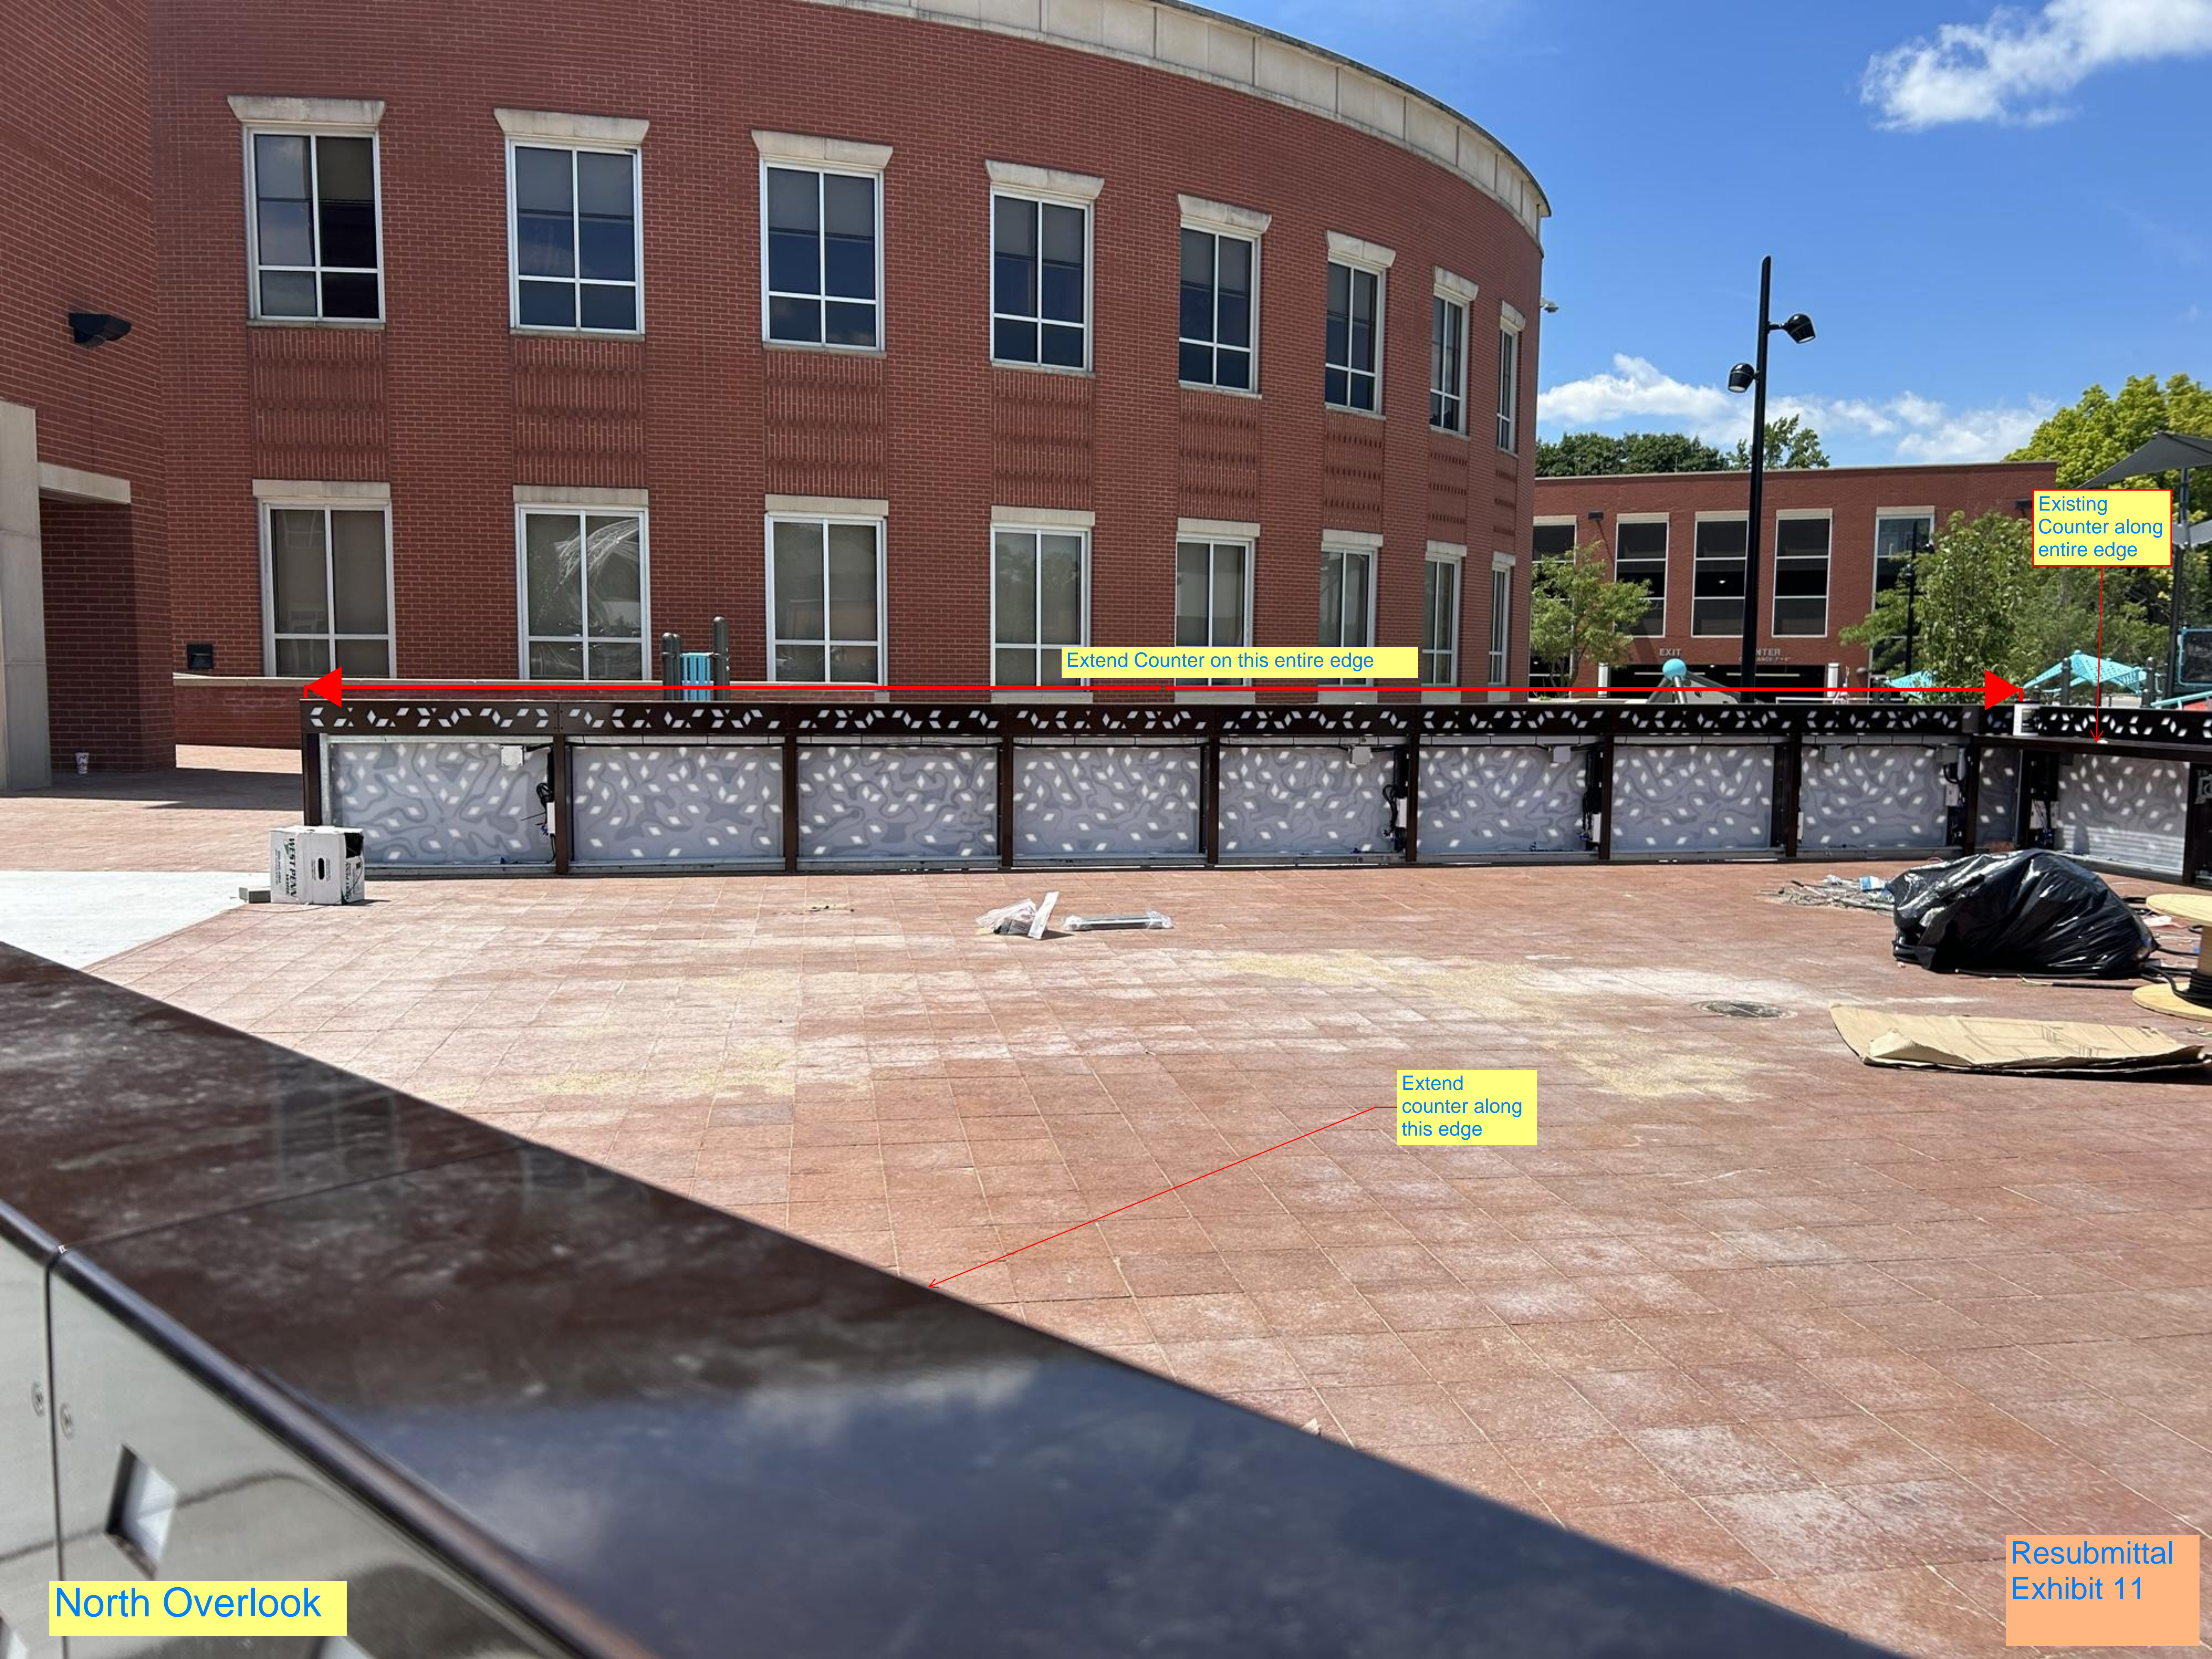
Resubmittal Exhibit 11

Existing Counter along entire edge

North Overlook

Extend Counter on this entire edge

Extend counter along this edge

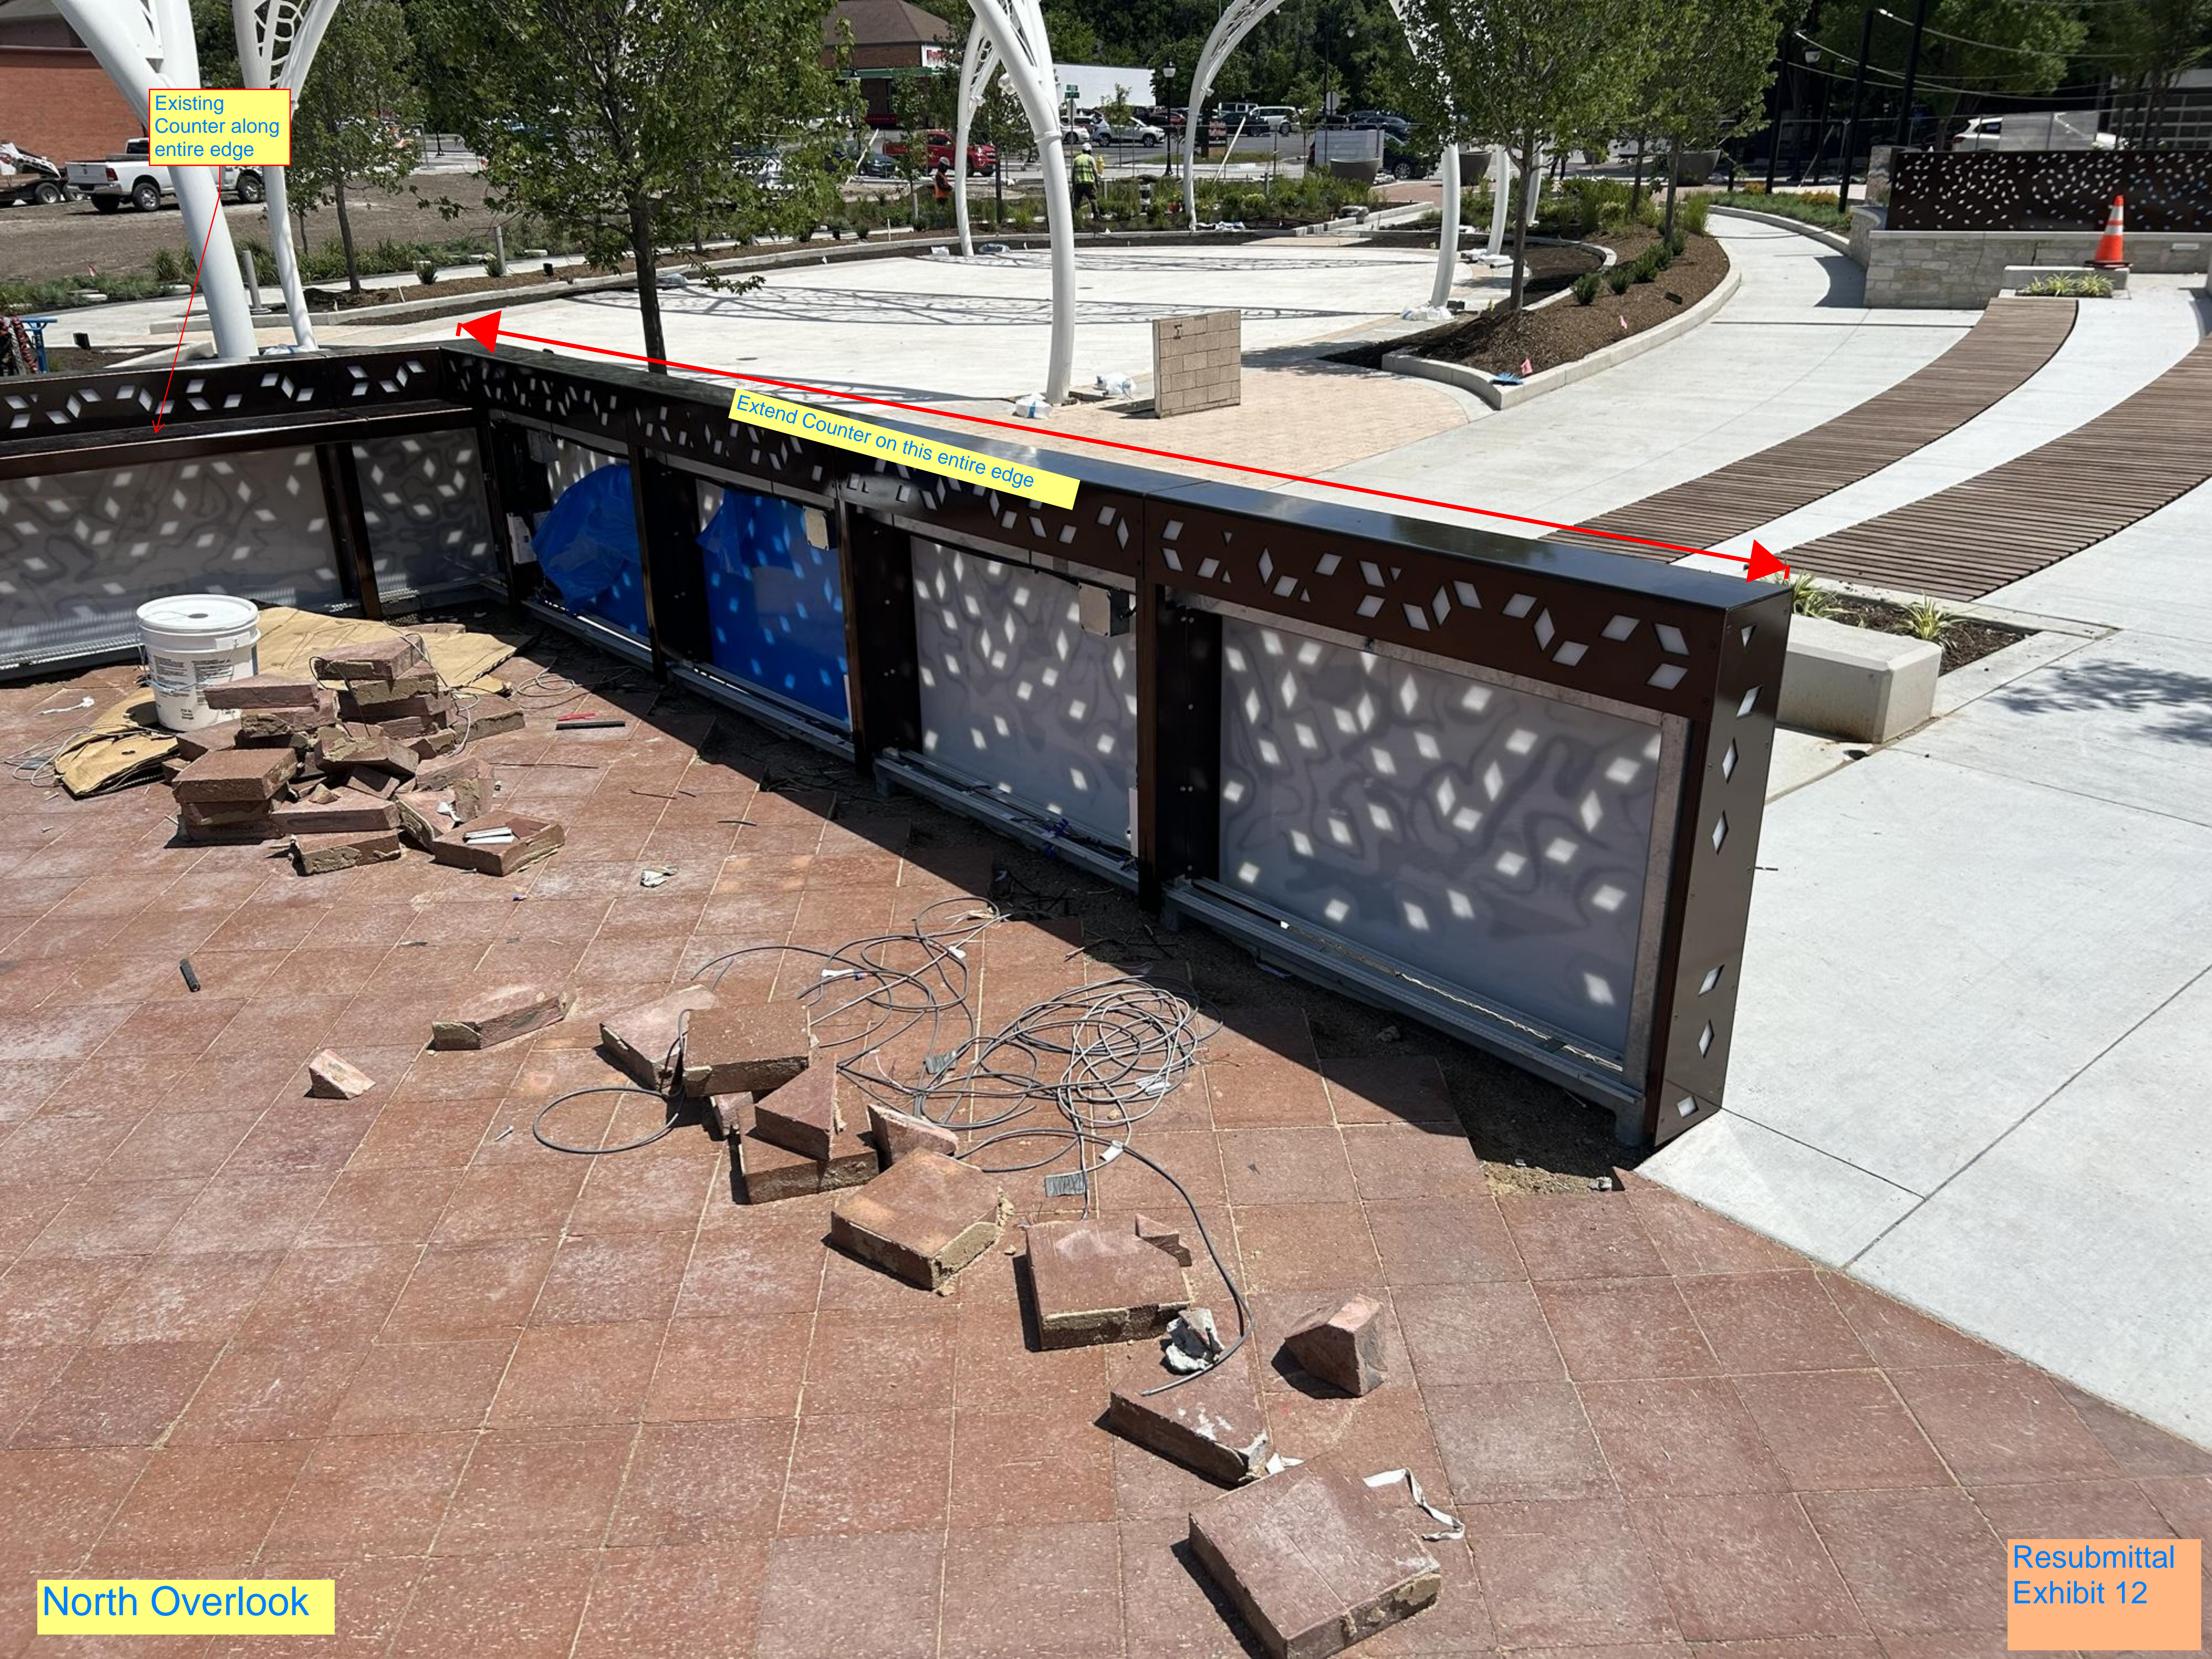
Resubmittal Exhibit 13

Existing Counter along entire eastern edge

Note: South overlook only has a north and east edge / panel. Easterly panel has counter the entire length.

South Overlook

Extend Counter on this entire northerly edge

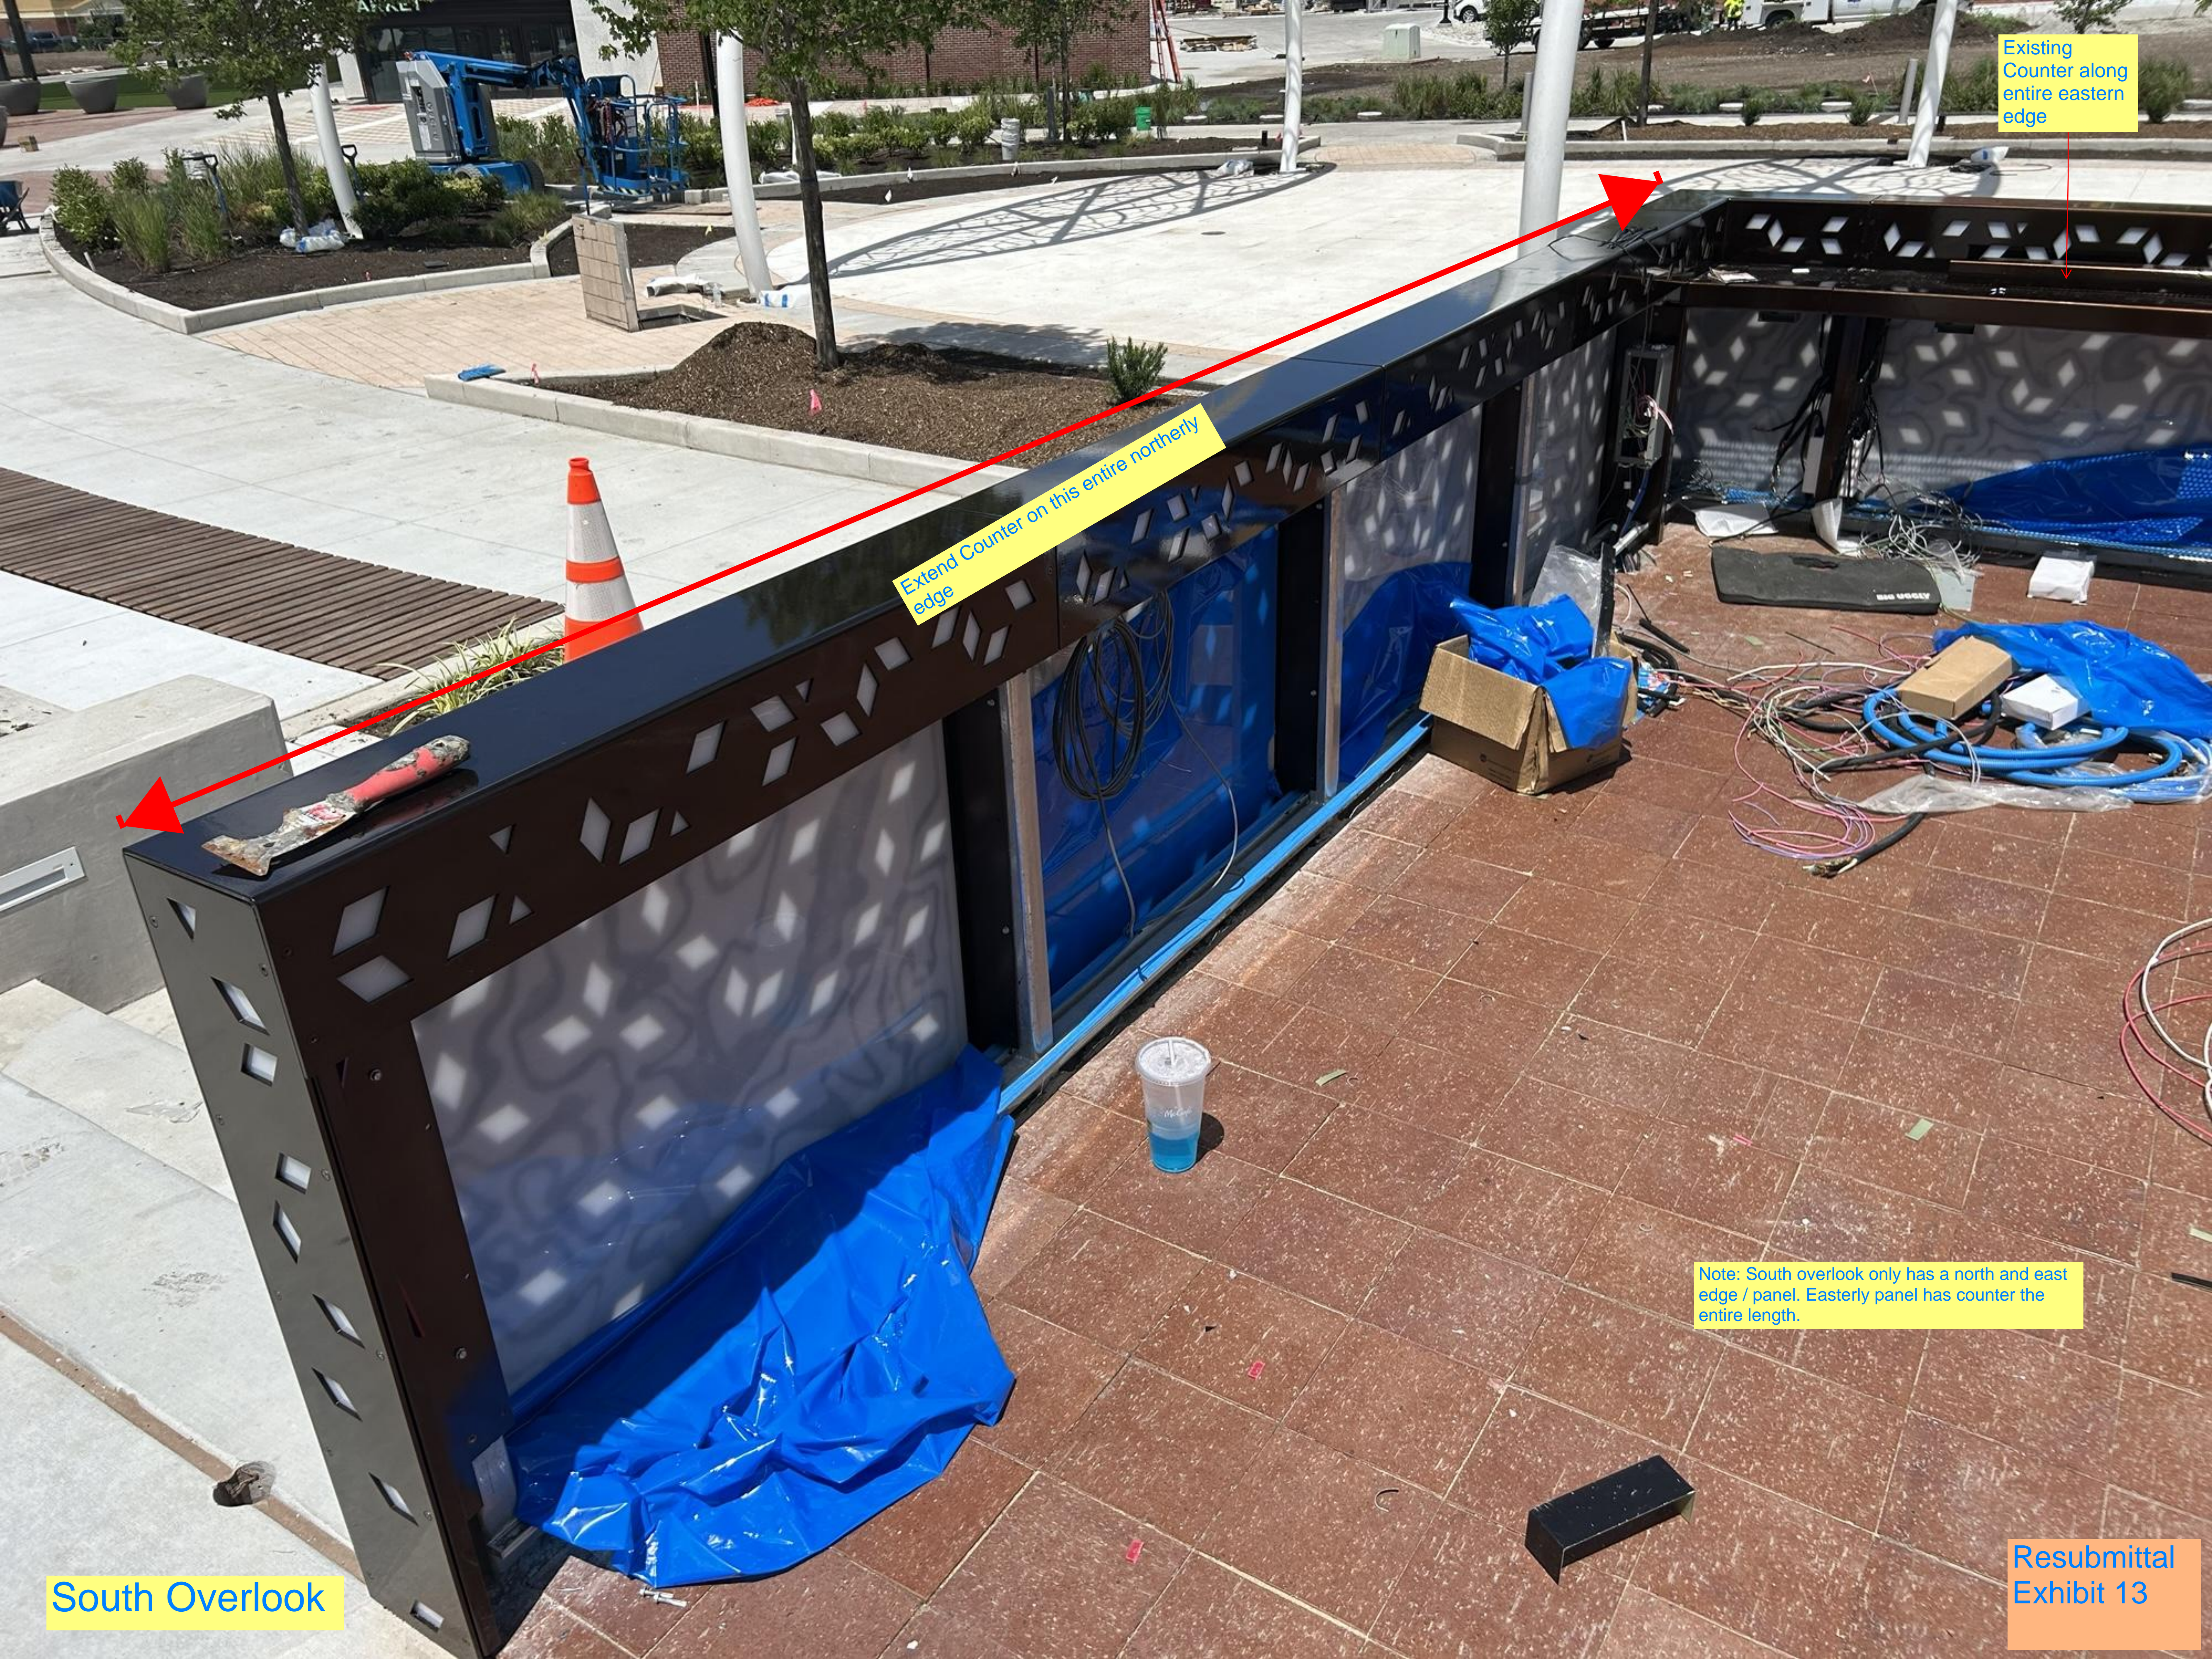
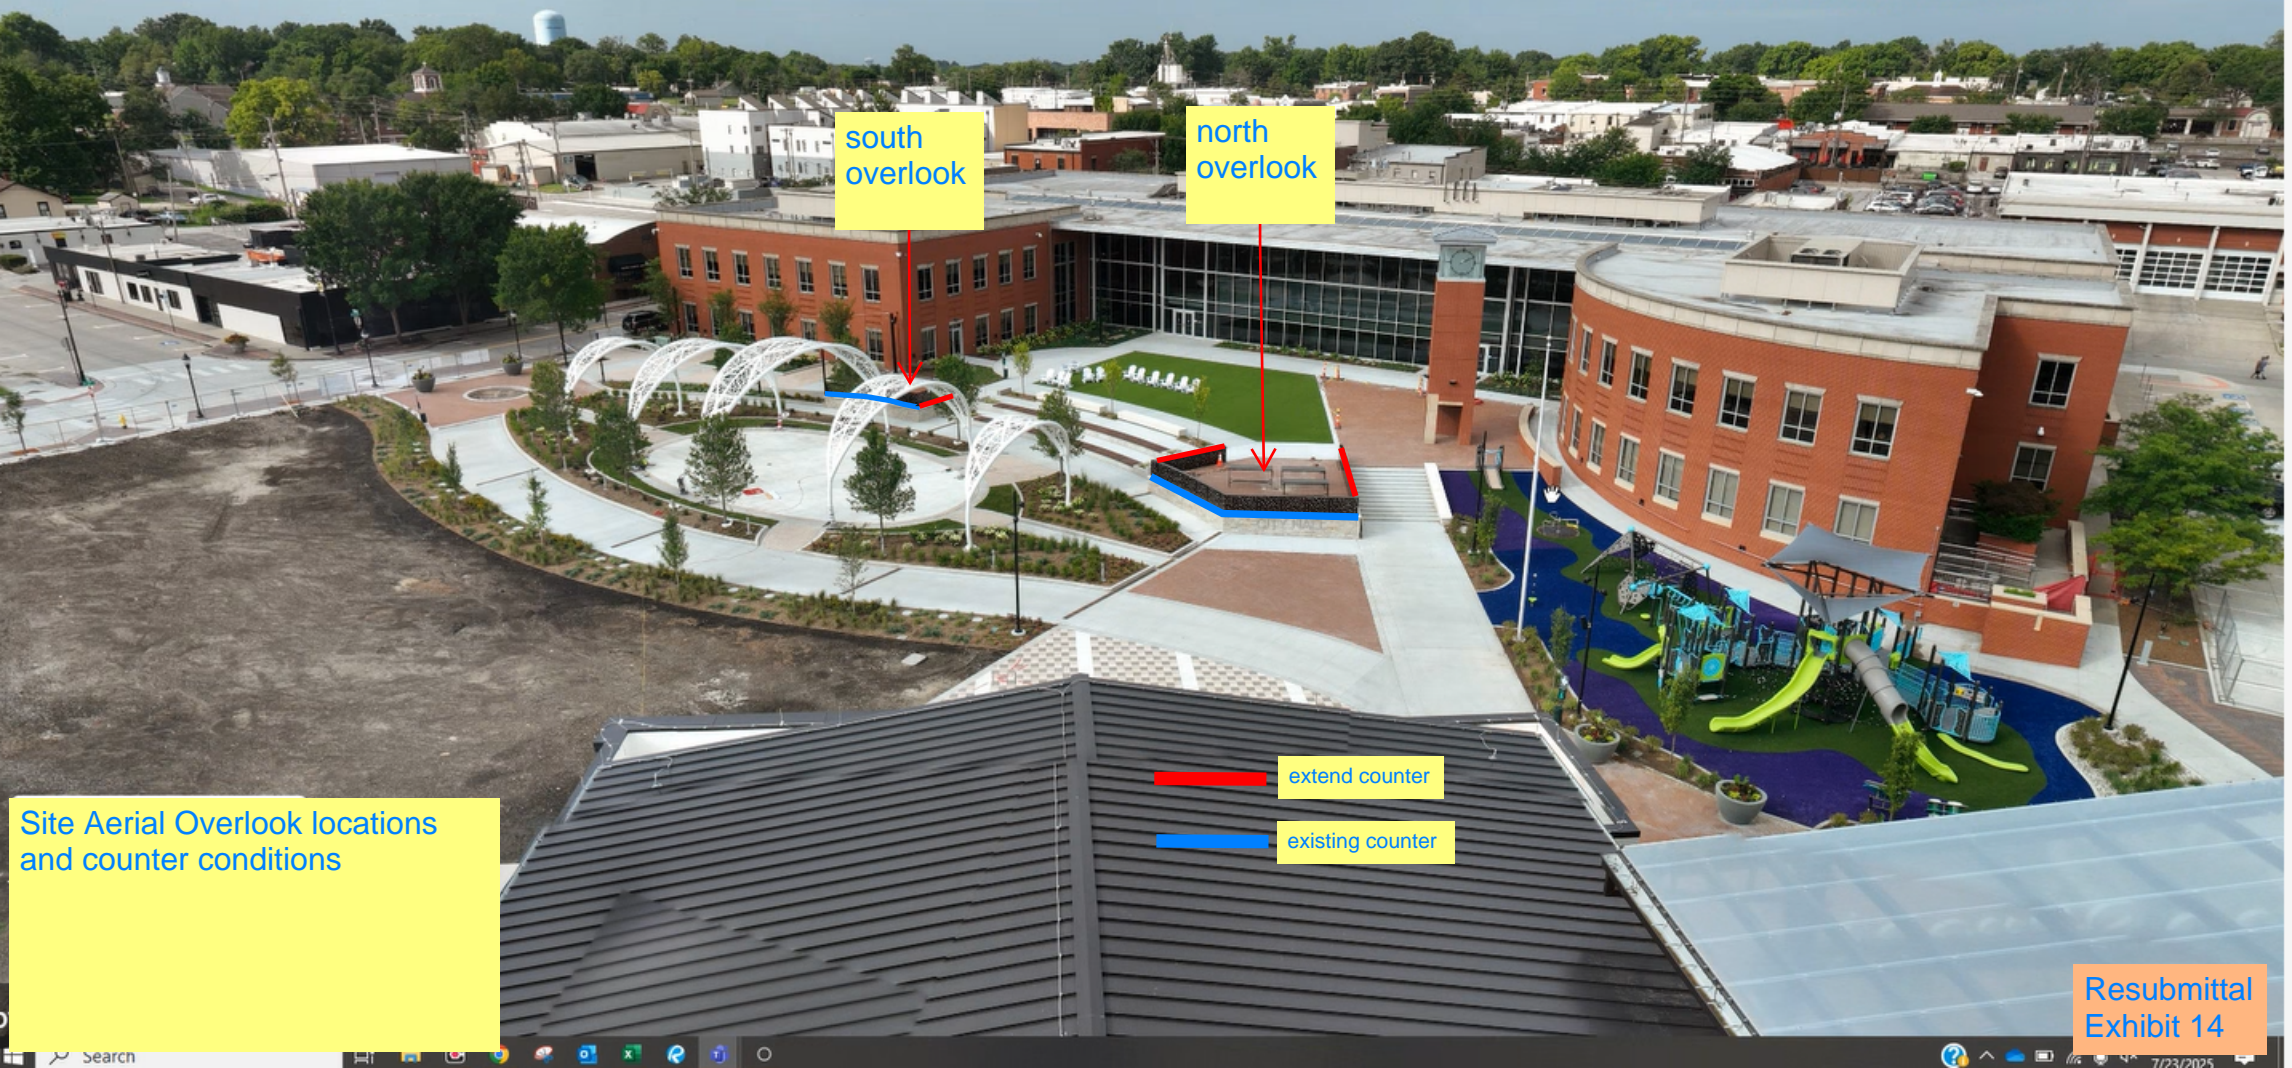
Resubmittal Exhibit 14

south overlook

north overlook

existing counter

Site Aerial Overlook locations and counter conditions

extend counter
