HD Engineering & Design

RE: PRRES20211291 2316 SW CHASE CIR LEE'S SUMMIT, MO.

Our firm has been asked to address rough framing inspection items for the home being built at the location listed above. At the time of inspection the home was in a rough framed state. Please find below the inspection item and our firms response.

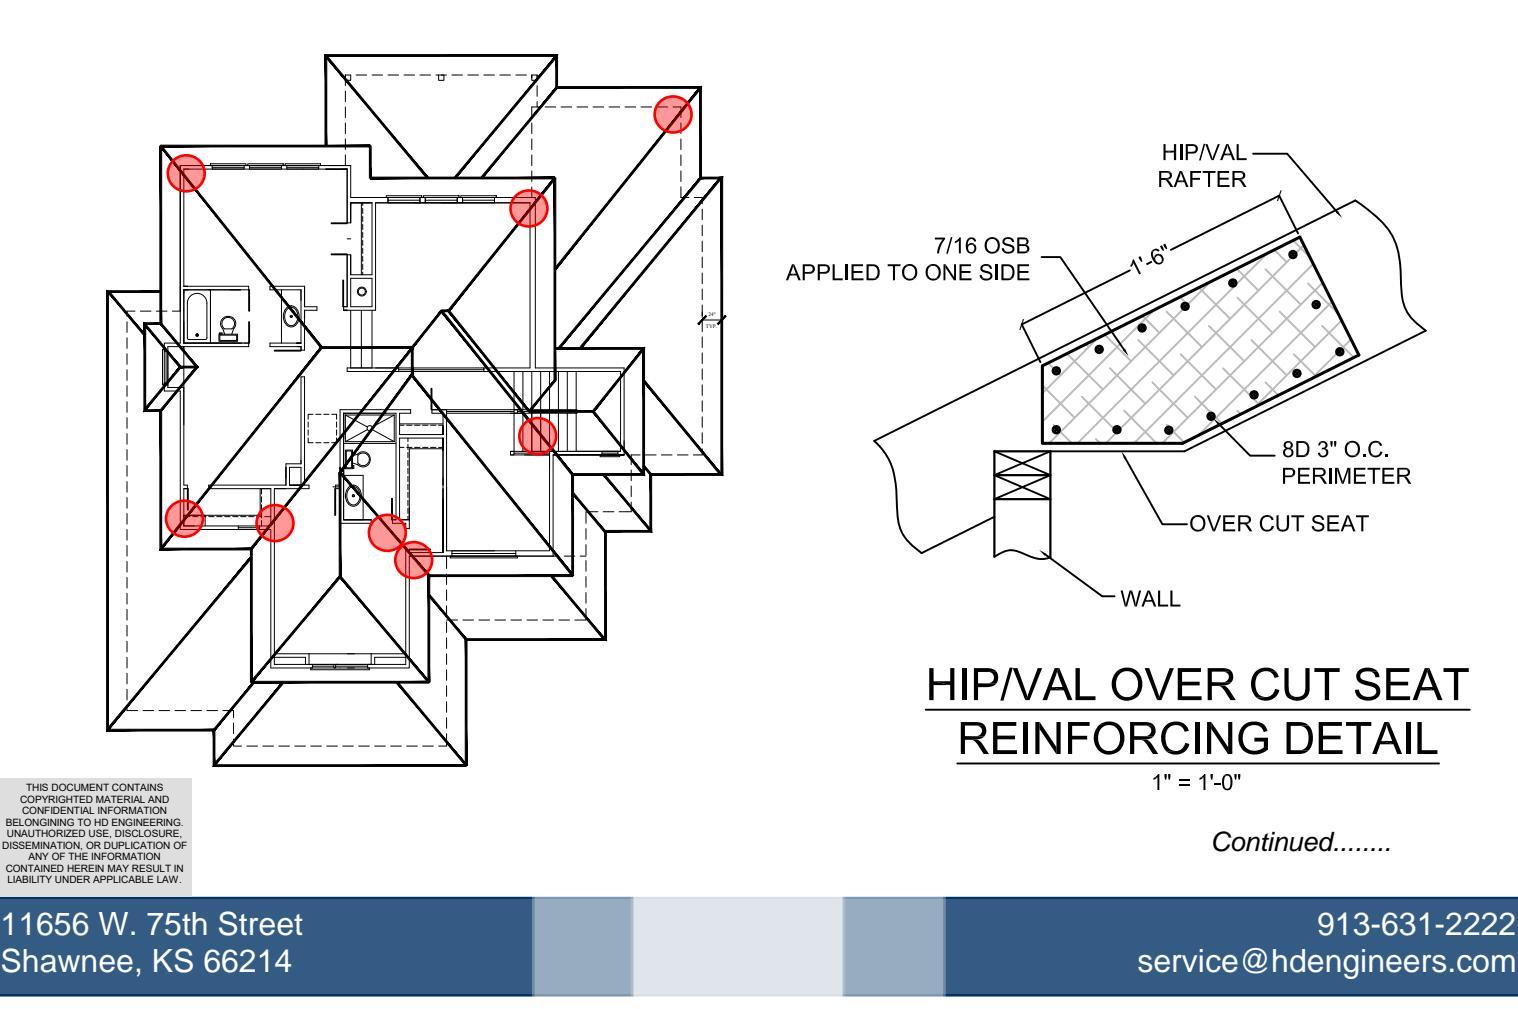
-Address notched valley rafter and bearing

There are several locations were the hip and valley seat cuts have been over cut to allow clearance. After review of the roof loads our firm has identified the locations (see below marked in red) in need of additional reinforcing to ensure proper transfer of roof loads. The locations marked will be reinforced with a layer of 7/16 OSB attached as shown in the detail below.
