- RE: Field Issue of over notched joist for Lot # 156 Woodside Ridge 365 NW Patch Ct Lee's Summit, MO 64081 Permit # PRRES20222875
 - 1. Over notched floor joist in garage:
 - Floor joist was notched on the side $\frac{1}{2}$ " to accommodate plumbing for the depth (9.25") of the 2x10

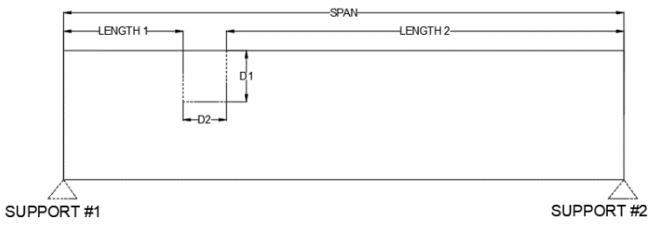
SIMPLE SPAN

- D1 9.25"
- D2 4''
- Length 1 9"
- Length 2 14' 8"
- Span 15' 9"
- Support #1 Rear LBW at garage
- Support #2 Garage W12 X 22 STL beam
- Location Garage, under bath #2
- Loading -

Sister a 6' length DFL #2 2x10 flush with rear garage load bearing wall. Attach with glue and
(4) 3" Simpson SDS screws per linear ft. in a "w" pattern.
