## WATERS OF THE UNITED STATES JURISDICTIONAL EVALUATION & WETLAND DELINEATION

# Cobey Creek – Residential Development JACKSON COUNTY, MISSOURI

**APRIL, 2017**

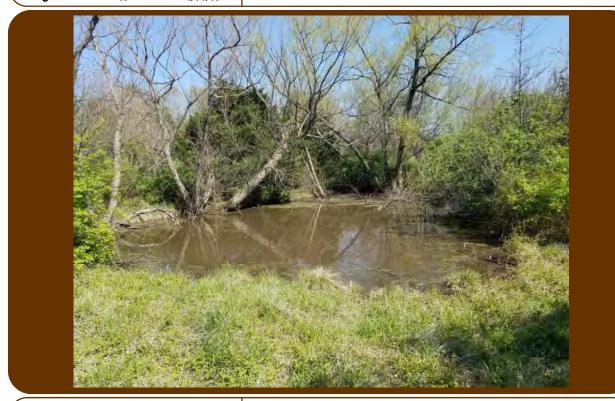
4 E 4/11/17

Open Water 1 (OW-1; Photo 4) is a 0.06 acre man-made pond created in uplands. The pond has no outfall structure and any overflow hydrology flows over the dam and into a vegetated swale (S-1).

Open Water OW-1 is NOT a jurisdictional water of the U.S.

Description: Looking at the open water OW-1.

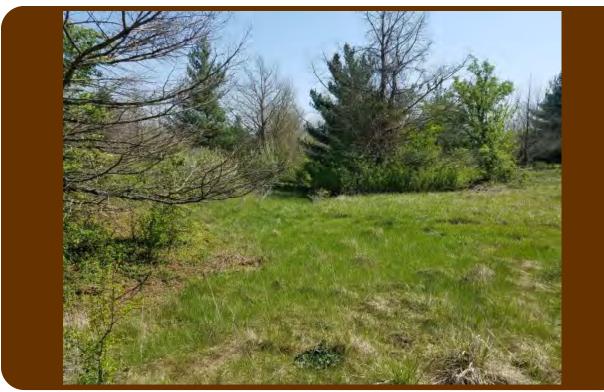
5 E 4/11/17

Swale 1 (S-1) begins as a vague swale below open water (OW-1). The swale is fully vegetated and carries overland flows east (Photos 5, 6 & 7). The swale goes under a residential driveway through a culvert. Upon discharging the downstream side of the culvert the swale begins to show evidence of erosion due to velocities (Photo 8). Eventually, flows increase east of the driveway enough for the swale to transition into an erosive drainage (Photo 9) before then discharging into Non-RPW-1. The swale is fully vegetated and is in uplands.

Description: Looking down the vegetated swale S-1.

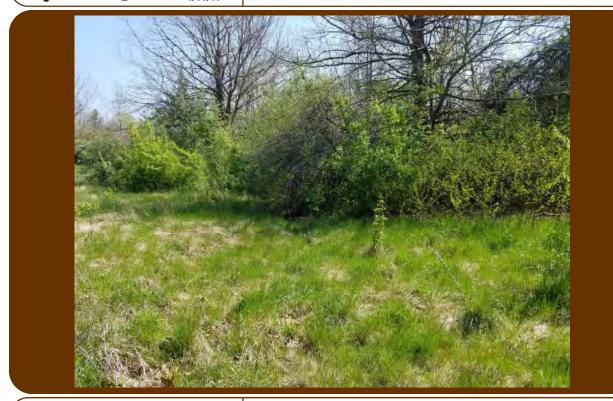
Photo No. Photo Dir. Date
6 E 4/11/17

Description: Looking down the vegetated swale S-1.

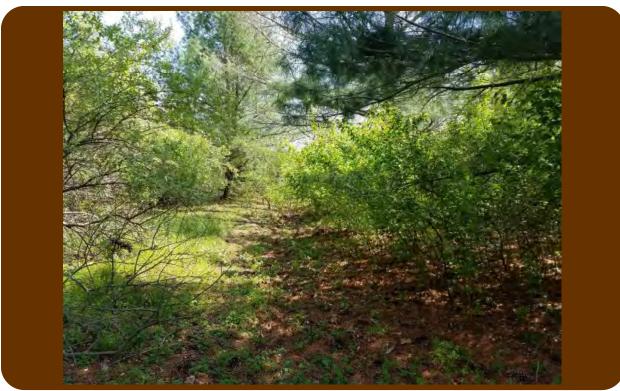
7 E 4/11/17

Description: Looking down the vegetated swale S-1.

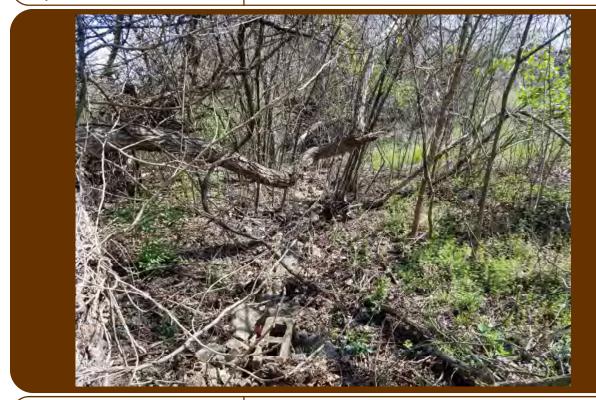
8 E 4/11/17

Description: Looking down the vegetated swale S-1 just after it exits a culvert under a private drive.

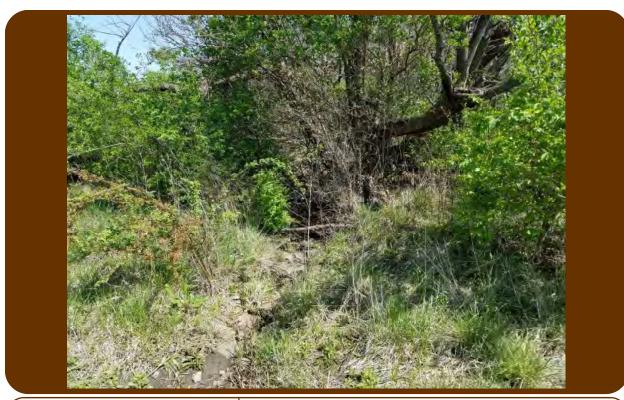
9
 E
 4/11/17

Non-RPW-1 (Photos 9, 10, 11, 14 & 15) is an ephemeral tributary beginning near the confluence of two vegetated swales. The channel includes a well defined bed and bank and a discernible ordinary high water mark (OHWM). The ephemeral tributary flows northeast and off the property into a relatively permanent water approximately 2,500 feet from the property. That tributary further discharges into Big Creek an additional 2,500 feet downstream of RPW-1. The tributary is approximately 3 feet wide and 1-foot deep at the OHWM elevation.

Description: Looking down the vegetated swale S-1 at the point in which it becomes a tributary.

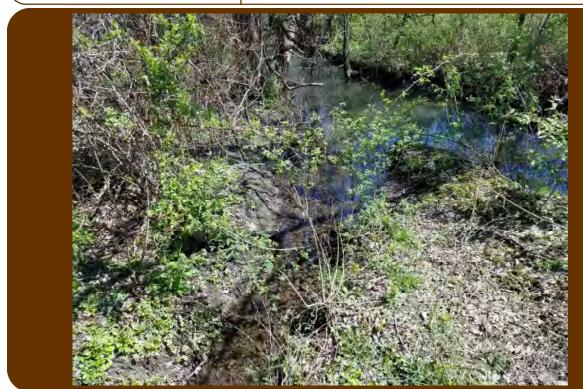
10
 E
 4/11/17

This photo depicts the location where S-1 becomes a tributary and enters Non-RPW-1.

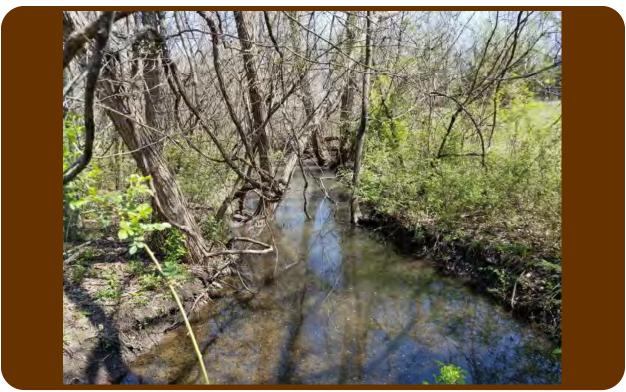
Photo No.Photo Dir.DateDescription:Looking down Non-RPW-1.11N4/11/17

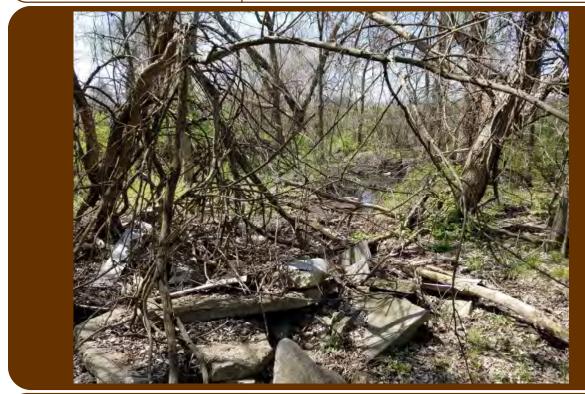
14 N 4/11/17

Description: Debris in Non-RPW-1.

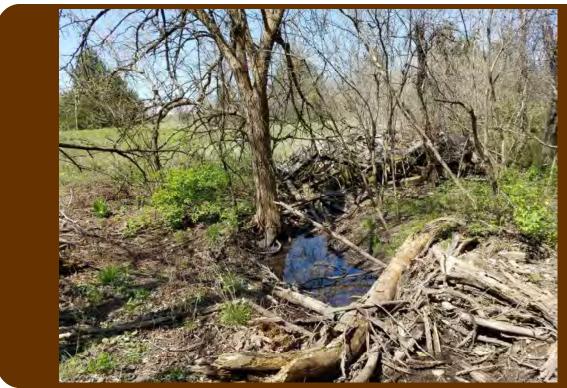
15 NE 4/11/17

Description: Depicts where Non-RPW-1 leaves the property.

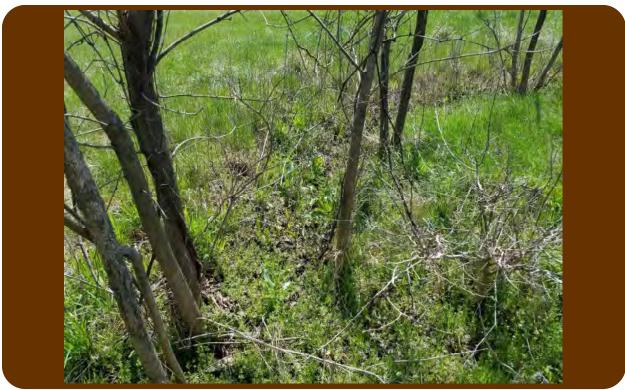
17 S 4/11/17

Swale 2 (S-2) is a wooded corridor through uplands. The wooded corridor was filled over time by landscaping materials including lumber, plant pots, etc. (Photo 19). The swale becomes slightly more defined after it flows north under the residential driveway. At that point the swale becomes more confined but remains

vegetated (Photo 17). Eventually, flows increase through the swale enough to become erosive and transitions into Non-RPW-1. The swale is fully vegetated and is in uplands.

Description: Looking south along the vegetated swale S-2.

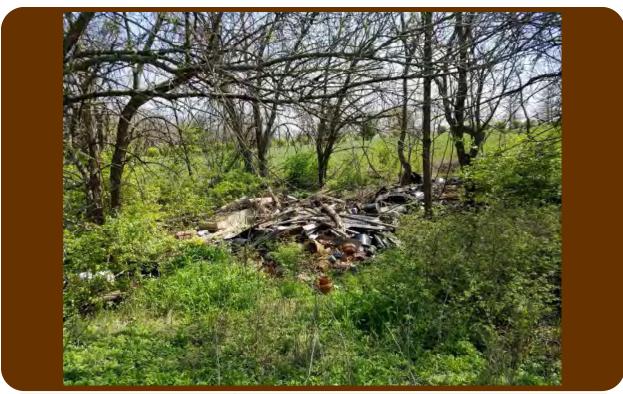
19 SW 4/11/17

Description: Considerable debris in S-2.

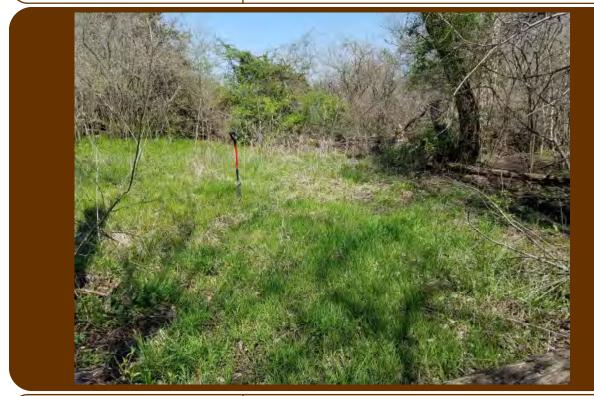
Wetland W-1 (Data Point 1, Photo 20) is a very small (0.02 ac.) wetland that is located adjacent to Non-RPW-1. The wetland appears to be influenced by additional hydrology entering Non-RPW-1 from the northwest and a slight flattening of the tributary grade at that location. The wetland is dominated in the center by Carex species and Kentucky bluegrass (*Poa pratensis*) with black willow (*Salix nigra*) and rough-leaf dogwood (*Cornus drummondii*) at the boundary of uplands. Soils are very dark (7.5YR 2.5/1) with distinct, common (5%) bright mottles (5YR 4/6) beginning at 12 inches below the surface. Wetland hydrology is supported for long durations during the growing season and is likely inundated or saturated often.

Wetland 1 (W-1) is a jurisdictional water of the U.S.

1	Photo No.	Photo Dir.	Date	Description:	Emergent wetland W-1.
1	20	S	4/11/17

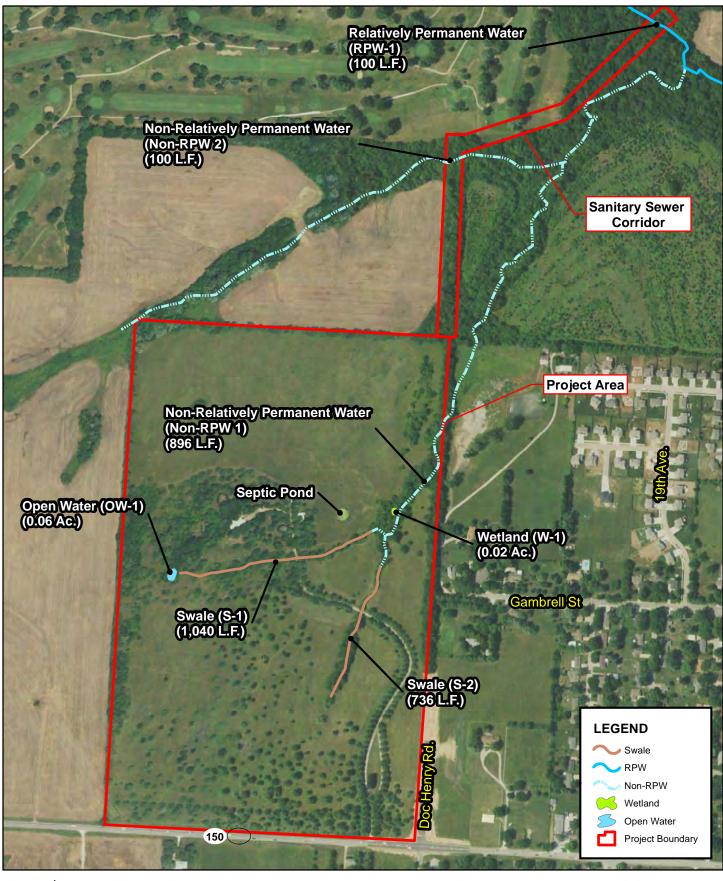
Source: NAIP 2016 Location: SE 1/4 of Sec 29 - T47N - R31W Pleasant Hill, MO 1:24K Quadrangle FIGURE D-1 WATER RESOURCES MAP

Open waters are un-vegetated bodies of water such as ponds and lakes. These features may be jurisdictional if connected to jurisdictional waters. Open waters identified within the project limits are depicted on Figure D-1.

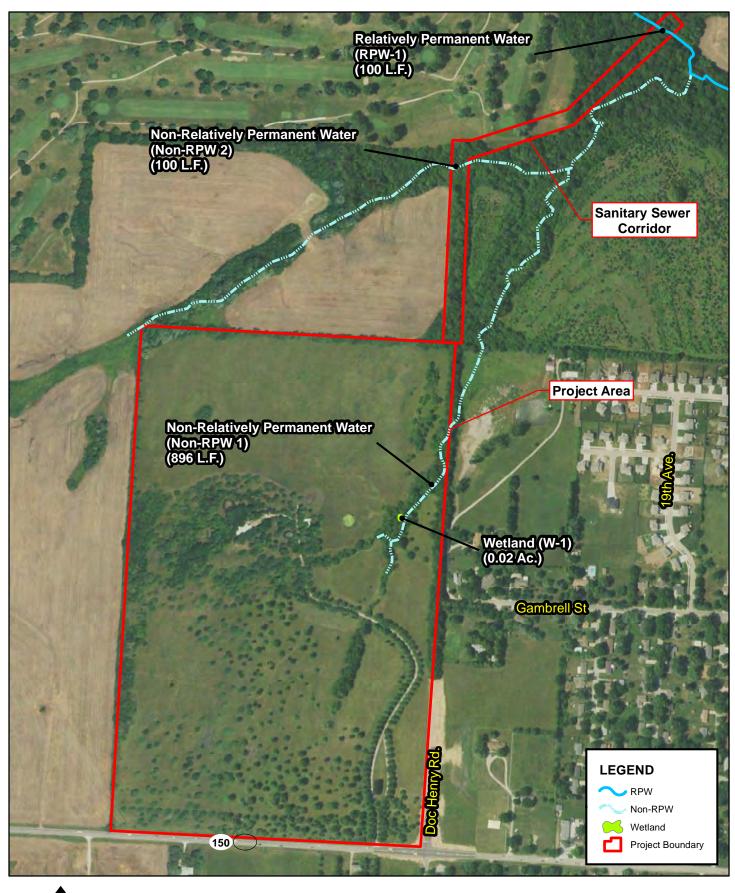
FIGURE D-2 WATERS OF THE U.S. and WETLAND DELINEATION MAP

There is a single wetland found on the property (Figures D-1 and D-2). Data sheets are located in Appendix C.
