RE: 2234 SW Crown Dr., Lee’s Summit, MO – Inspection Letter

Inspection Comment: Address rafter bearing throughout residence.

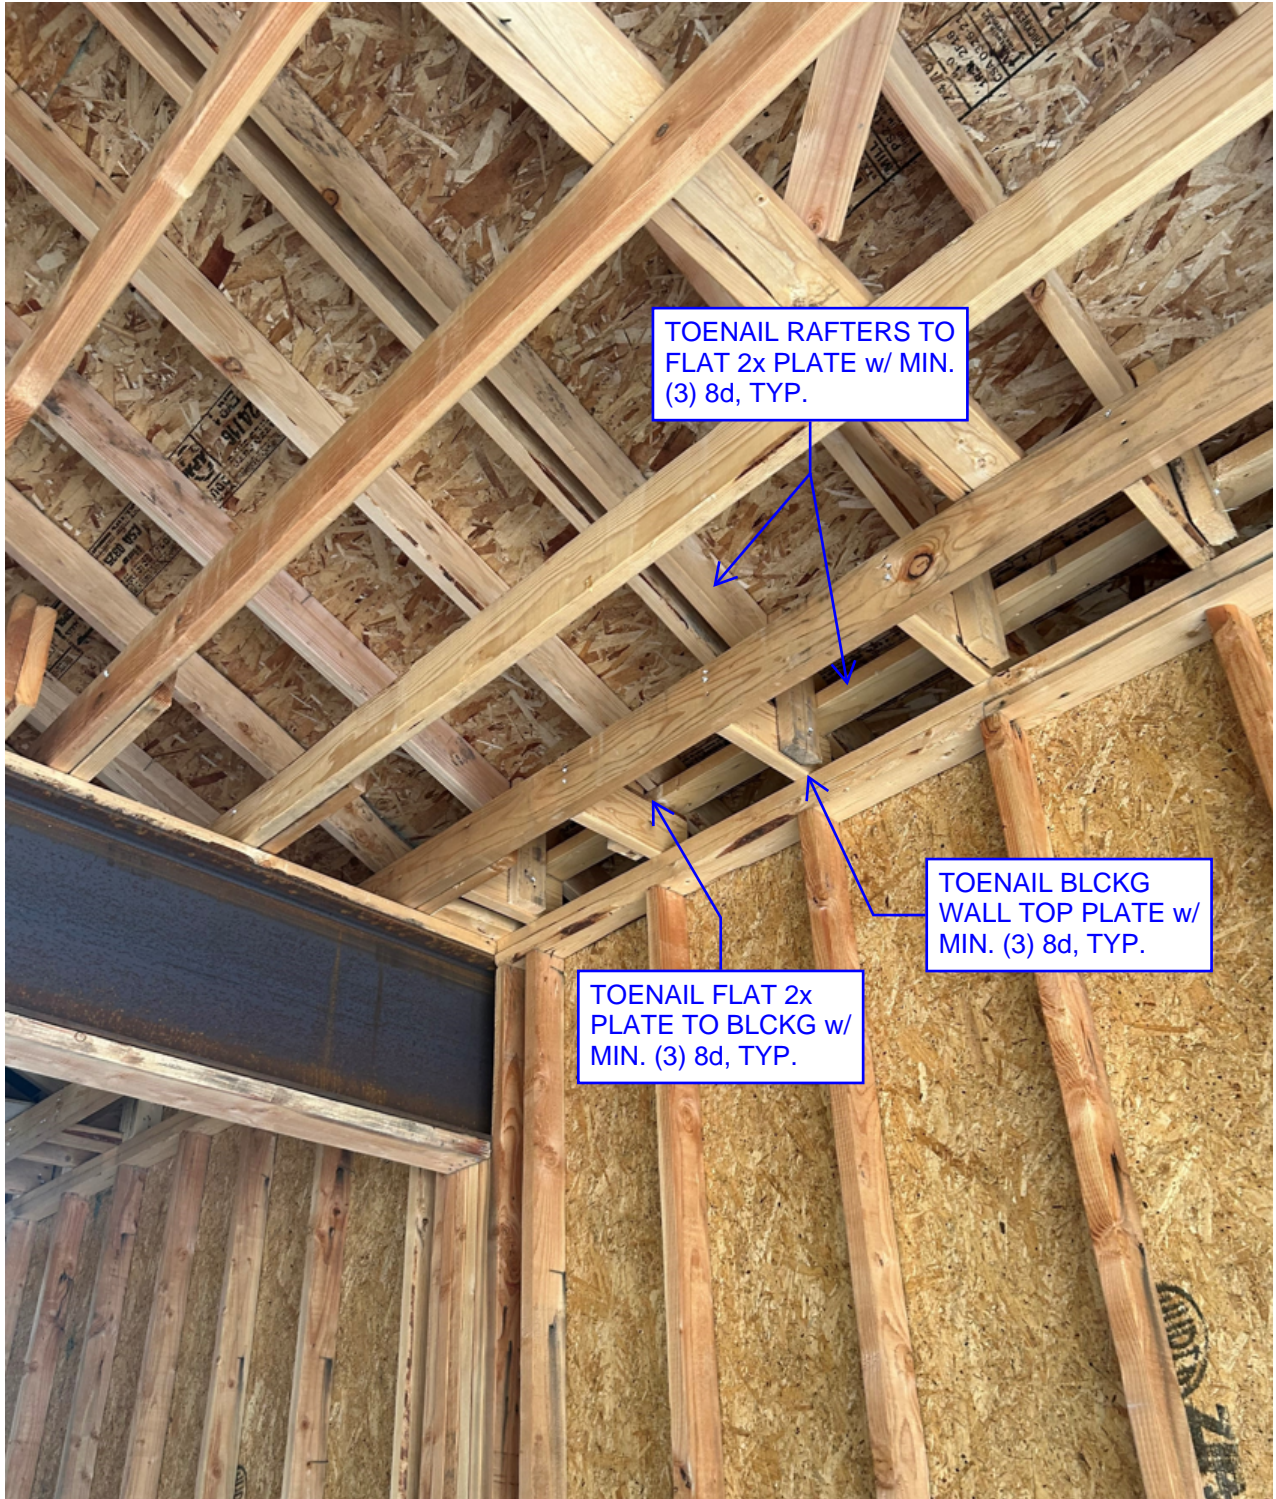
SITE PHOTO #1

VSE’s Response: Please reference attached site photos of rafter bearing conditions throughout residence. Please see the following recommendation/comments in accordance with site photo # reference.

- Site Photo #1: Toenail rafters to flat 2x plate, toenail flat 2x plate to blocking, and toenail blocking to wall top plate – min. (3) 8d toenails, typ. for connections listed (Ref. Site Photo 1 on pg. 2).
- Site Photo #2: Verify vertical 2x4 braces are fastened to rafters and blocking/ceiling joists with (3) 8d nails per detail 7/S3.0, typ. (Ref. Site Photo 2 on pg. 3).
- Site Photo #3: Install Simpson SDWC15600 screw to underside of flat 2x into bottom of LVL hip beam. Toenail ceiling joists to flat 2x member (above) with (3) 8d toenails, typ. Toenail ceiling joists to wall top plate with min (3) 8d toenails, typ. (Ref. Site Photo 3 on pg. 5).
