## Stormwater Pollution Prevention Plan Inspection Report

**Project Name and Location:** Blackwell

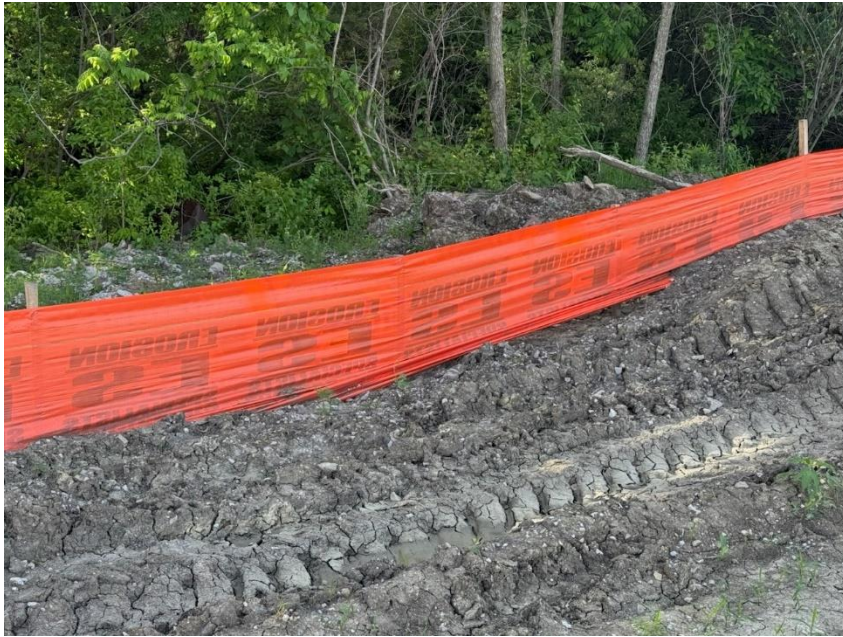
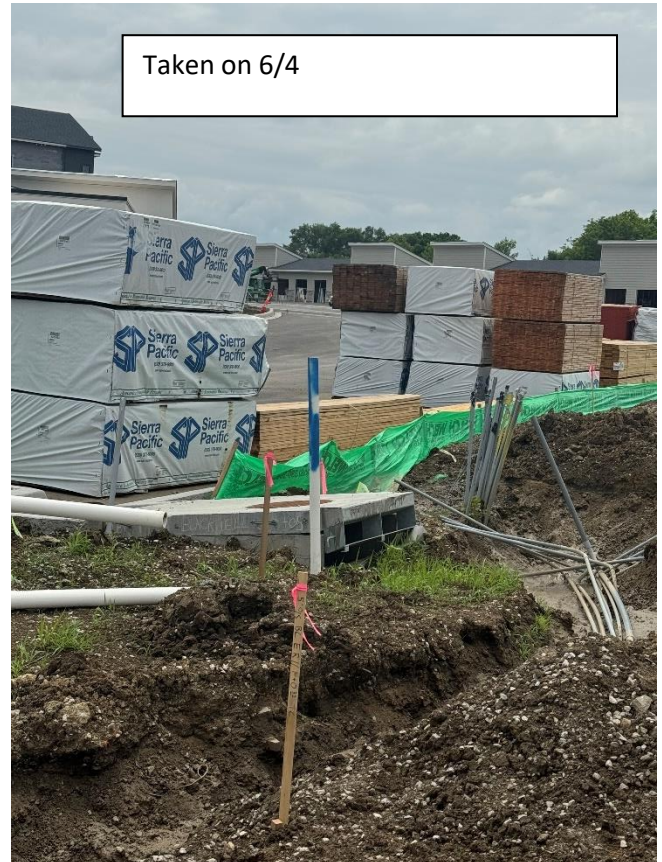
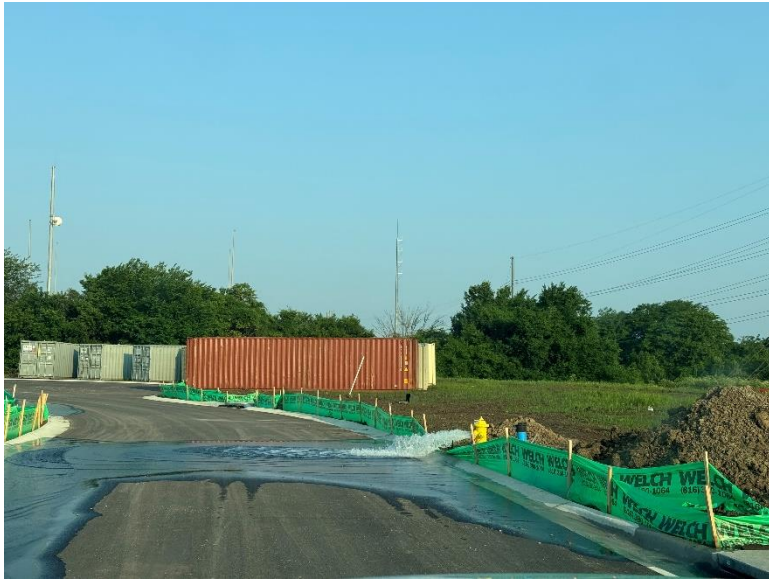
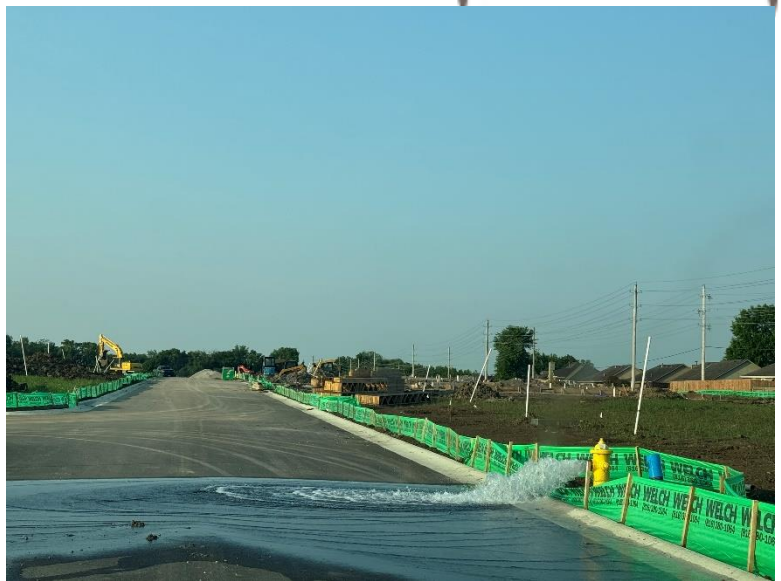
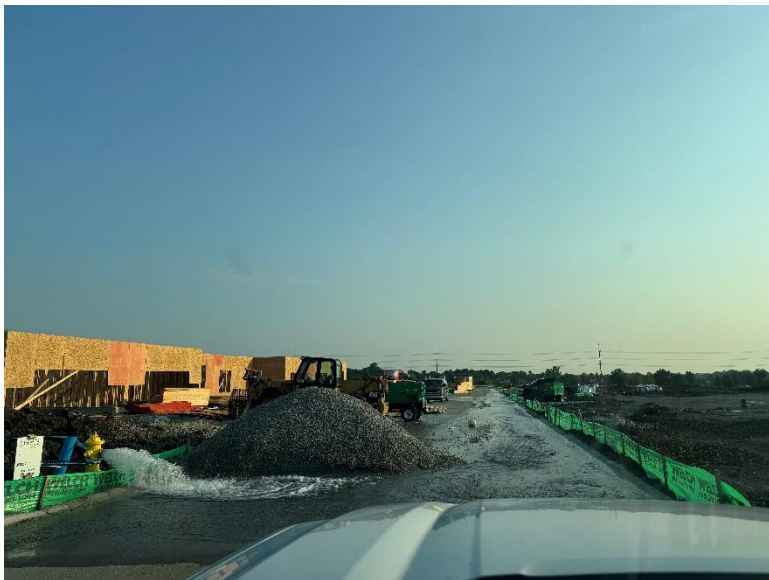
Taken on 6/9

<b>BMP</b>	<b>Location</b>	<b>Observation, Effectiveness, &amp; Corrective Actions Ordered</b>
Silt fence	Along curb	Repair a few areas where the fence has been damaged- New areas
Stabilize	In-active	Stabilize all areas that have been inactive for 14+ days- Weeds are not considered vegetation.
Stabilize	Swale	Stabilize swale on North end as soon as possible if work is done- More silt build up near pond from swale needs cleaned out
Stabilize	Detention Ponds	Stabilize detention ponds asap- weeds are not considered vegetation
Silt fence	Detention Pond	Reset silt fence along detention pond behind Residences
Silt fence	Perimeter	Orange silt fence is not trenched in on East side of pond behind Residences- See picture below

BMP	Location	Observation, Effectiveness, & Corrective Actions Ordered
Rock Ent.	Construction Ent	Need more rock at construction entrance. Rock needs to be 3"-6"- tracking out
Concrete Washout	Throughout Site	Need more concrete washouts installed. Saw trucks cleaning out along curbs on 6/2
Grate Inlets	In soon to be streets/alley	Need to protect grate inlets- install silt fence inside grate
Silt fence	Along backfilled curb	Install silt fence along backfilled curb throughout site
Inlet	Parking lot	Back side of inlet needs wrapped in silt fence. Parking lot of Residences- picture below
Inlet/Street	Various	Clean out various inlets and streets
Inlet/Street	Various-See pictures	Clean out inlets and streets where hydrants were opened and running water. Repair silt fence where hydrants damaged fence

Have items noted on the last inspection been corrected? ☐ Yes ☒ No (if no explain) : Need to stabilize in-active areas and det. ponds.
