**Firestone**  
COMPLETE AUTO CARE™

3561 SW MARKET STREET  
LEE'S SUMMIT, MISSOURI 64082

# STORM PLAN AND PROFILE

# C301

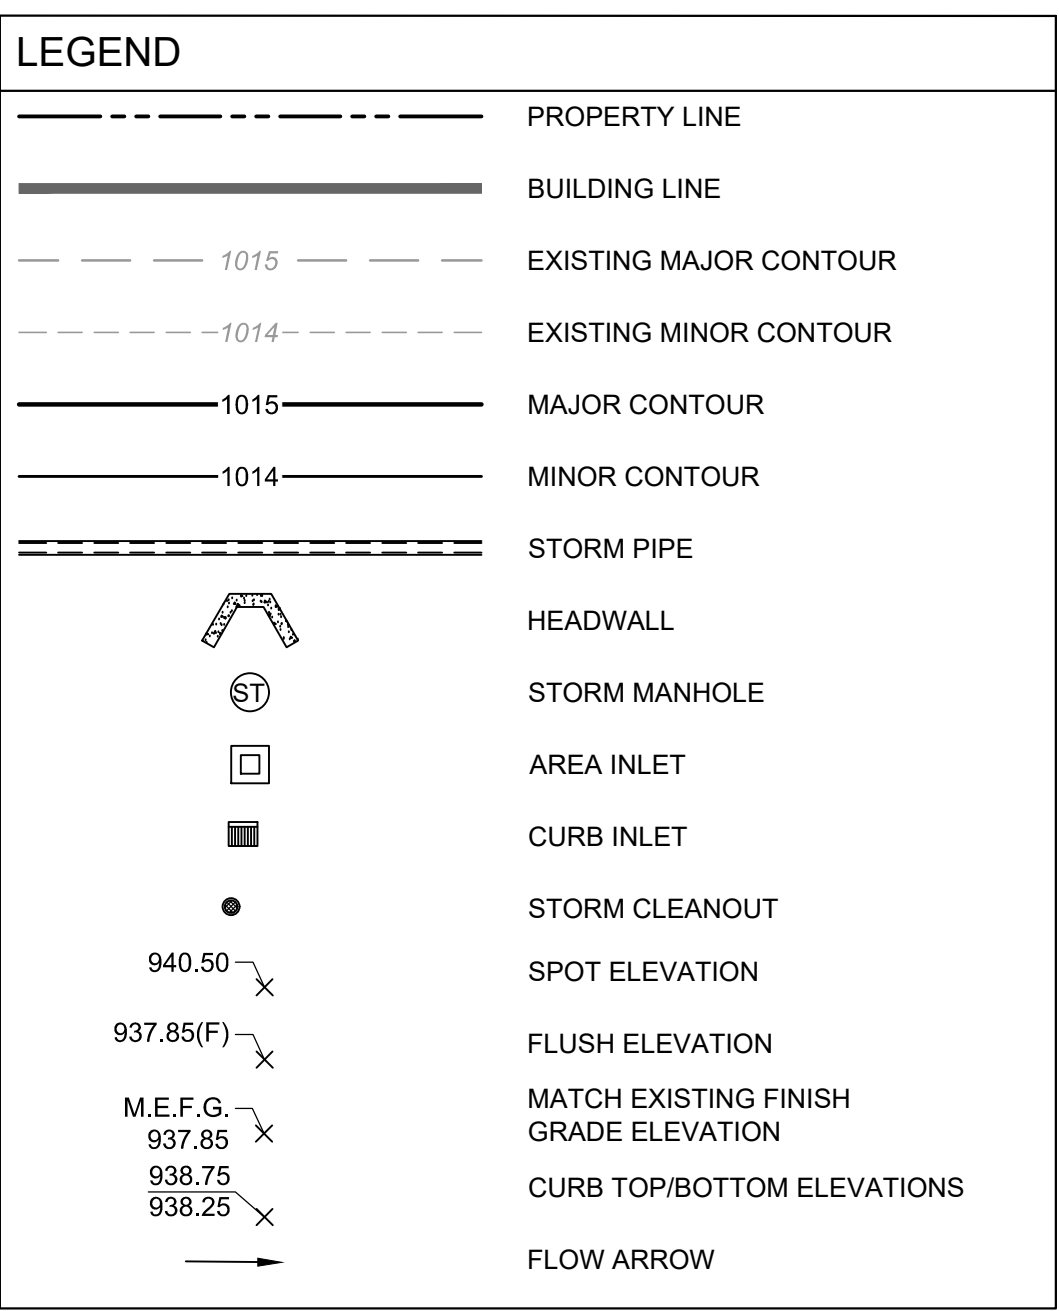
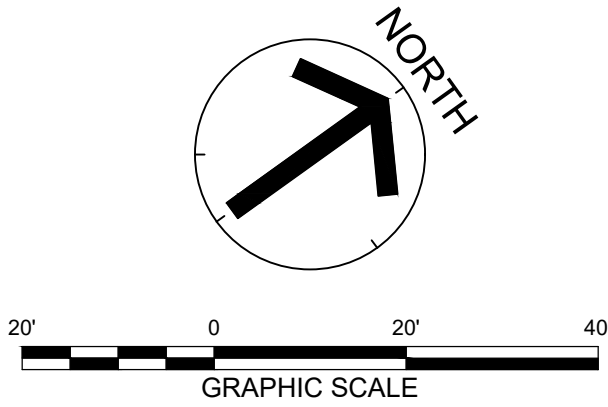
1. FOR SITE PREPARATION AND GEOTECHNICAL RECOMMENDATIONS, REFER TO INTERTEK PSI GEOTECHNICAL REPORT 03381947, DATED 7/24/2019.  
**ITEMS IN RED AND CLOUDED IN RED INDICATE AS BUILT CONDITIONS.**
3. **ITEMS IN BLUE AND CLOUDED IN BLUE INDICATE AS BUILT FIX. ONCE FIX IS COMPLETED, PROVIDE TOPO SURVEY OF THE ENTIRE SITE INCLUDING PARKING, BUILDING FFE, AREA INLET TOP OF CASTING, POND, POND STRUCTURE INVERTS AND DIMENSIONS.**
