**WATERS OF THE UNITED STATES DELINEATION REPORT
PROPOSED PEDESTRIAN BRIDGE
LEE'S SUMMIT MEDICAL CENTER
LEE'S SUMMIT, MISSOURI**

J045666.01

Re: Waters of the United States Delineation Report
Proposed Pedestrian Bridge
Lee's Summit Medical Center
Lee's Summit, Missouri
Project No. J045666.01

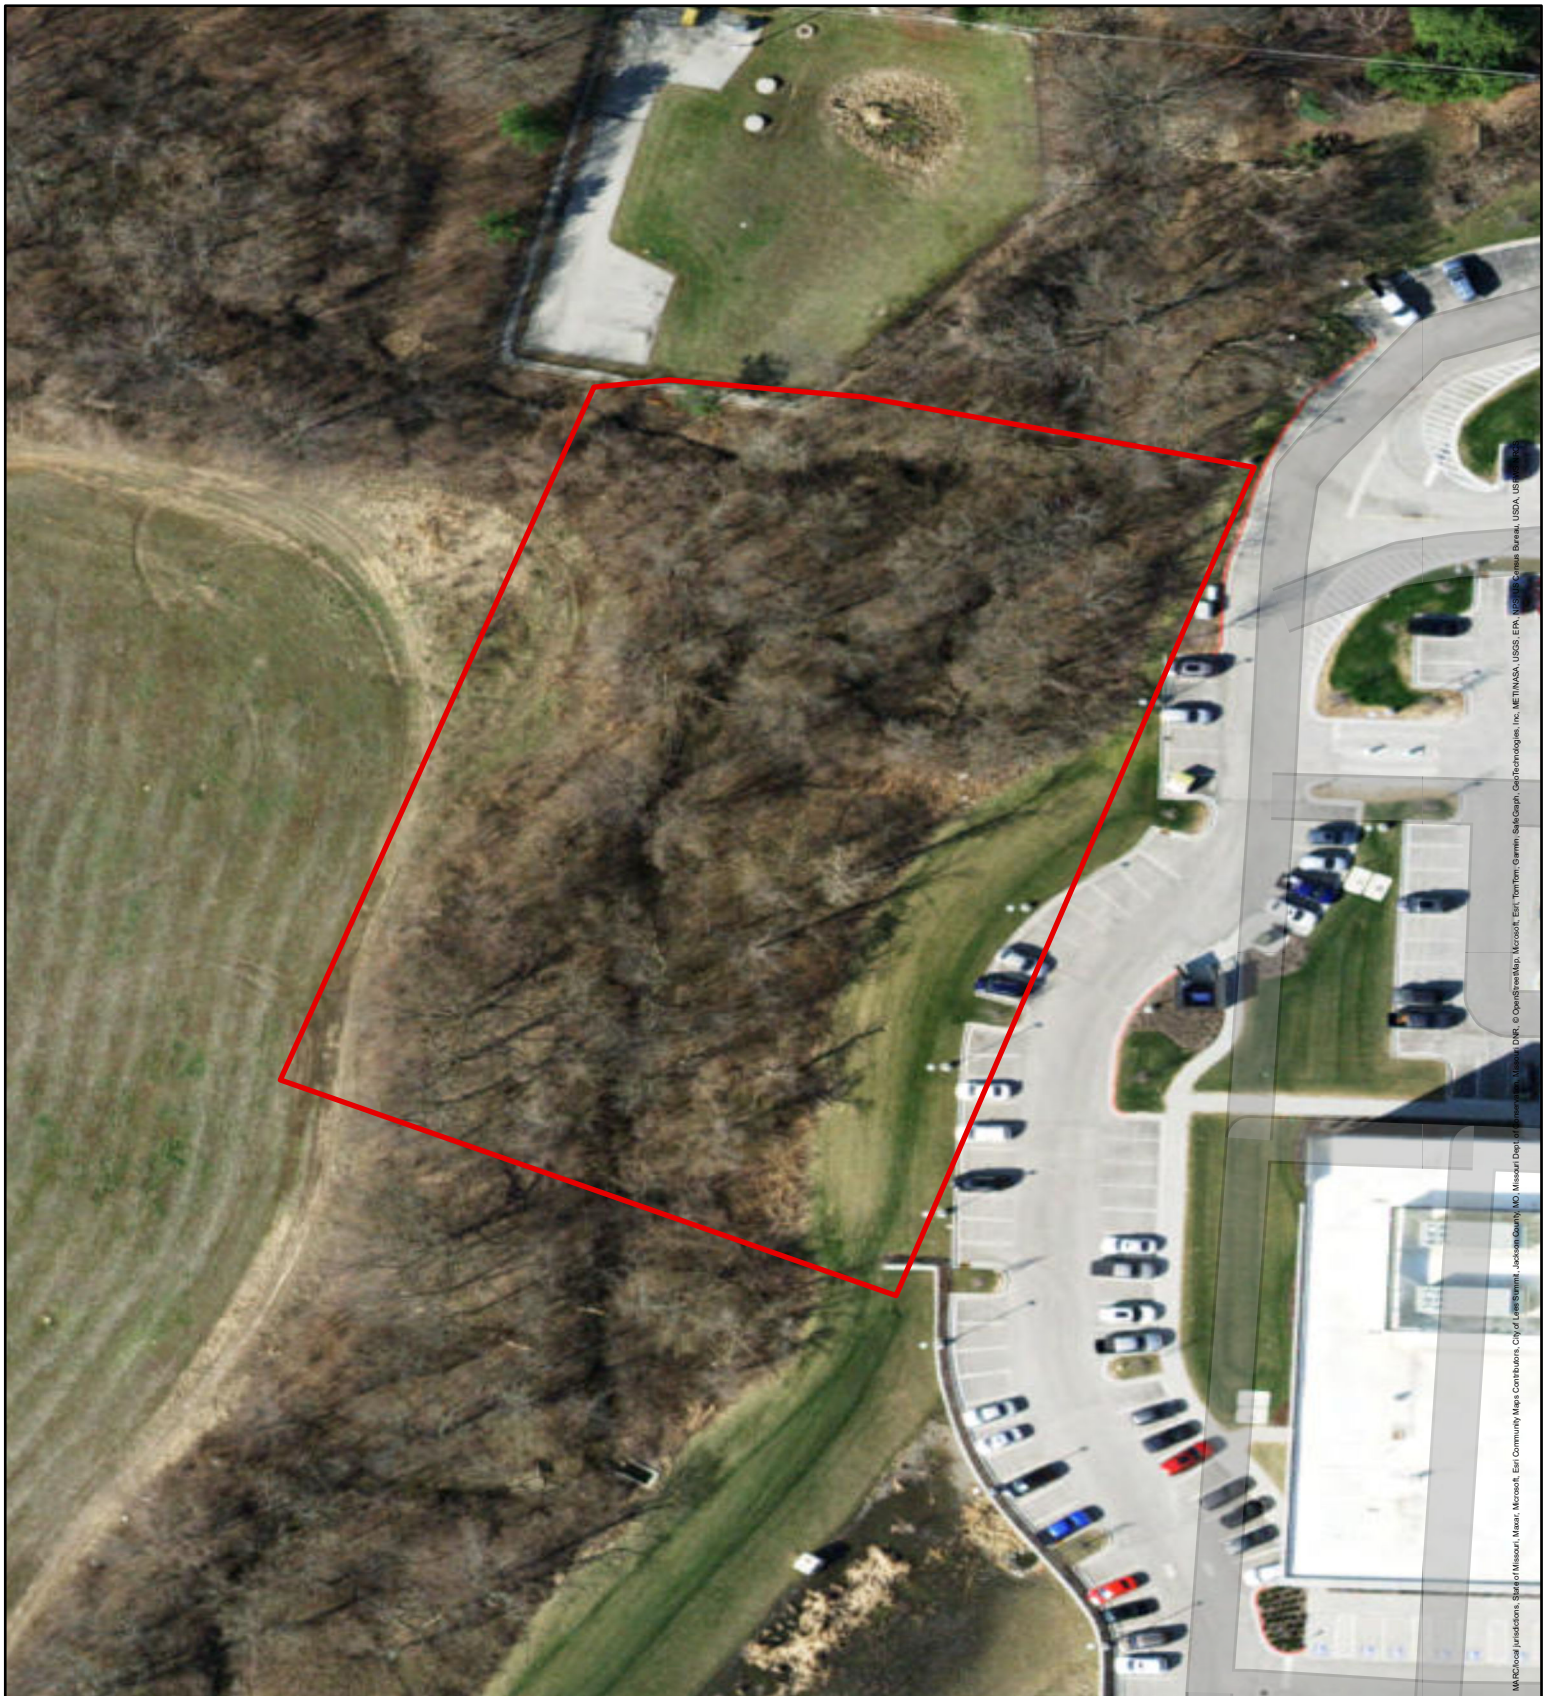
FIGURE 3. AERIAL MAP
PROPOSED PEDESTRIAN BRIDGE
LEE'S SUMMIT MEDICAL CENTER
2100 SE BLUE PARKWAY
LEE'S SUMMIT, MISSOURI 64063

UES reviewed Google Earth aerial images dating back to 1990 to identify land uses, changes in natural systems, and areas exhibiting inundation or saturation on the Site (Figure 3; Google Earth Pro, 2024). Aerial imagery from 1990 to 2005 indicates a wooded riparian stream corridor with row crop agriculture located on the east and west sides. This corridor corresponds to the drainage and stream observed in Figure 2. Hard infrastructure was not depicted during this time period. The construction of the current medical center occurred during the years 2006 and 2007. The area west of the stream corridor appeared to be used for construction laydown and staging. Additional parking areas were constructed on the east side of the stream corridor in the years 2019 and 2020. From 2007 to 2022, imagery indicates that the area west of the stream corridor has been fallow or has been used for row crop agriculture.

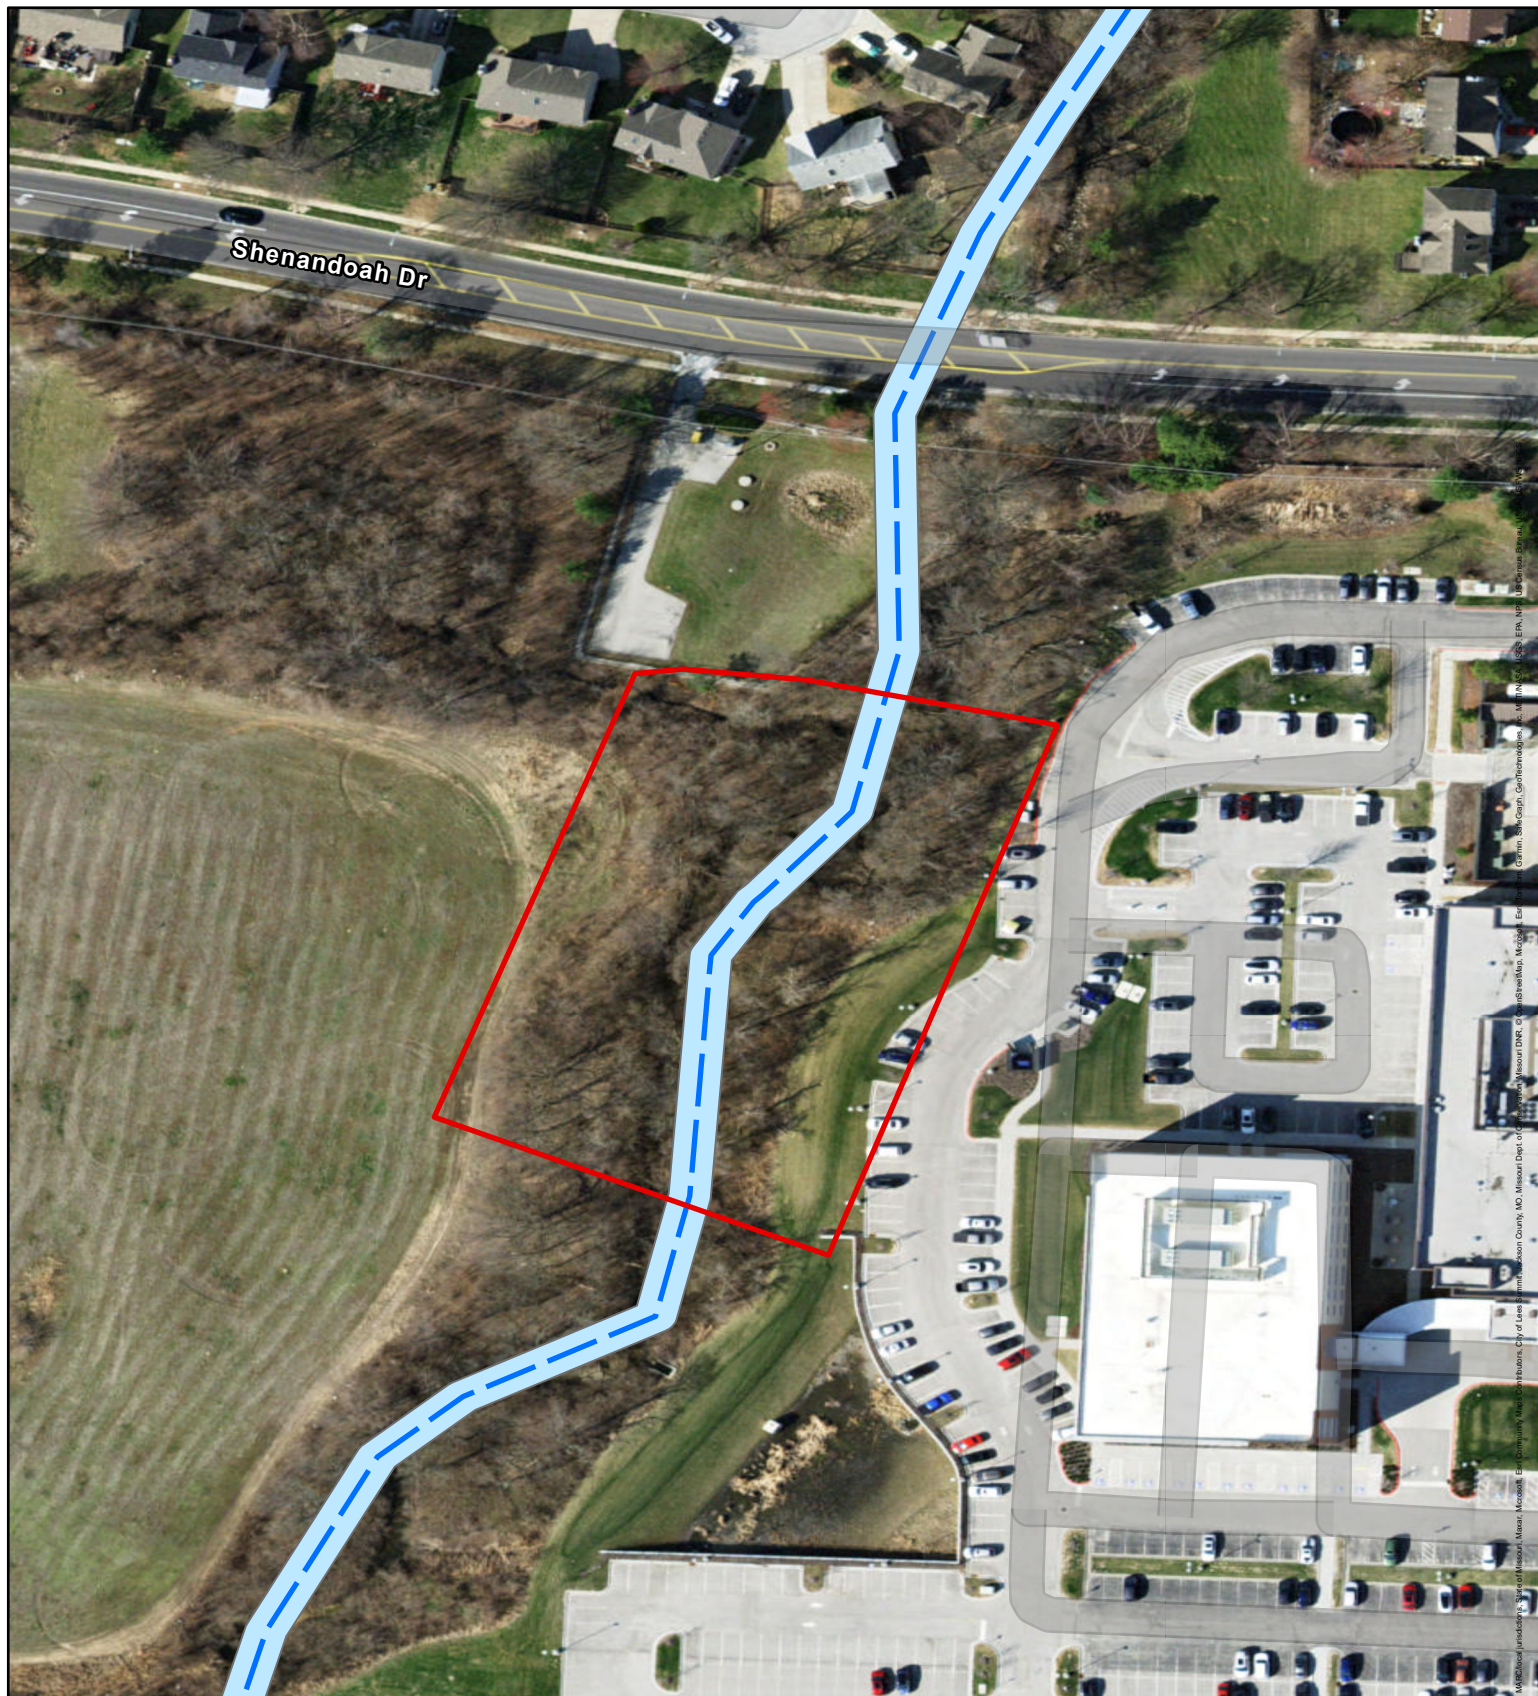
FIGURE 4. NATIONAL WETLAND INVENTORY
 AND NATIONAL HYDROGRAPHY DATA
 PROPOSED PEDESTRIAN BRIDGE
 LEE'S SUMMIT MEDICAL CENTER
 2100 SE BLUE PARKWAY
 LEE'S SUMMIT, MISSOURI 64063

The United States Fish and Wildlife Service (USFWS) National Wetlands Inventory (NWI) data was reviewed to obtain information about NWI-mapped wetlands and waterbodies at the Site (USFWS, 2024, Figure 4). The NWI data indicates the presence of a riverine wetland, which is typically ascribed to linear stream corridors.

The National Hydrography Data (NHD) was also reviewed to determine if streams are located on the Site (USGS, 2024). One intermittent stream was listed in the NHD data. Both the wetland and stream data correspond to those described in Figures 2 and 3.

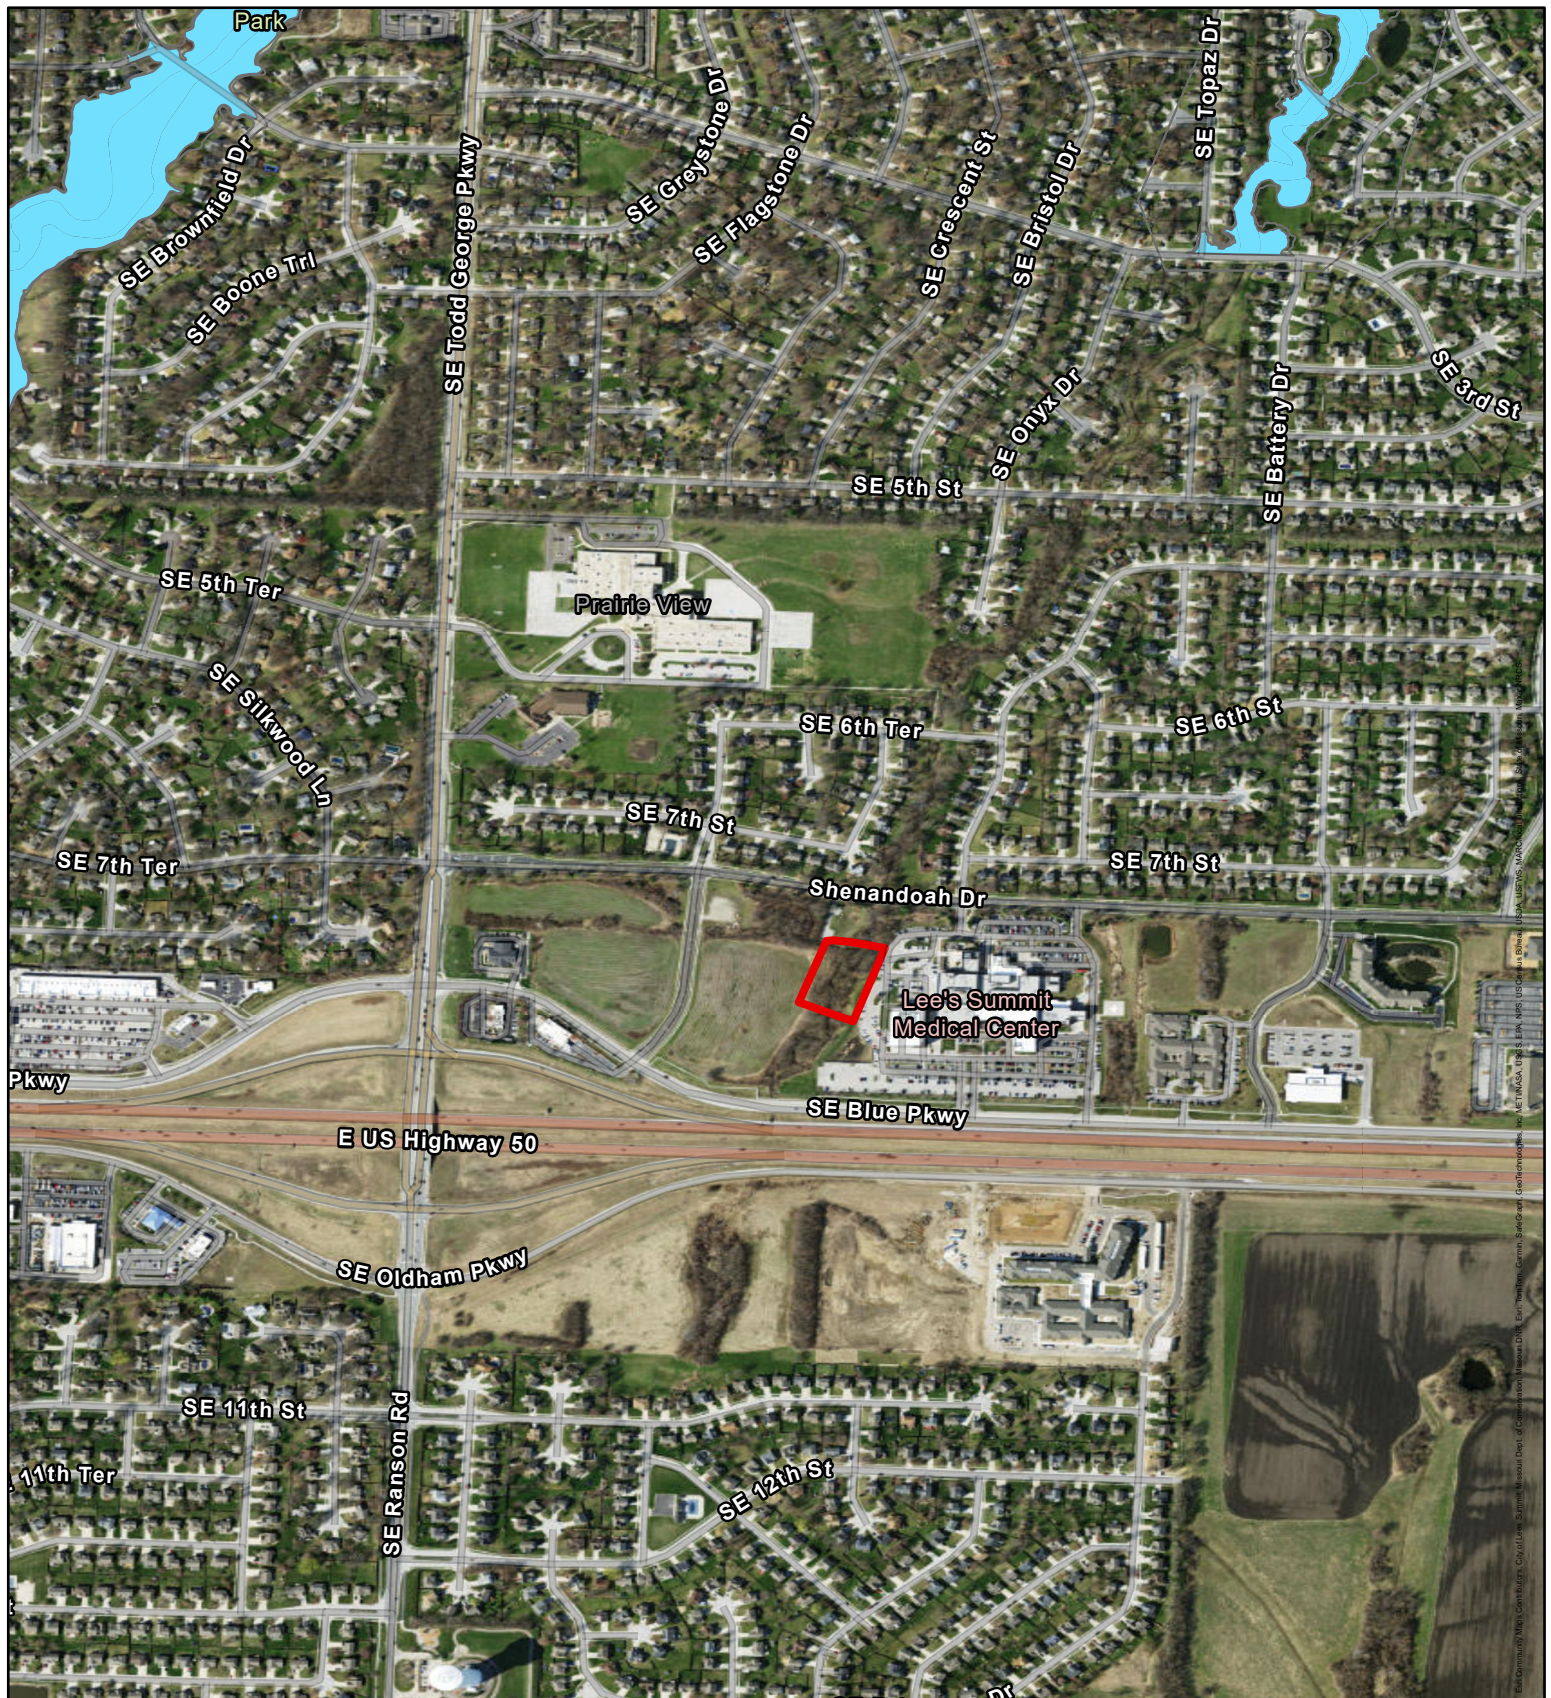
FIGURE 5. FEMA NATIONAL FLOOD HAZARD LAYER
 PROPOSED PEDESTRIAN BRIDGE
 LEE'S SUMMIT MEDICAL CENTER
 2100 SE BLUE PARKWAY
 LEE'S SUMMIT, MISSOURI 64063

UES reviewed the Federal Emergency Management Agency (FEMA) flood insurance rate map (FEMA, 2017; Firm Panel 29095C0439G). This map indicates that 100-year (1.0%) floodplains do not occur within the Site (Figure 5).

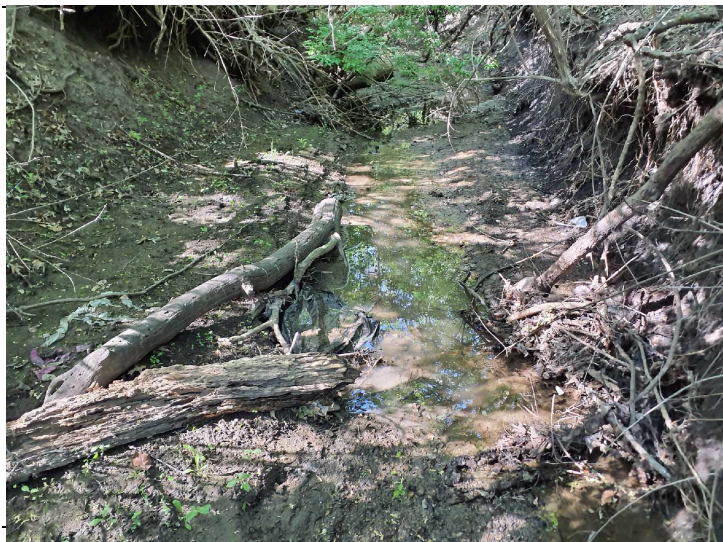
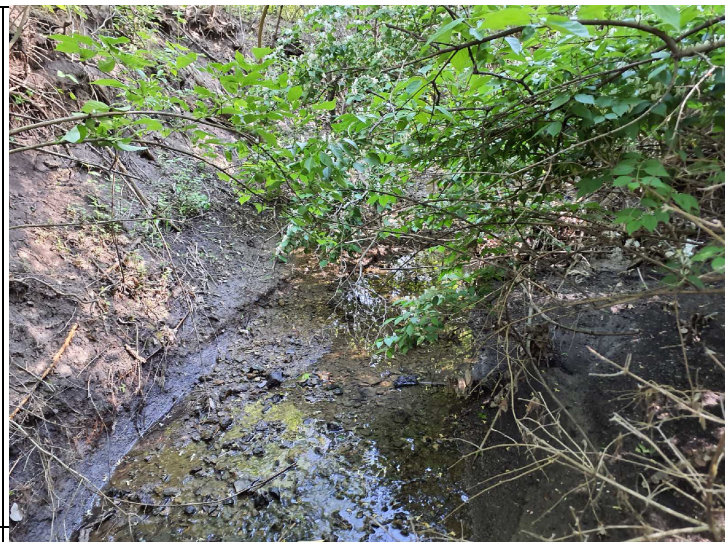
An intermittent stream, stream S1, was documented at the Site (Figure 7). This sinuous stream corresponds with the NWI and NHD data described above. It flows from south to north in a channel composed of silt and cobble. Excessive erosion and exposed tree roots were noted within the

channel along with numerous exposed pipes or utilities throughout its stretch. The ordinary high-water mark (OHWM) was approximately nine feet wide with a depth of approximately one foot. The stream was shaded by a thick community of bush honeysuckle.

Feature: S1		Project: Proposed Pedestrian Bridge		Project #: J045666.01		Date: 4/24/2024	
Location: Lee's Summit Medical Center (38.904062, -94.334745)				County: Jackson		State: Missouri	
Type: perennial stream ✓ intermittent stream ephemeral stream gully/draw other:				Substrate: ✓ silt bedrock sand artificial: gravel other: cobble			
Feature Type Rationale: Well developed channel, stream flow, indicated by NHD data.				Buffer Type: ✓ forested ✓ scrub-shrub herbaceous agricultural other:			
Hydrology: ✓ flowing standing none other:							
Water Quality: ✓ clear turbid oily other:				Characteristics: ✓ exposed tree roots ✓ steep slopes vegetated banks incised ✓ excessive erosion bank collapse oxbow riffles pools disappearing other:			
OHWM: ✓ present absent				Geometry: ✓ straight meandering			
OHWM Characteristics: N/A ✓ line on bank shelving vegetation (%) other:				Buffer Vegetation: Pecan, bush honeysuckle.

N/W Buffer Width (ft.)			
				S/E Buffer Width (ft.)			
				Jurisdictional: Unknown.			
OHWM Width (ft.) 9.0				Reason:			
OHWM Depth (ft.) 1.0				Under the Sackett Guidance, some intermittent streams are jurisdictional and some are not. Further coordination with the U.S. Army Corps of Engineers may be needed to determine jurisdictionality.

View looking south (upstream).

View looking north (downstream).

If this stream is spanned and not impacted, no Section 404 permit will likely be needed.

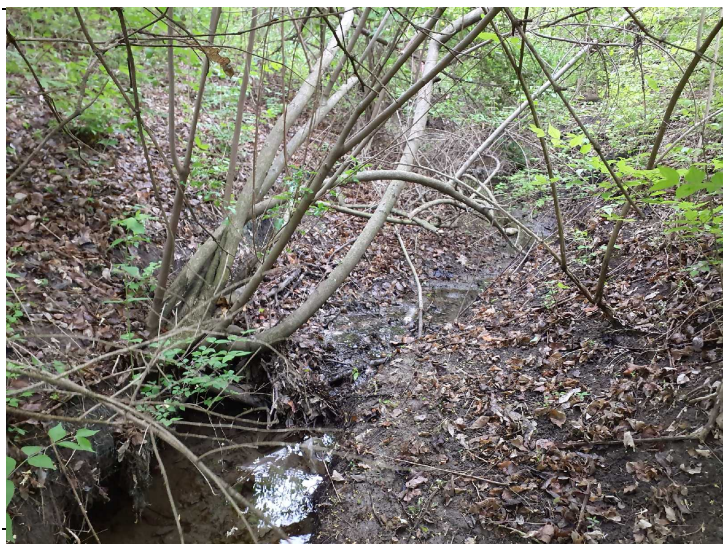
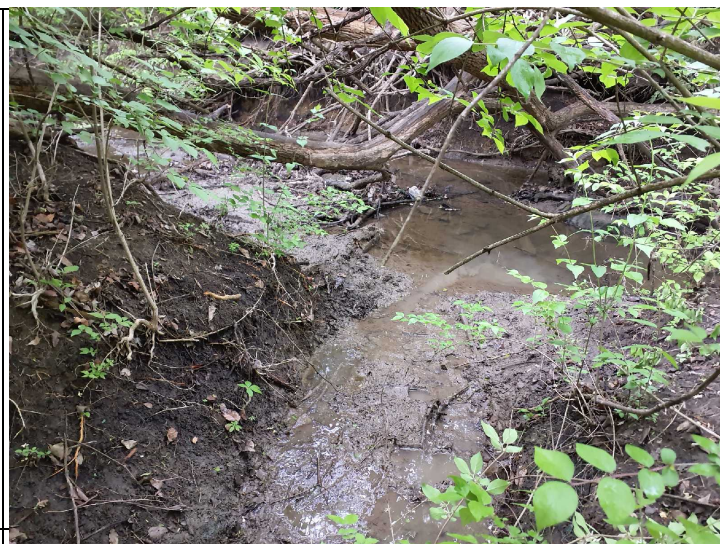
An ephemeral stream, Stream S2, flows into S1 in the northern portion of the Site (Figure 7). This channel showed evidence of an OHWM that was approximately two feet wide and 0.75 feet deep. The substrate was silt and a dense bush honeysuckle community shaded the entire stretch. Significant flow was not observed, but scattered pools were noted.

Feature: S2		Project: Proposed Pedestrian Bridge		Project #: J045366.01		Date: 4/25/2024	
Location: Lee's Summit Medical Center. (38.904383, -94.334716)				County: Jackson		State: Missouri	
Type: perennial stream intermittent stream <input checked="" type="checkbox"/> ephemeral stream gully/draw other:				Substrate: <input checked="" type="checkbox"/> silt sand <input checked="" type="checkbox"/> gravel cobble bedrock artificial: other:			
Feature Type Rationale: No flow, poorly developed.				Buffer Type: forested <input checked="" type="checkbox"/> scrub-shrub herbaceous agricultural other:			
Hydrology: flowing <input checked="" type="checkbox"/> standing none other:							
Water Quality: <input checked="" type="checkbox"/> clear turbid oily other:				Characteristics: <input checked="" type="checkbox"/> exposed tree roots <input checked="" type="checkbox"/> vegetated banks excessive erosion oxbow pools disappearing steep slopes incised bank collapse riffles other:

OHWM: <input checked="" type="checkbox"/> present absent				Geometry: <input checked="" type="checkbox"/> straight meandering			
OHWM Characteristics: N/A <input checked="" type="checkbox"/> line on bank shelving vegetation (%) other:				Buffer Vegetation:			
				N/W Buffer Width (ft.) 100+			
				S/E Buffer Width (ft.) 100+			
				Jurisdictional: No			
				Reason:			
OHWM Width (ft.) 2.0				Under the Sackett Guidance, ephemeral streams are not jurisdictional.			
OHWM Depth (ft.) 0.75

View looking west (upstream).

View looking east (downstream) at it's nexus with S1 (background).

Stream S2 is an ephemeral stream and under the Sackett Ruling, ephemeral streams are not jurisdictional and do not require permits for their impacts. During this time of regulatory transition, consultation with the USACE is recommended if any part of these streams are impacted.
