DEMOLITION PERMIT APPLICATION

Re: 900 NE Douglas St. Asbestos Testing
Lee's Summit, MO 64086
KCTE Project Number E20-20-122

Figure 1
Asbestos Location Map
900 N.E. Douglas Street
Lee's Summit, MO
Project No. E20-20-122

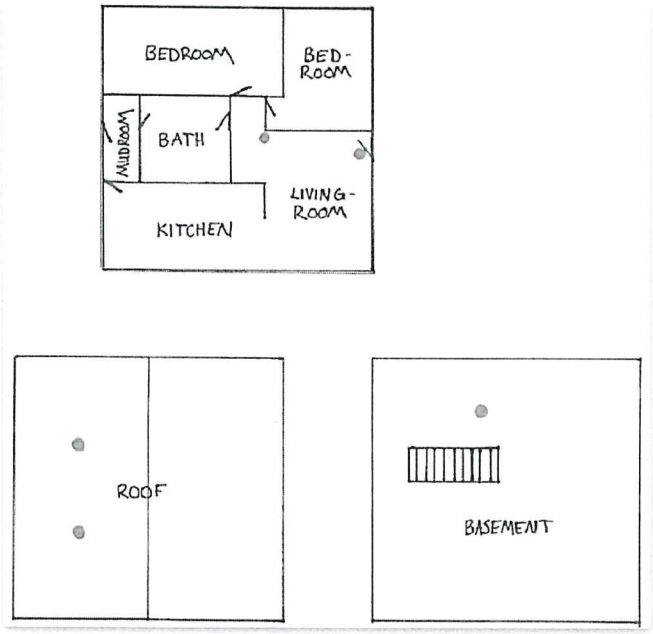
Asbestos Containing Material
Note: Exterior siding contained asbestos

SAMPLE ID	MATERIAL	COLOR	SAMPLE RESULT	LOCATION	ESTIMATED QUANTITY
TS-1	SIDING	BLUE/GREY	CHRYSOTILE 18%	EXTERIOR	1500SF
TS-2			CHRYSOTILE 18%		
TS-3			CHRYSOTILE 18%		
RF-1	ROOF FLASHING	BLACK	CHRYSOTILE 15%	ROOF	2SF
RF-2			CHRYSOTILE 15%		
RF-3			CHRYSOTILE 15%		
FV-1	FLOOR VINYL	YELLOW	CHRYSOTILE 65% (BACKING)	ENTRY	125F
FV-2			CHRYSOTILE 65% (BACKING)		
FV-3			CHRYSOTILE 65% (BACKING)		
TT-1	LOOSE TILES	GREY	CHRYSOTILE 18%	PILE IN LIVING ROOM	5SF
TT-2			CHRYSOTILE 18%		
TT-3			CHRYSOTILE 18%		
DC-1	FURNACE DAMPENING CLOTH	TAN	CHRYSOTILE 90%	BASEMENT HVAC	1
DC-2			CHRYSOTILE 90%		
DC-3			CHRYSOTILE 90%
