Firestone COMPLETE AUTO CARE
3561 SW MARKET STREET
LEE'S SUMMIT, MISSOURI 64082

No.	Date	Description
1	02.07.2020	CITY COMMENTS
2	02.20.2020	CITY COMMENTS
3	03.27.2020	CITY COMMENTS
4	05.15.2020	CITY COMMENTS
5	04.12.2021	AS BUILT
6	04.15.2021	AS BUILT
7	06.29.2021	AS BUILT FIX

SITE DETAILS

C903

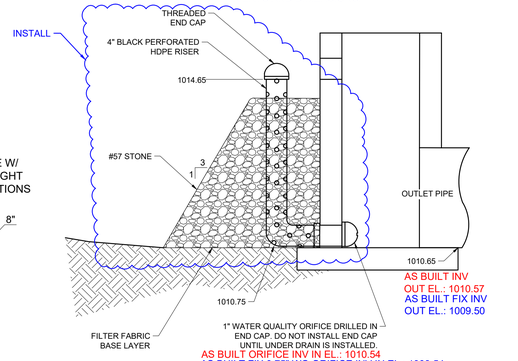
01 C903 — PRECAST OUTLET CONTROL STRUCTURE WITH PERFORATED PIPE
NOT TO SCALE

NOTE:
1. ITEMS IN RED AND CLOUDED IN RED INDICATE AS BUILT CONDITIONS.
2. ITEMS IN BLUE AND CLOUDED IN BLUE INDICATE AS BUILT FIX. ONCE FIX IS COMPLETED, PROVIDE TOPO SURVEY OF THE ENTIRE SITE INCLUDING PARKING, BUILDING FFE, AREA INLET TOP OF CASTING, POND, POND STRUCTURE INVERTS AND DIMENSIONS.

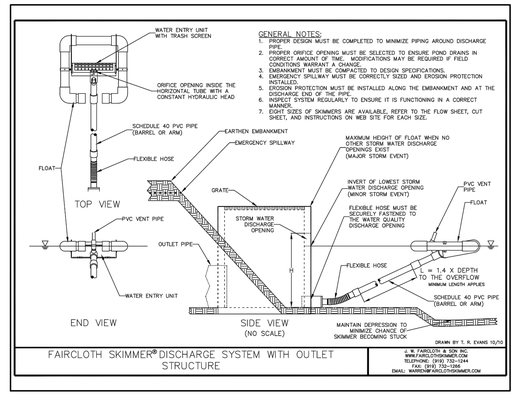
03 C903 — FAIRCLOTH SKIMMER
NOT TO SCALE

NOTE:
1. ITEMS IN RED AND CLOUDED IN RED INDICATE AS BUILT CONDITIONS.
2. ITEMS IN BLUE AND CLOUDED IN BLUE INDICATE AS BUILT FIX. ONCE FIX IS COMPLETED, PROVIDE TOPO SURVEY OF THE ENTIRE SITE INCLUDING PARKING, BUILDING FFE, AREA INLET TOP OF CASTING, POND, POND STRUCTURE INVERTS AND DIMENSIONS.
