January 9, 2026

**RE: DECK DESIGN
2826 SW HEARTHSTONE PLACE
LEE'S SUMMIT, MISSOURI**

JOB #2025-2443

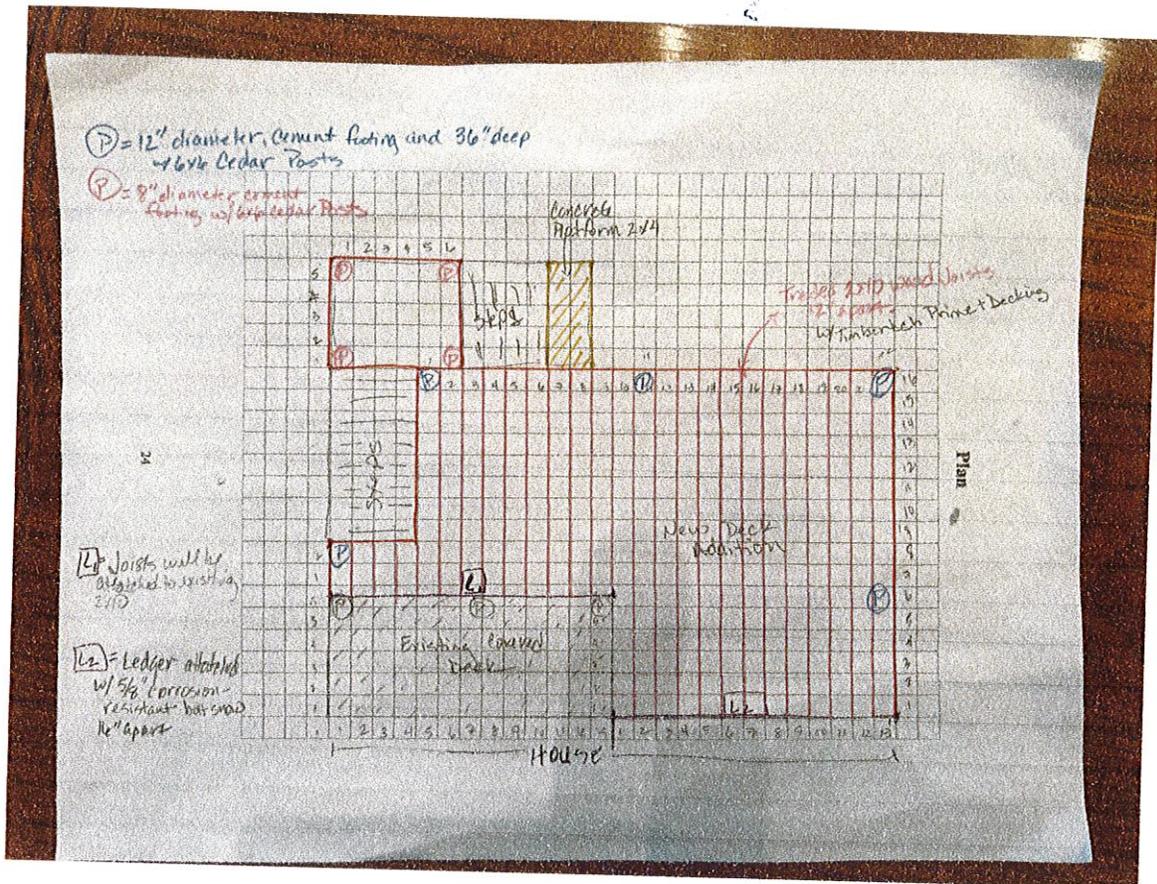
The existing deck at the rear of the house had 3 posts (6x6's) at approximately 6.5 feet on center along the west side of the deck. According to the contractor the piers supporting the posts were 24" in diameter (see attached photograph). In order to reduce the additional load to the posts, I recommend that an additional interior beam be added at the top of the stairs and run across the length of the existing deck (see attached sketch). I have also upsized the pier diameters of the two pier types, flush beams, and ledger attachments to the existing house to be consistent with the Johnson County Deck guidelines, per the Lee's Summit deck permit guidelines indicated on the website.
