Re: 212 NW Carson Drive Lot 1452, Winterset Valley Permit #20200164

Apex Engineers, Inc. observed the excavation for the proposed house located at the address above. The sub-grade bearing conditions were evaluated.

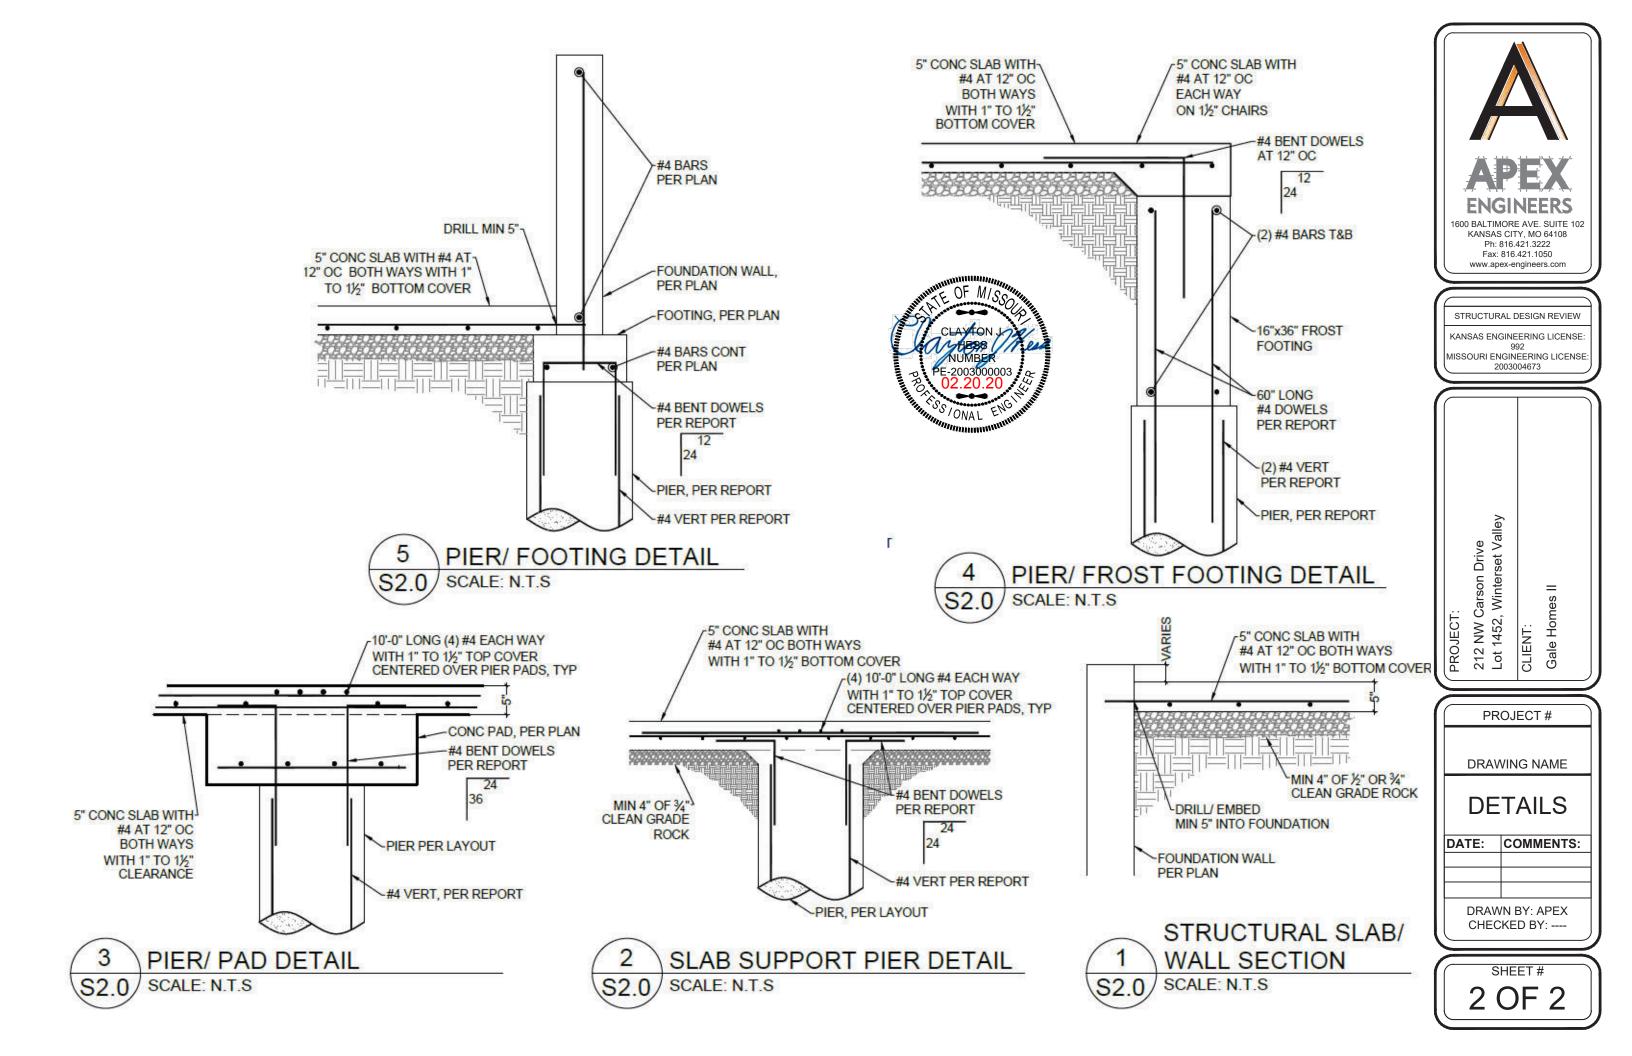
The excavation terminates on material that will not adequately support the proposed house. Our firm recommends the following foundation system:

- Drill 18" and 24" diameter reinforced concrete piers per the attached layout.
- Piers shall be drilled/dug to refusal on and end bear on competent original limestone, sandstone, or shale.

- The piers shall be reinforced with (2) #4 bars for the depth of the pier.
- (2) #4 bars shall be embedded a minimum of 24" into the top of each pier and shall extend a minimum of 24" into the footings.
