SUMMIT APARTMENT
LEE'S SUMMIT, MISSOURI
STEEL BEAM FIREPROOFING - INSPECTION

Activity Discrepancy

23-1037
Summit Square III Apts (Insp/Test)
800 NW Ward Road
Lee's Summit, MO

Site Observation Report

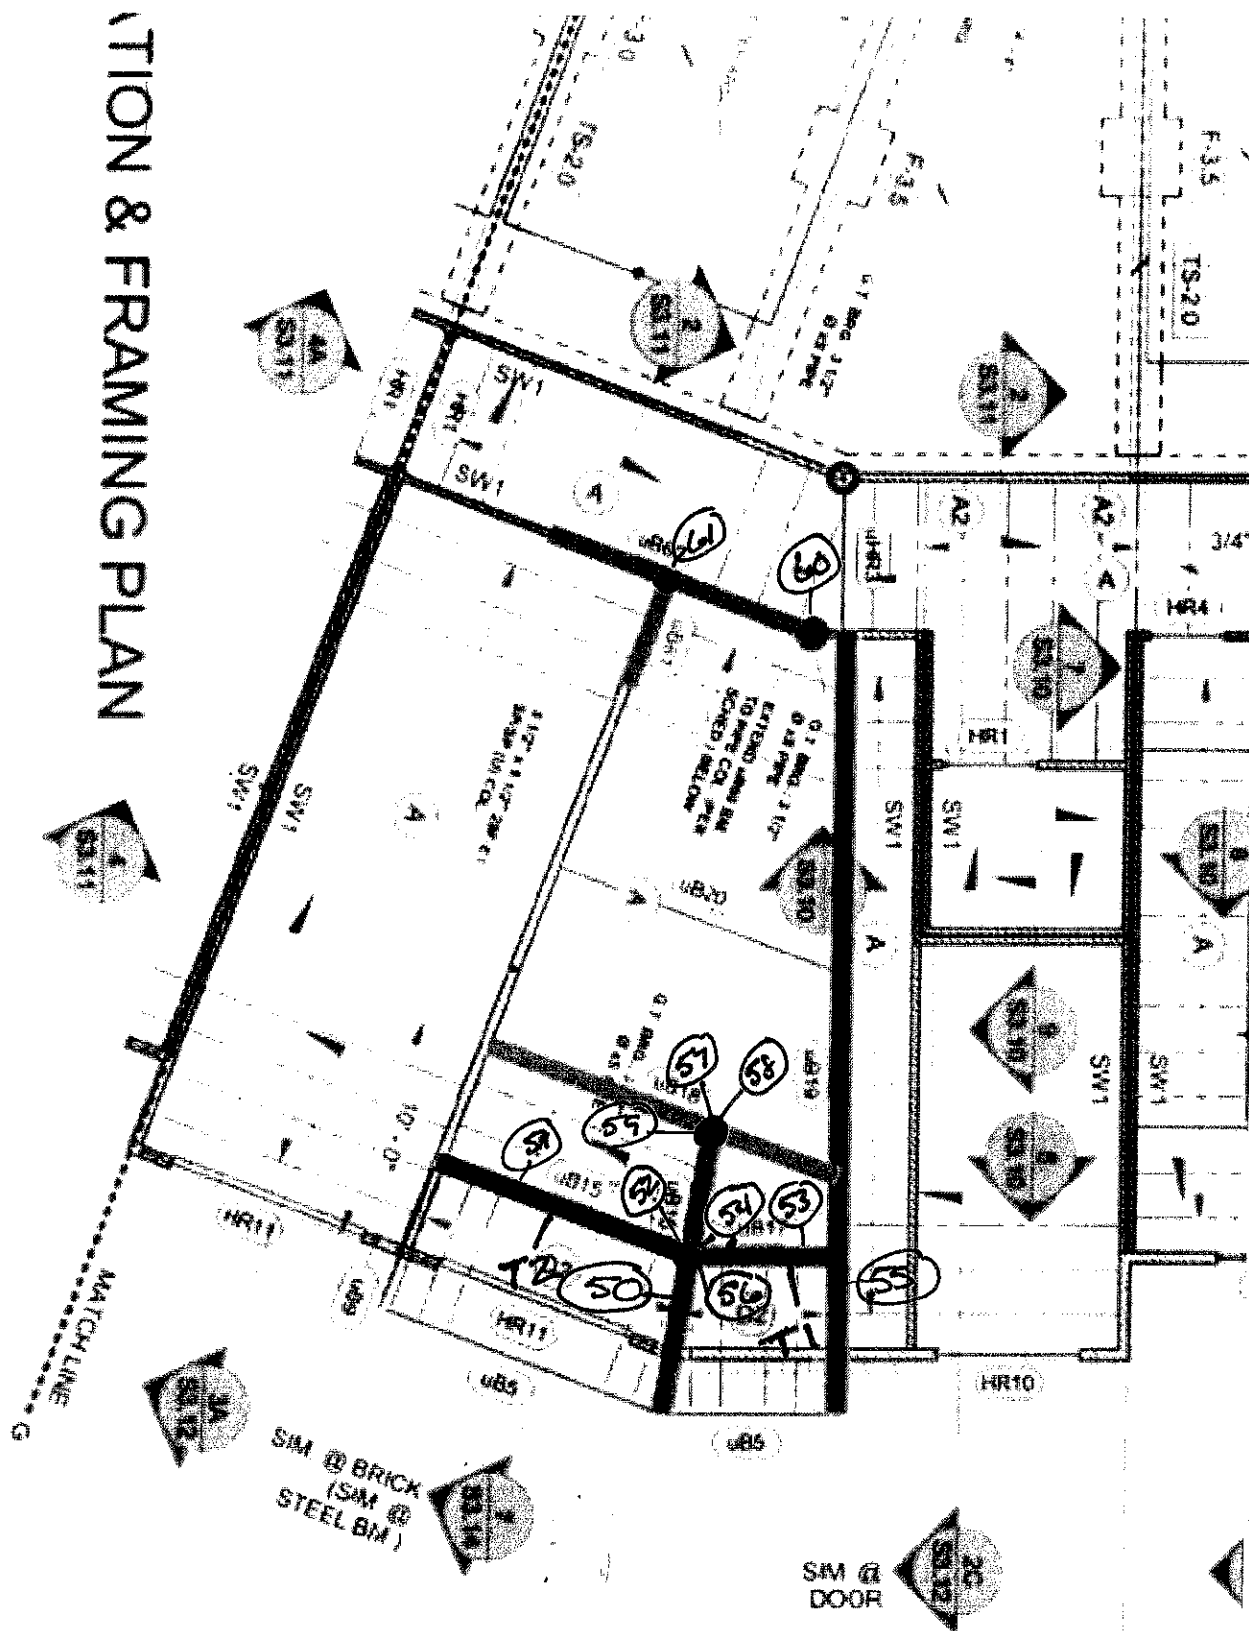
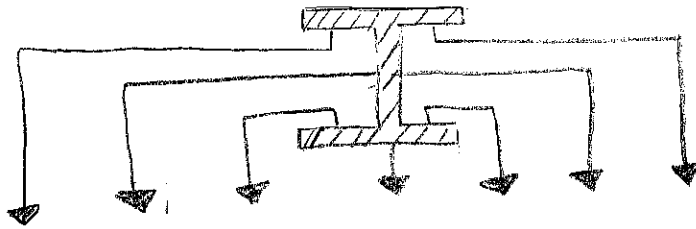
Summit Square III 23-1037
 Building 2 Segment 6 in Basement

ID	Description	Status	Date Resolved	Resolution
48	Segment G basement level beam on grid line 1.1 on the west side failed required TFIFRM thickness.	Open		
51	Segment G TFIFRM placement: Tthere are various spots on beams and columns that are nicked or missing TFIFRM paint where steel is exposed.	Open

FAIL
 PASS

1	2	3	4	5	6	7	Total	AVG
1 st									
1	X	X	X	51	42	122	38	253	63
2	X	X	X	78	26	100	91	295	74
3	X	X	X	76	13	89	83	261	65
4	X	X	X	55	27	104	46	251	63
AVG	X	X	X	65	27	104	65	261	65
2 nd									
1	X	X	X	80	80	75	80	315	79
2	X	X	X	80	80	80	80	320	80
3	X	X	X	80	80	80	80	320	80
4	X	X	X	80	80	80	80	320	80
AVG	X	X	X	80	80	80	80	320	80
	X	X	X	80	80	79	80	319	80

1st test
 Reg Mil \Rightarrow 102
 Min Mil \Rightarrow 82

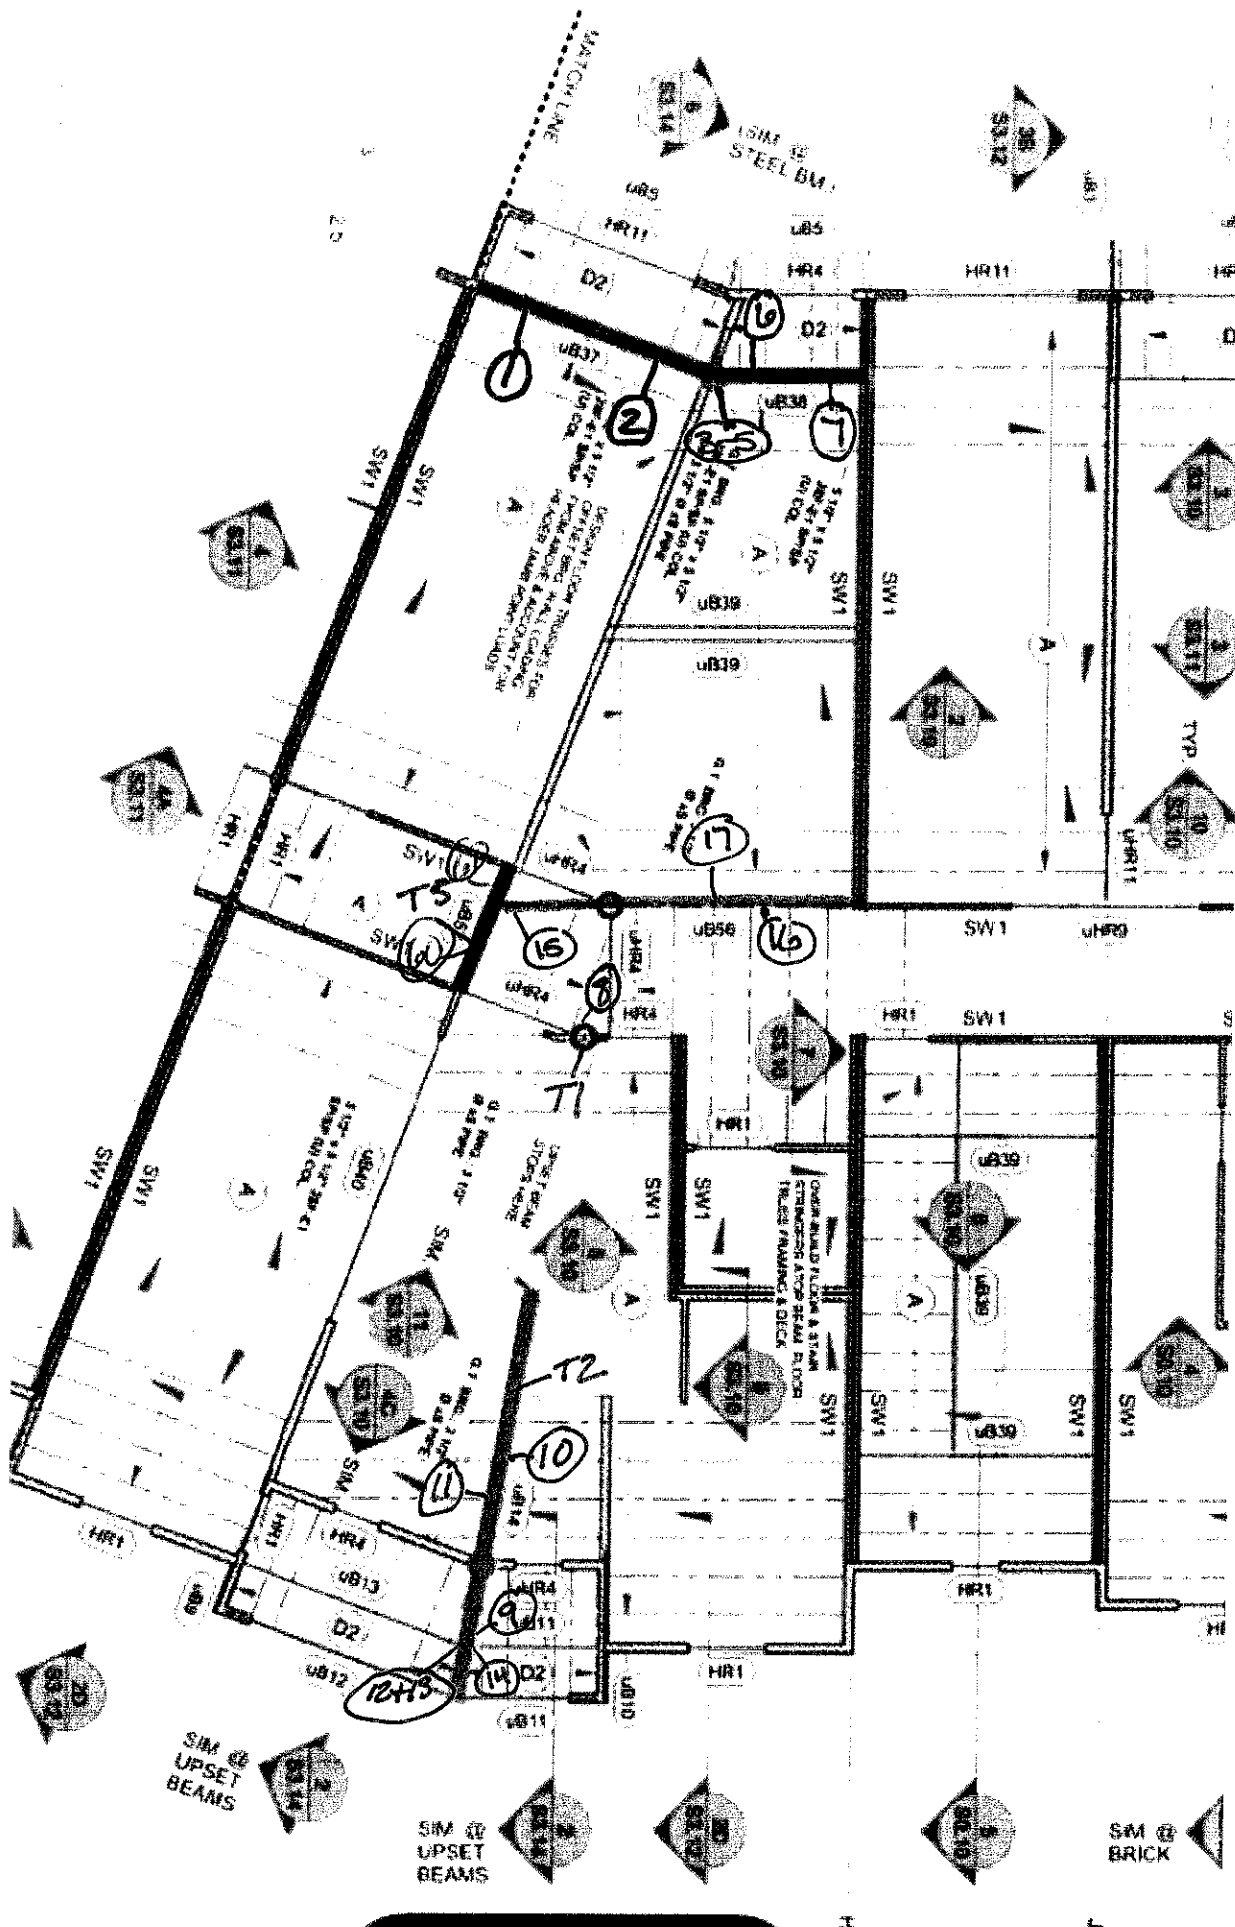
Basement Segment G
east column in hallway wall

- Exposed steel at wood
beams at top of
column
