Lot 81 Summer View Farms
2315 SW Serena Place
Lee's Summit, MO, 64082
Midwest Lumber

Foundation\Floor Joists\J2-16_ O_C_(i7573) (Joist)

BC CALC® Member Report

Repair is Required

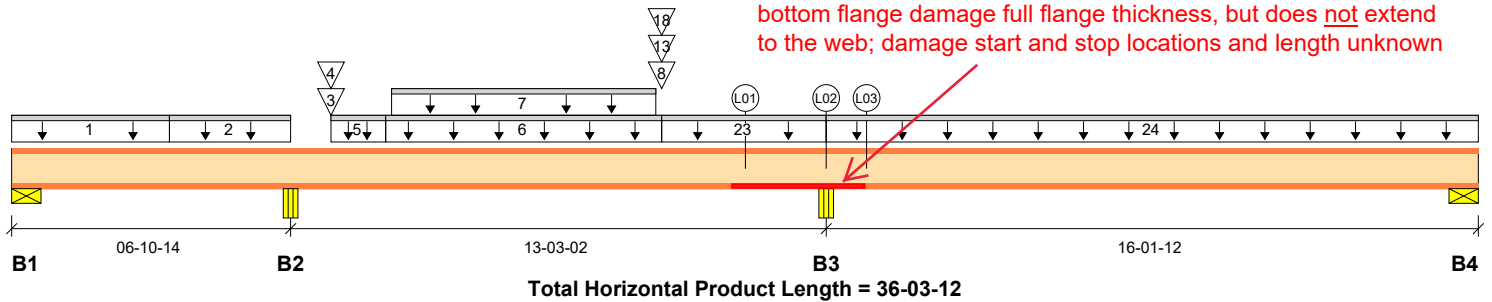
Photos:

**PASSES when
repaired as shown**

Required Repair: Jack up /shore up I-joist before repair installation.

Apply construction adhesive to cover all contact surfaces. **Backer:** Install 3/4" - 7/8" APA Rated Sheathing x (clear web depth - 1/4") x 2'-0" min. length backer tight-fit to the top of the bottom flange centered at the bearing opposite the damaged side. **Reinforcer:** Install 1 1/8" APA Rated Rim Board x 9 1/2" depth x 2'-0" min. length, tight-fit to the top of the bearing, centered at the bearing opposite the damaged side. **Through web:** fasten with 2 staggered rows 10d nails at 4" o.c., clinched downward where possible. **Through top flange only:** fasten with 1 row 8d nails at 6" o.c..

Apply construction adhesive to cover all contact surfaces. Min. 2x4 x (1'-6" min. beyond both ends of bottom flange damage) #2 & Btr. SPF & Btr. KD-19, or VERSA-LAM® LVL reinforcement damaged flange side of web, tight-fit to top of bottom flange

- 1) Center backer and reinforcer at the center of the bearing support.
- 2) Center 2x4 at the center of the flange damage and extend 1'-6" min. beyond the ends of the damage.
