April 9, 2025

Re: 2739 SW Heartland Road (Lot 191, Retreat at Hook Farms) – city inspection items

Vista Structural Engineering, LLC, was asked to address city inspection structural items for the new house being built at 2739 SW Heartland Road. The following are the inspection comments and our responses.

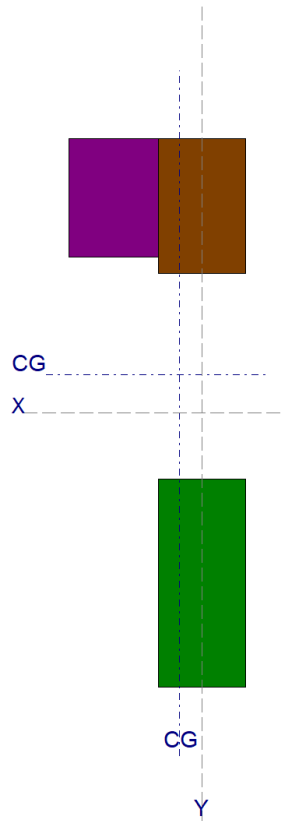
BUILT-UP SECTION WITH 1 1/2" x 2" SECTION ADDED TO (AND BEYOND) SECTION WHERE HOLES ARE LOCATED.

SECTION MUST MEET MINIMUM I_x AND S_x VALUES OF A FULL 2x10 (I_x=98.9in⁴ AND S_x=21.39in³)

PER CALCULATIONS ABOVE:

I_x = 127.0in⁴ (OK)

S_x = 24.1in³ (OK)

PROPOSED BUILT-UP SECTION OK

INSTALL 3'-0"-LONG SECTION, CENTERED OVER HOLES, FASTENED W/ 10d NAILS @ 4" O.C. TO EXISTING 2x10 JOIST.
