# TERRA TECHNOLOGIES

## **Old Longview Lake Rehabilitation/Restoration Study Lee Summit, Missouri**

**August 2017**

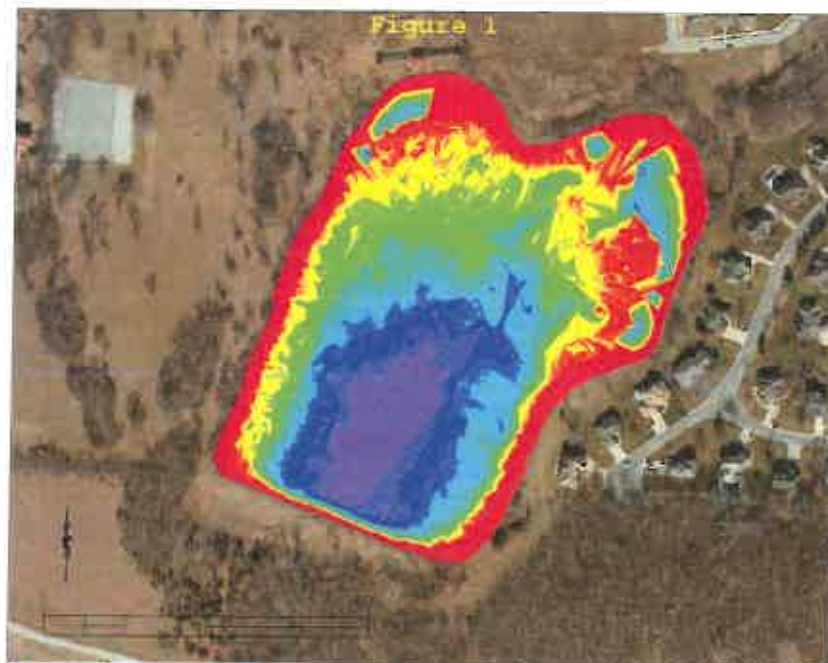
Old Longview Lake has received sediments along with inflows since original completion in 1914. Consequently, a significant volume of sediment has accumulated in Old Longview Lake over the past 100+ years. A bathymetric survey of the lake was completed by SKW Engineering revealing generally shallow depths. Figure 1 shows the results of this bathymetric survey. Red is shallowest and purple is the deepest. Depths range from 0 feet to 9 feet. As expected, sediments have accumulated in upstream and edge areas such that water depths are limited. A small area in the middle of the lake has generally acceptable depths greater than 5 feet, but most of the lake is shallower, particularly along the edges.
