Re: Old Longview Lake - Dam and Spillway Observations and Preliminary  
Recommendations Letter  
Lee's Summit, MO  
Olsson Project No. 017-0305

An Olsson Associates (**Olsson**) Geotechnical Engineer visited the site on April 30<sup>th</sup>, 2018 to observe the existing dam and spillway. This letter discusses our observations and includes recommendations for temporary remediation to the dam and spillway. This letter does not address the future design or construction plans for the lake. Recommendations and opinions on future design and construction plans will be presented under a separate cover.

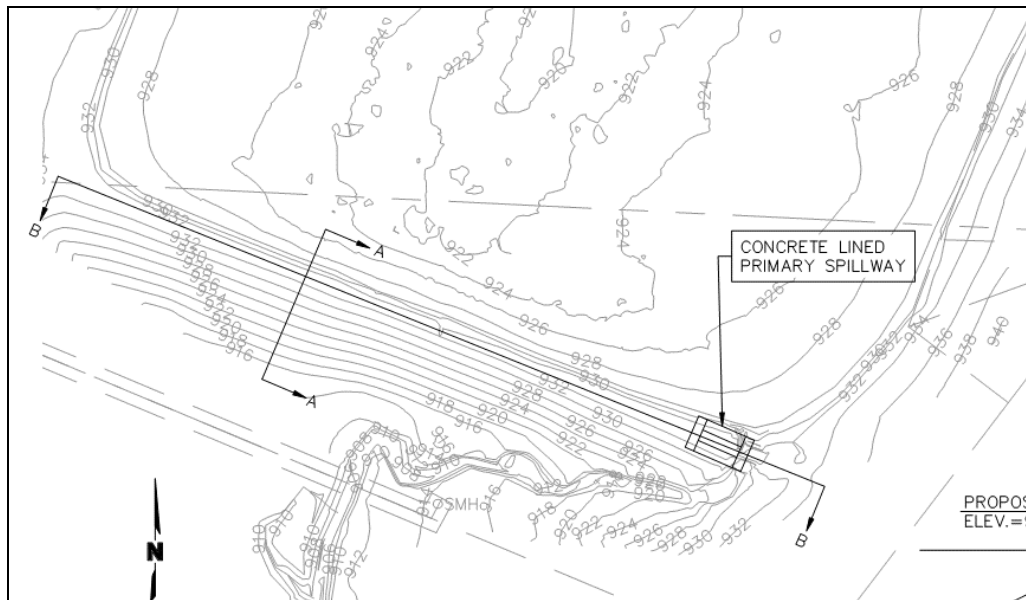
Figure 2: Dam, Spillway and Lake Survey

We understand the lake was constructed in 1914 and includes an approximately 20 feet high by 630 feet long earthen dam that has a downstream slope between 3H:1V to 5H:1V. Currently, a reinforced double box concrete spillway is located on the east side of the dam. The lake survey indicates a maximum water depth of around 9 feet, however several areas are significantly shallower as siltation has occurred across the majority of the lake. The survey depicting the dam, spillway and southern portion of the lake is shown in Figure 2.
