GEOTECHNICAL ENGINEERING REPORT

OLD LONGVIEW LAKE DAM AND SPILLWAY IMPROVEMENTS

LEE'S SUMMIT, MISSOURI

AUGUST 13, 2018

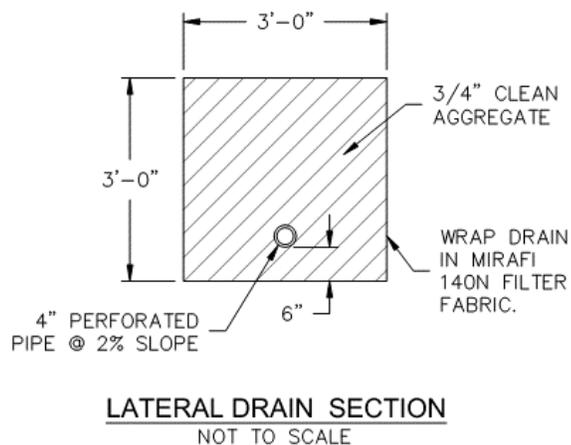
Figure 7: Later Drain Cross-Section

We recommend a lateral trench drain be installed near the toe of the slope on the west side of the embankment. As mentioned previously, water was observed seeping out of the ground in this area. The drain should be a minimum of three feet from the toe with at least 1 foot of clay cover. The location of the drain is shown in Figure 6 below.

The lateral drain should be three feet deep by three feet wide and consist of ¾ inch clean rock wrapped in Mirafi 140 N filter fabric. A four-inch diameter perforated pipe should be placed near the bottom of the drain and positioned to drain to the settling basin at a minimum slope of 2 percent. A typical detail of the drain is shown below.

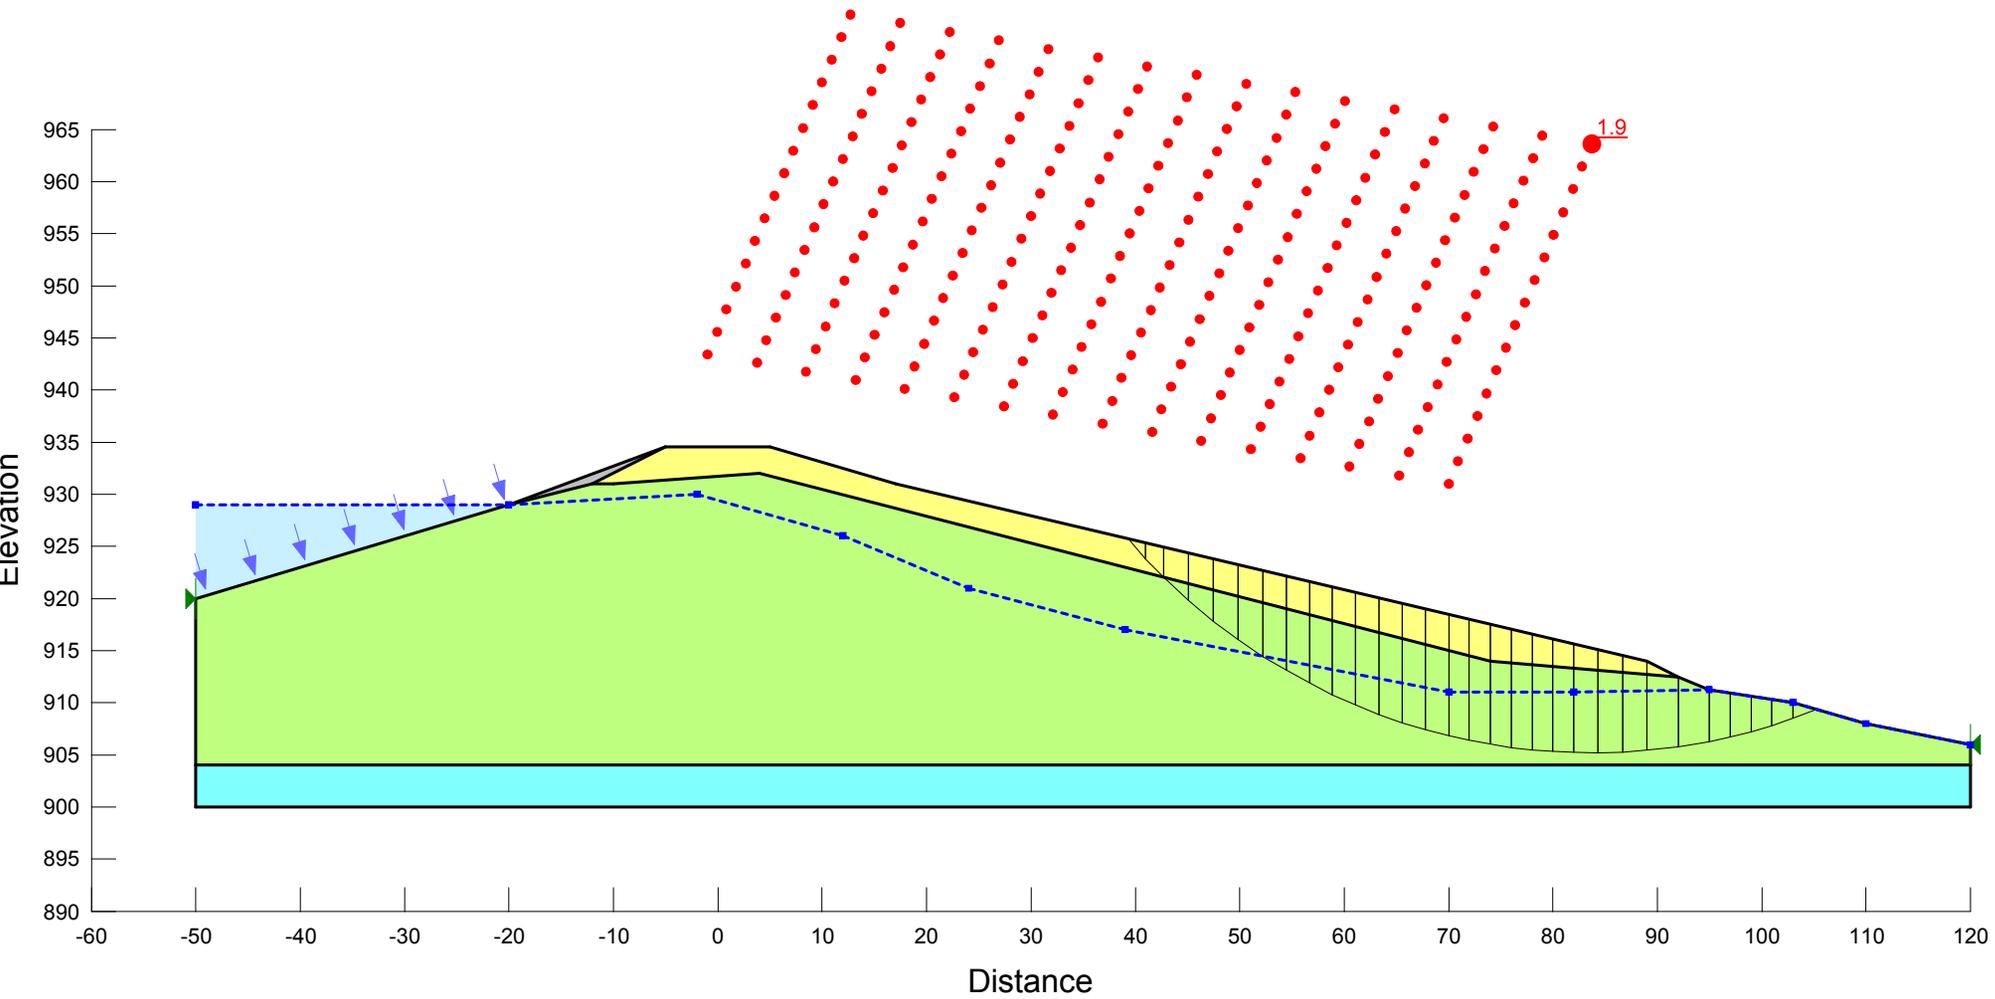
**Steady State Seepage
Full Reservoir
Effective Stress Analysis**

Condition Analyzed	Calculated Factor of Safety	MDNR Req. Minimum Factor of Safety
Steady State Seepage (Full Reservoir)	1.9	1.5
Steady State Seepage (Max Reservoir)	1.9	1.3
Rapid Drawdown	1.2	1.2
Earthquake, a = 0.20g	1.0	1.0

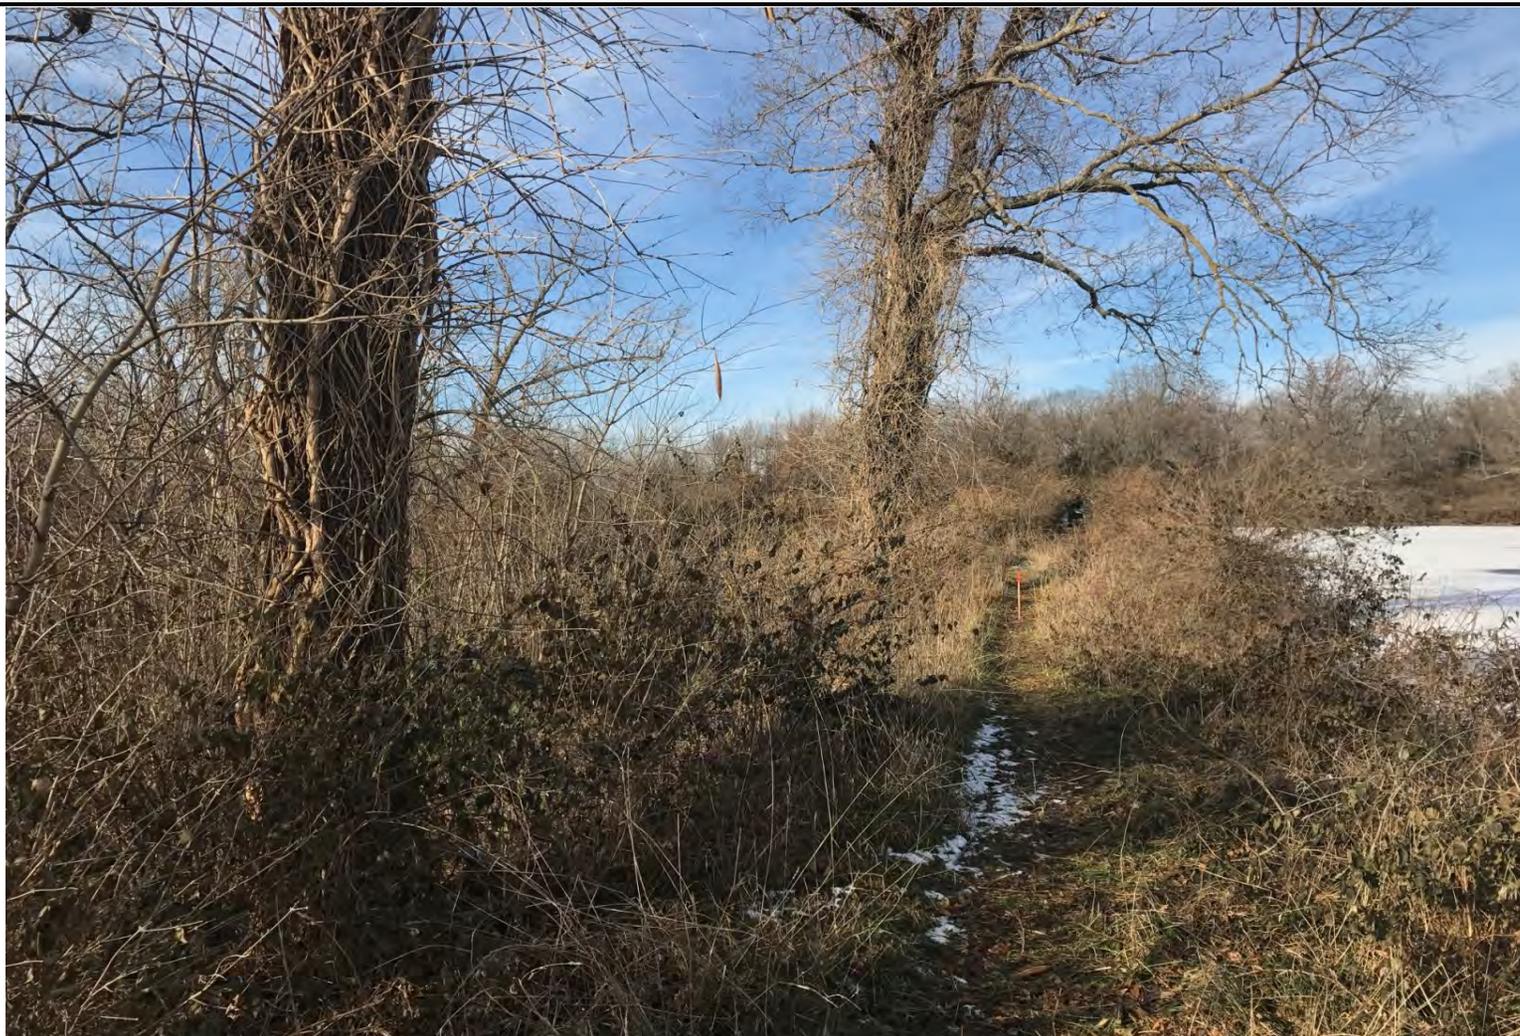
Site Photograph #1

Typical view of dam crest looking west.

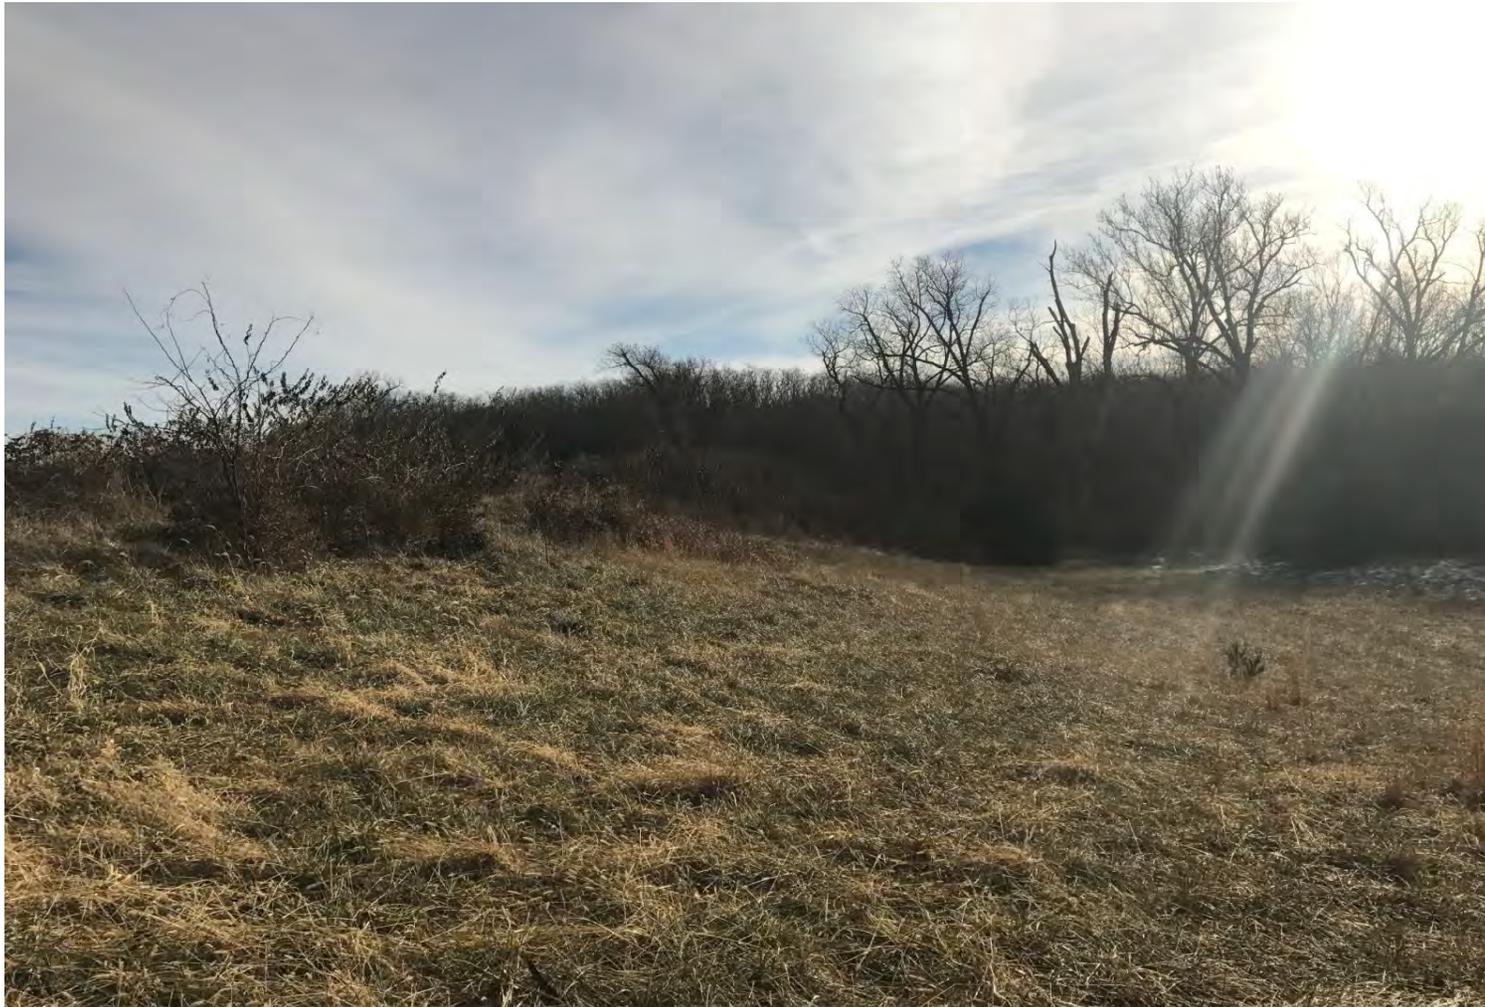
Site Photograph #3
Longview Dam - North
Lee's Summit, Missouri

Typical view of downstream face in western portion of dam, looking east.

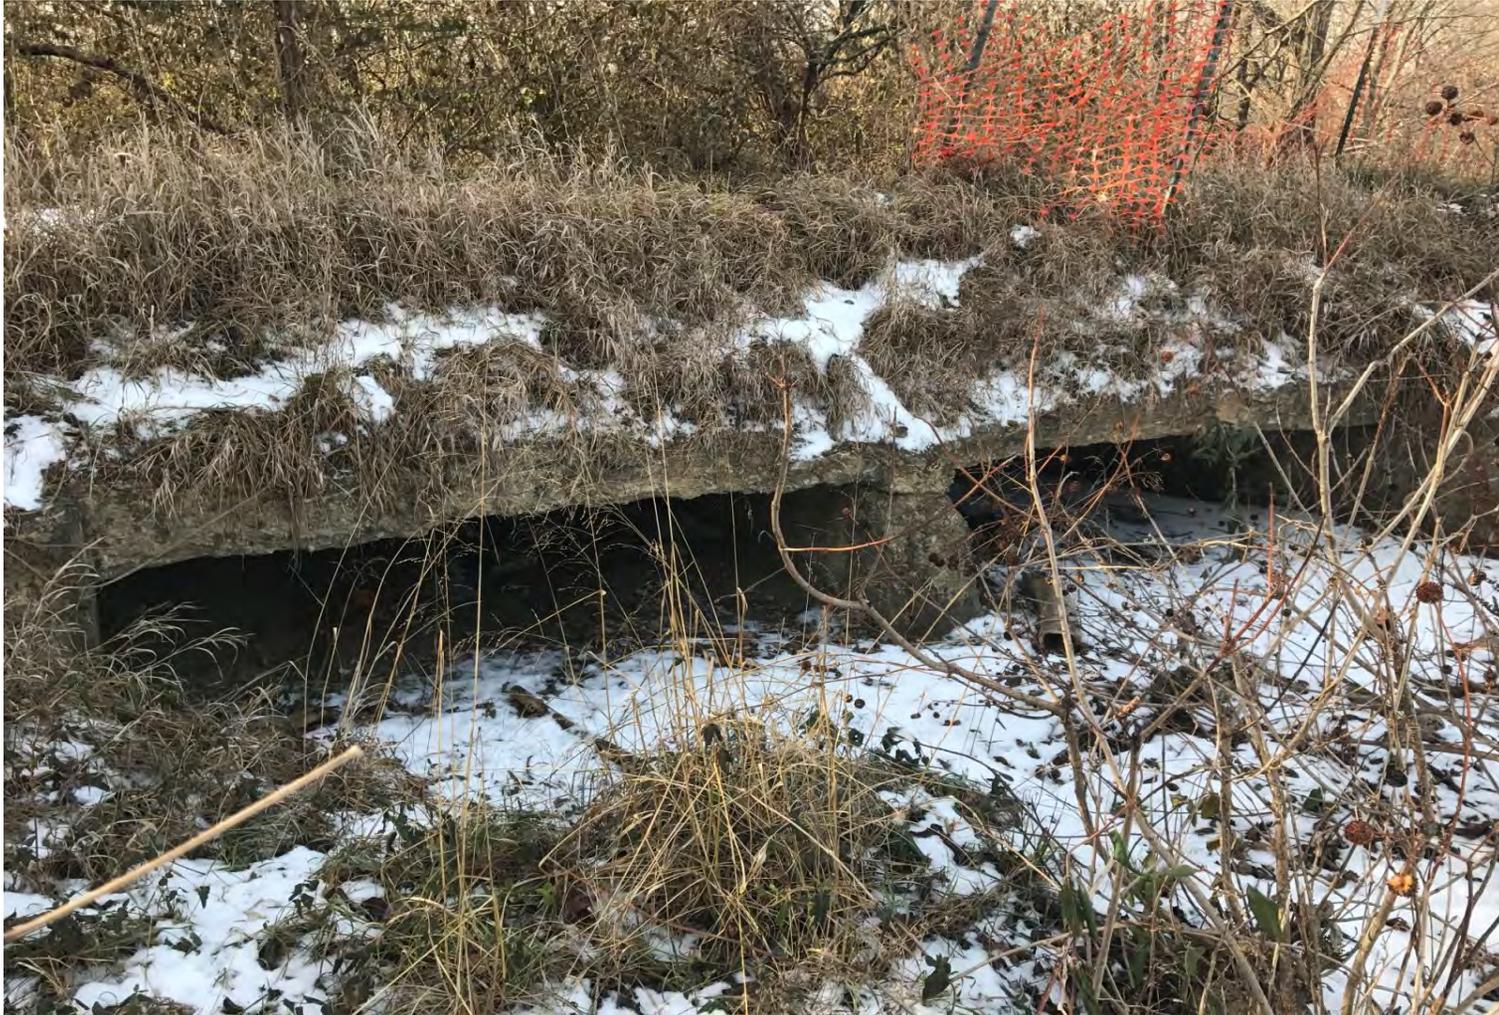
Site Photograph #4
Longview Dam - North
Lee's Summit, Missouri

Typical view of spillway structure, looking downstream from reservoir.

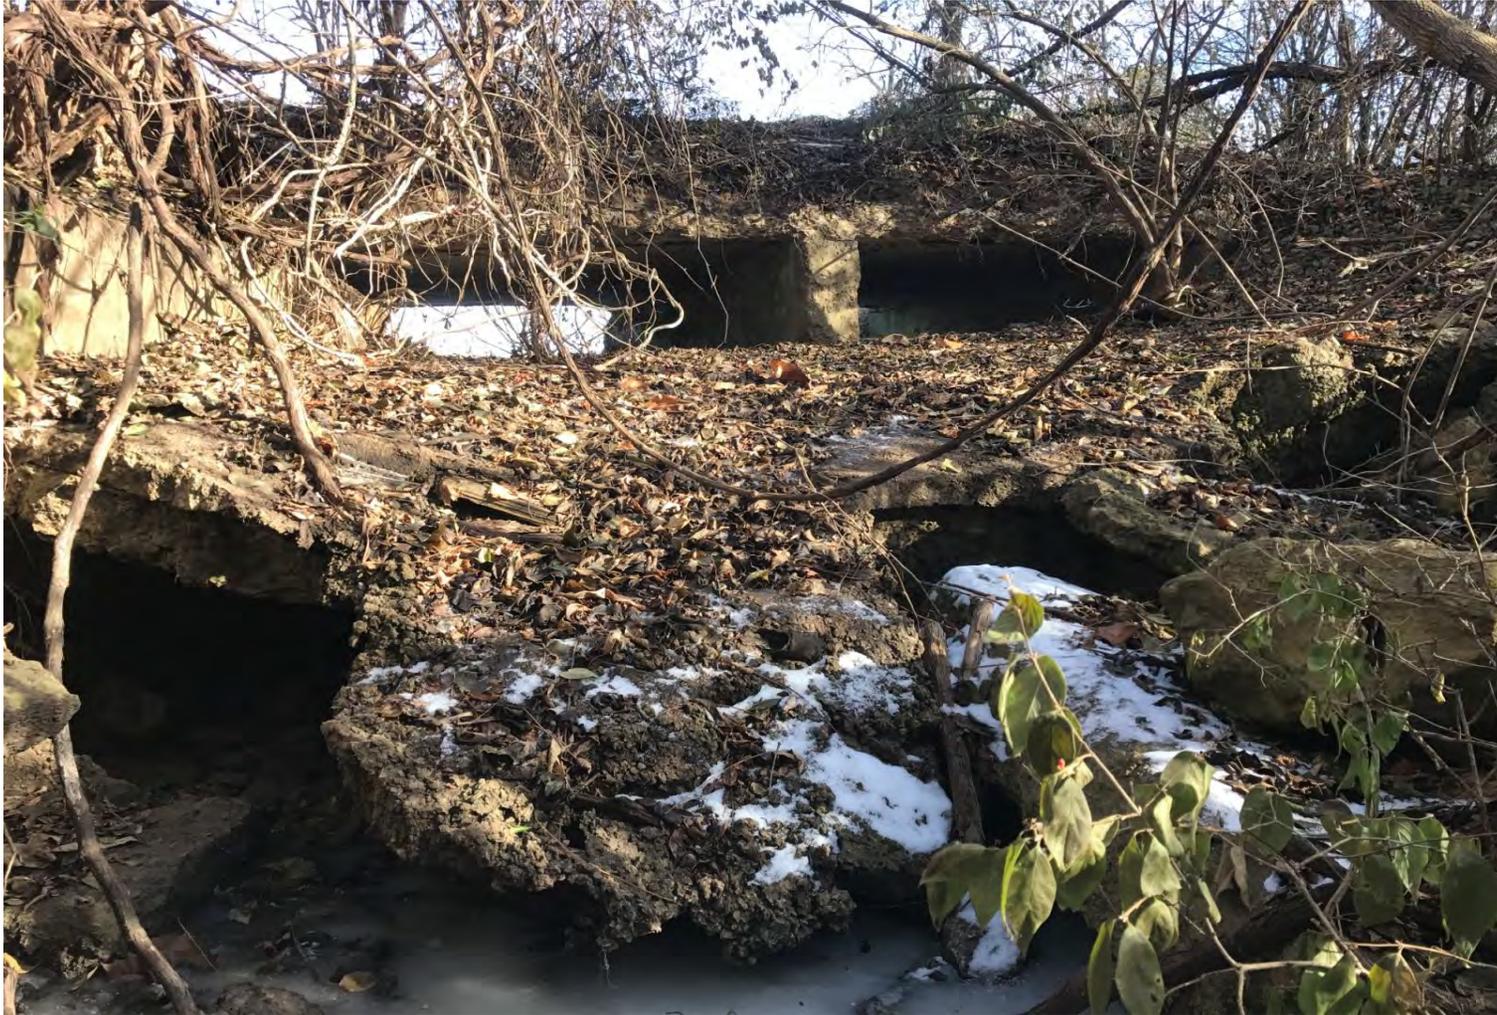
Site Photograph #5
Longview Dam - North
Lee's Summit, Missouri

Typical view of spillway structure, looking upstream from spillway channel.

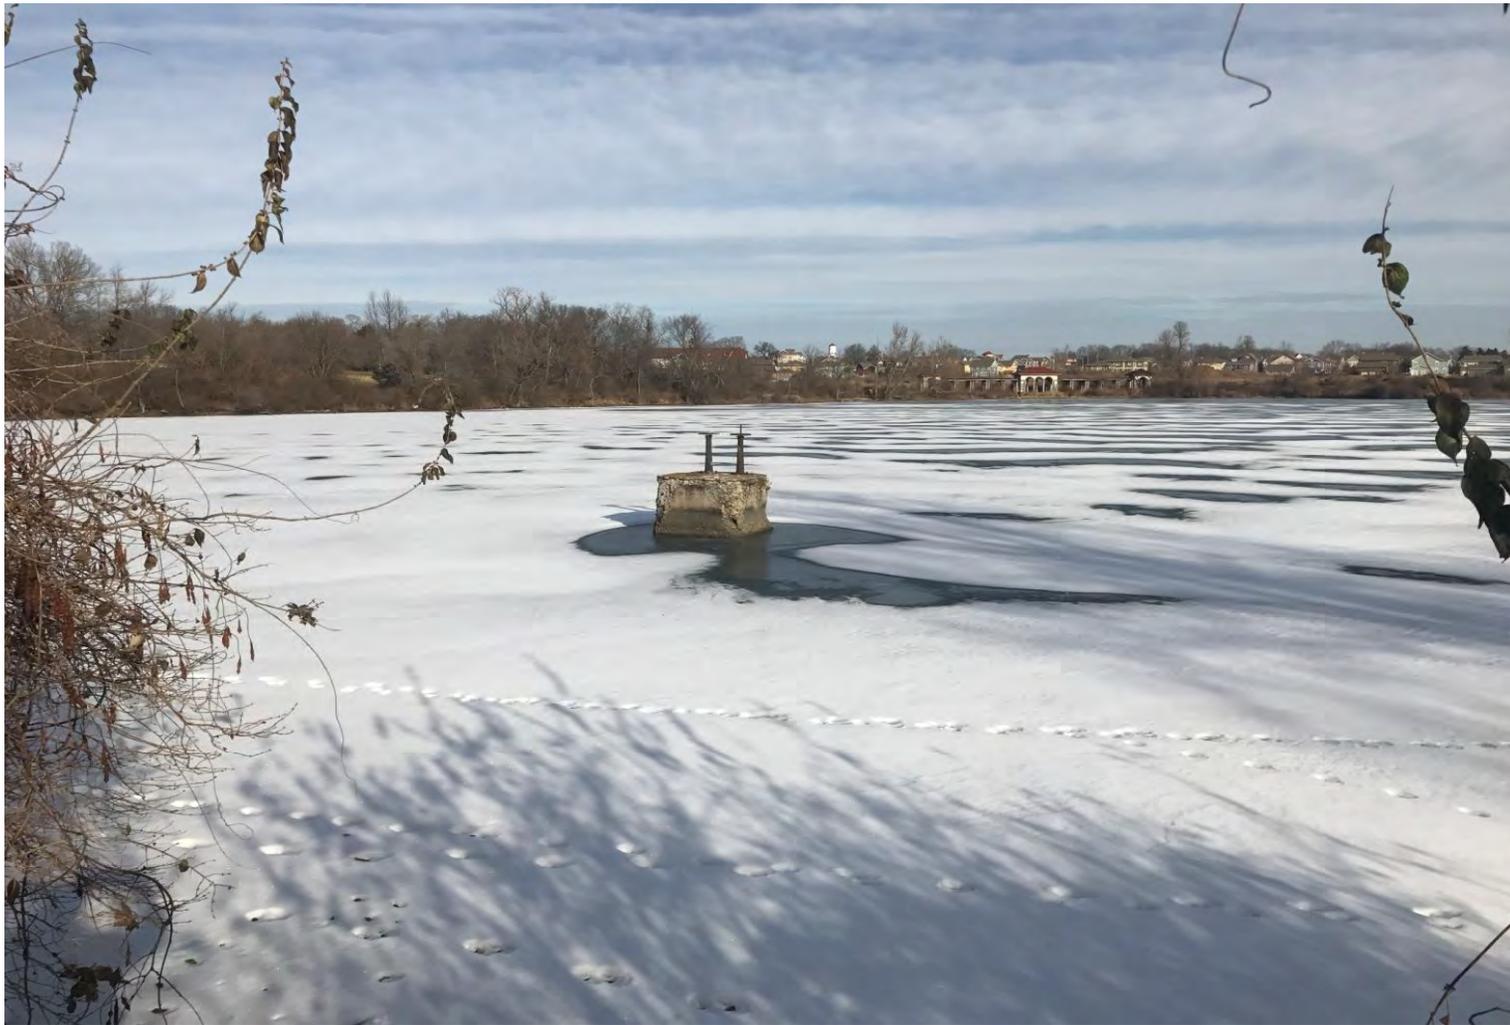
Site Photograph #7
Longview Dam - North
Lee's Summit, Missouri

Typical view of intake / gate house structure.
