Stormwater Pollution Prevention Plan Inspection Report

Project Name and Location: Blackwell

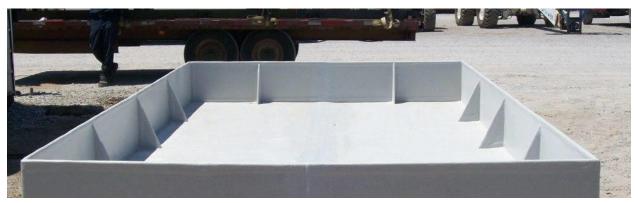
BMP	Location	Observation, Effectiveness, & Corrective Actions Ordered
Silt fence	Along curbs	Repair/replace silt fence in various areas along curb
Fuel Tank	Off SE Wood Lane	Is fuel tank onsite double walled? If not, the tank needs to be removed from the site or placed in a secondary containment. An example is pictured below
Street	Various	Clean streets

Examples of fuel tanks in secondary containments.
