4517 SW Nautilus PI

Lot 13 Creekside at Raintree LSMO Permit #2018-0263

Apex Engineers, Inc. observed the site located at the address above. The sub-grade bearing conditions were evaluated.

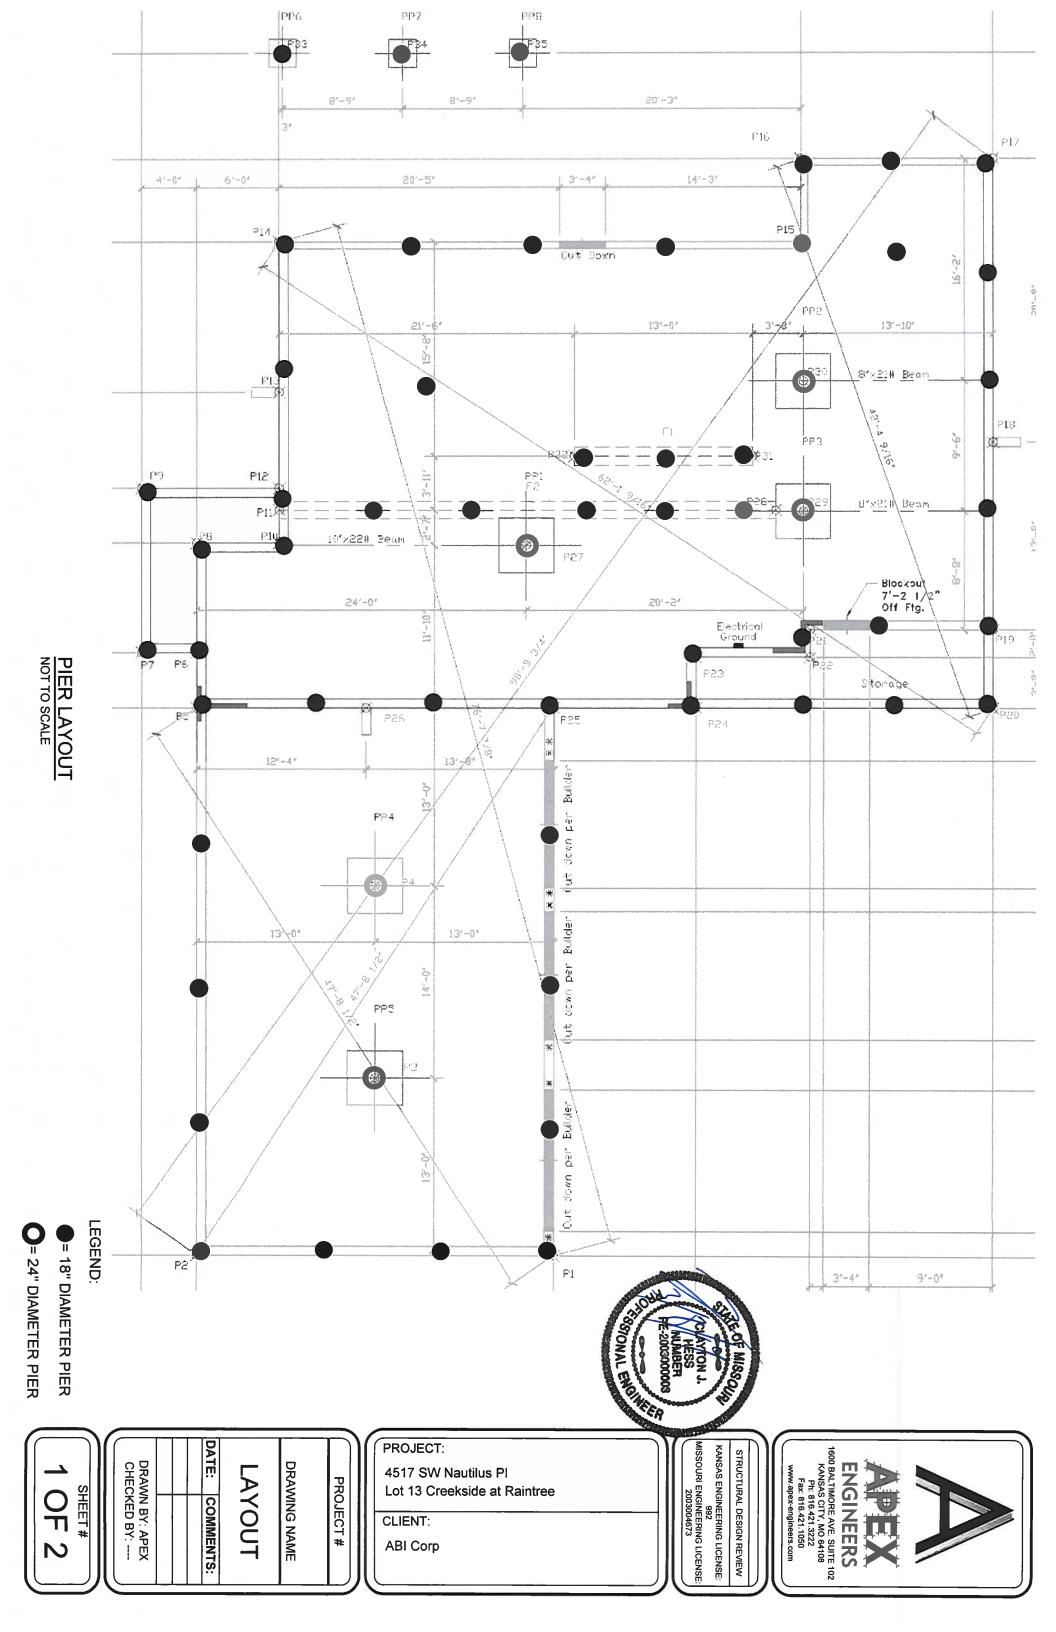
- Drill 18" and 24" diameter concrete piers per the attached layout.
- Piers shall be drilled to competent original limestone, sandstone, or shale.
- The piers shall be reinforced with (2) #4 bars for the depth of the pier.
