GEOTECHNICAL ENGINEERING REPORT

MID-CONTINENT PUBLIC LIBRARY COLBERN ROAD BRANCH

**1000 NE COLBERN ROAD
LEE'S SUMMIT, MISSOURI**

OLSSON PROJECT NO. A18-0330

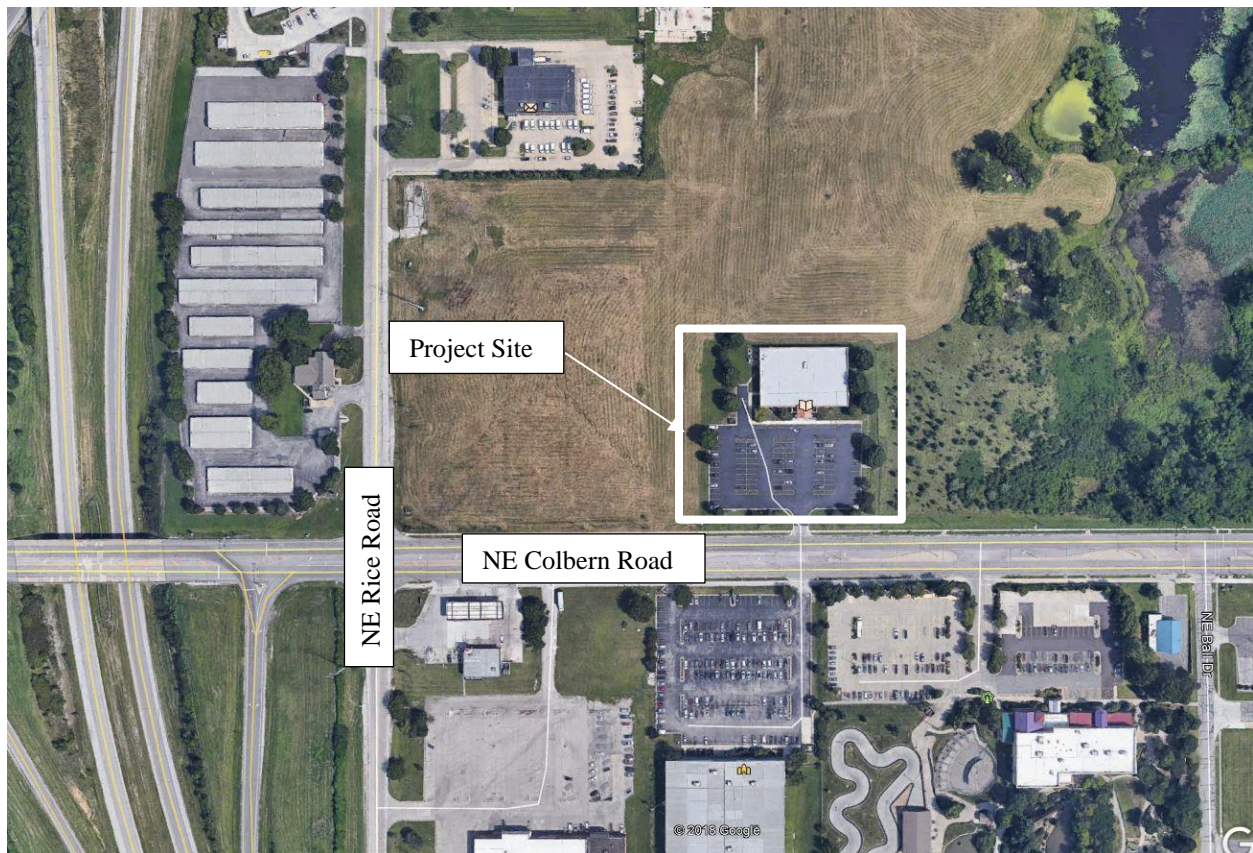
Figure 1: Site Location

The project site is located NE Rice Road and NE Colbern Road in Lee's Summit, Missouri as shown in Figure 1. The site is currently occupied by the existing library and associated pavements. We have not been informed of any foundation related distress within the existing structure. The existing site is relatively flat but gently slopes from the southwest to the northeast.

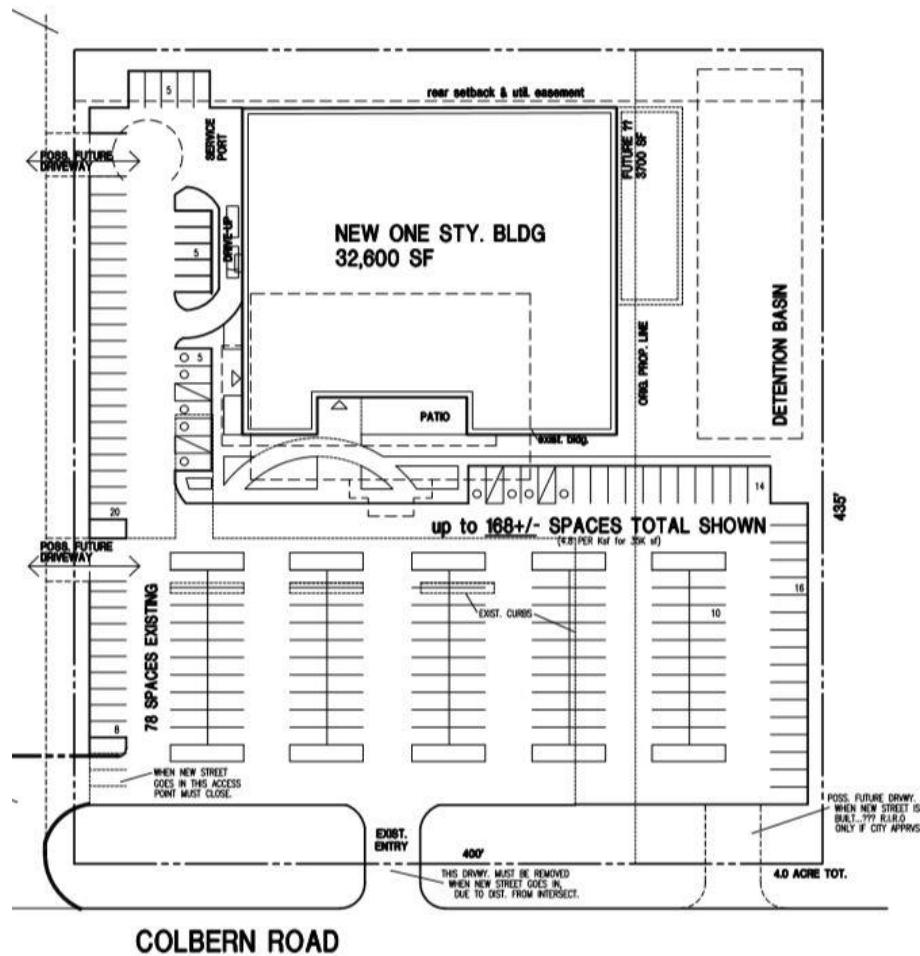
Figure 2: Site Layout

We understand that the project will include the demolition of the existing structure and the reconstruction of a new library. The new library will be a single story, slab-on-grade structure. We also understand that the current parking lot will likely remain on site for the future library. At the time of this report, the finished floor elevation (FFE) and grading plans were not yet finalized, yet we anticipate cuts and fill to be minimal and the new FFE will likely maintain the existing FFE. A detention basin is planned for the northeast corner of the project site. The proposed site layout is presented in Figure 2.
