RFI #149: LSFS 4&5 - Tel/Radio Room UL Listing Clarification

Please confirm that U419 called out for the Tel/Radio room walls is sufficient to achieve the necessary fire rating at these walls. Please note that at the wall under the middle stringer, the inside two layers of rock will extend up to the shower pans, but the layer on the outside of the wall will terminate at the wood sill called out in D4/A-410.

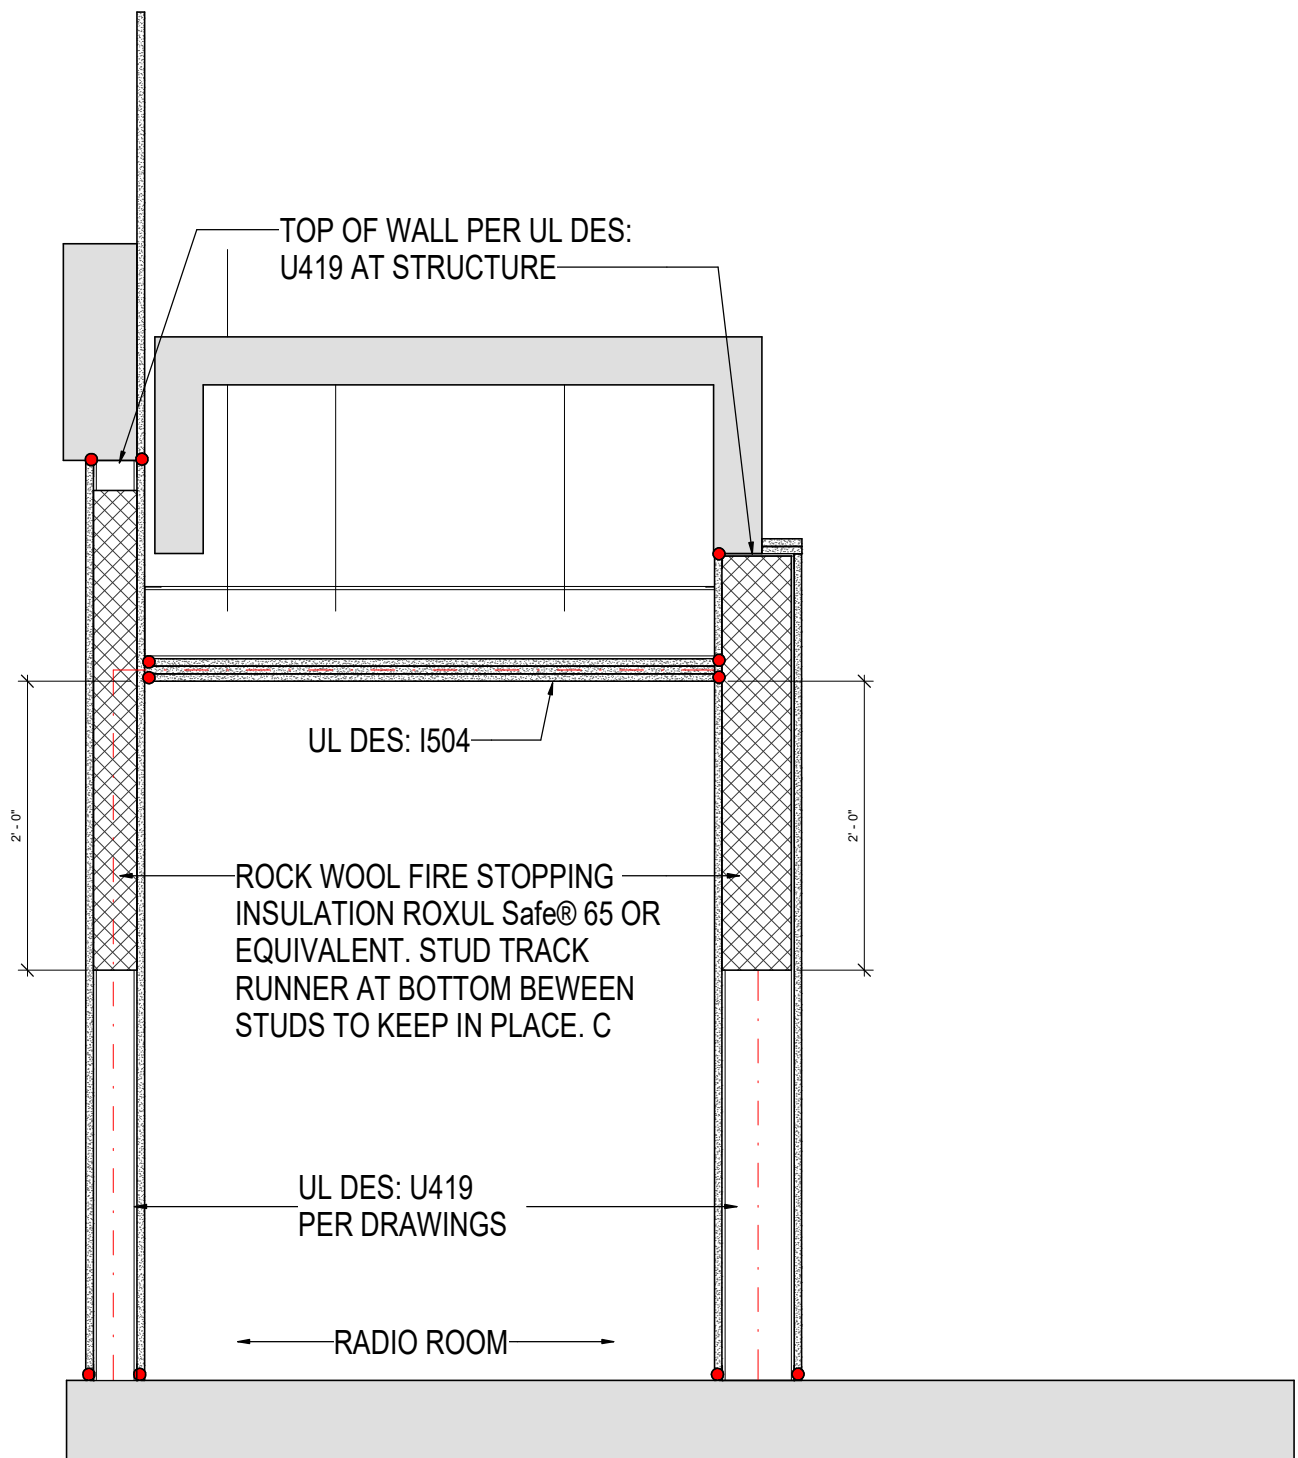
Refer to the image and email thread below for solution to this RFI.

WALL OPTION WITH EXISTING STUDS TO REMAIN.

Please provide details for how the ceiling shown in A6/A-410 is to tie into the walls to achieve the 1 hour fire rating.

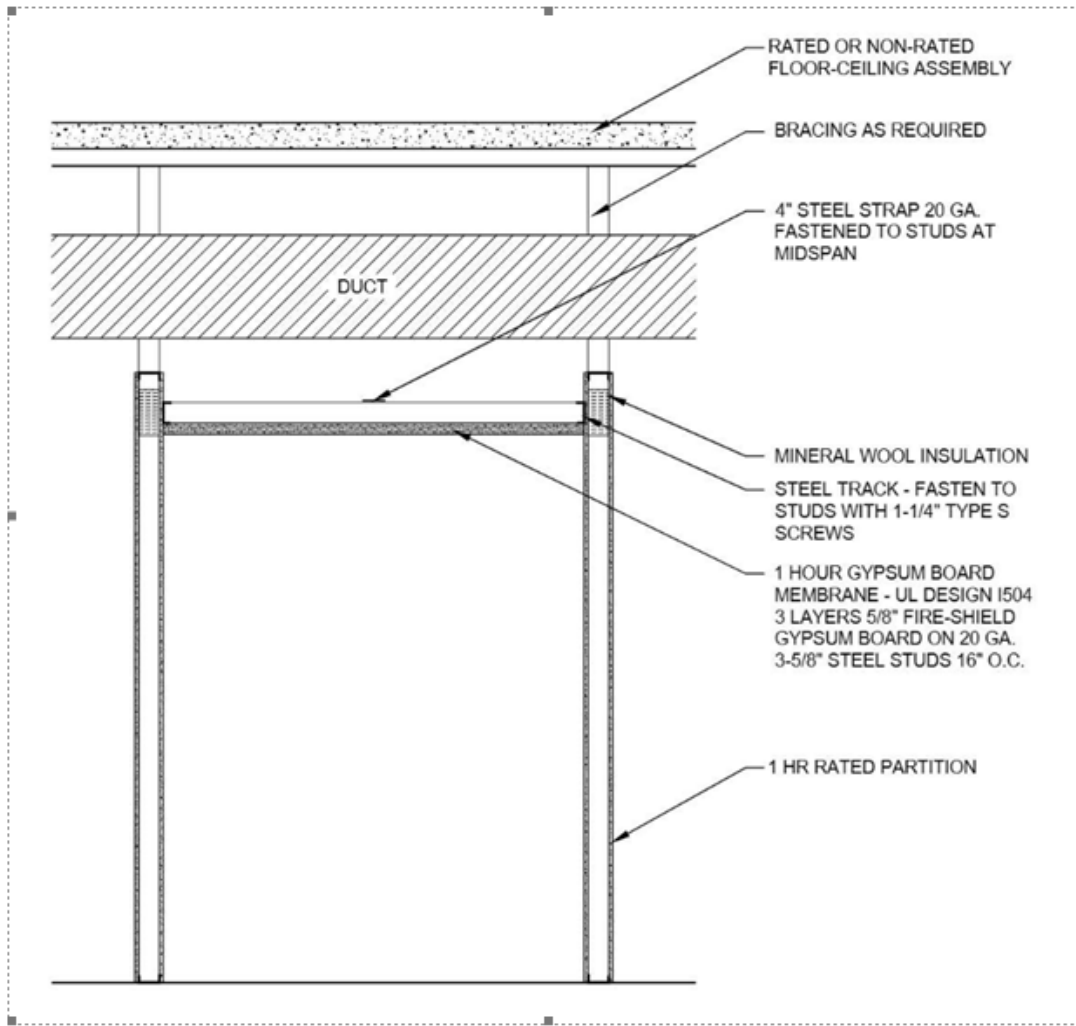
PCI brought up CR103 and asked if it would be possible to use this UL in our condition. It is on page 108 of the attached and snipped below. Looks a lot like what you sent before. What are your thoughts on this?

This works for me. It doesn't appear different than the assemblies I sent to you and is functionally the same. This particular arrangement is intended for corridors where the wall doesn't go up to a roof, deck, or floor. Let's proceed with it. The mineral wool as I called out is the key component to continuity at the wall / ceiling transition. Thanks.
