# Geotechnical Engineering Report

**Tudor Road Apartments  
Lee's Summit, Missouri**

Terracon Project No. 02225125

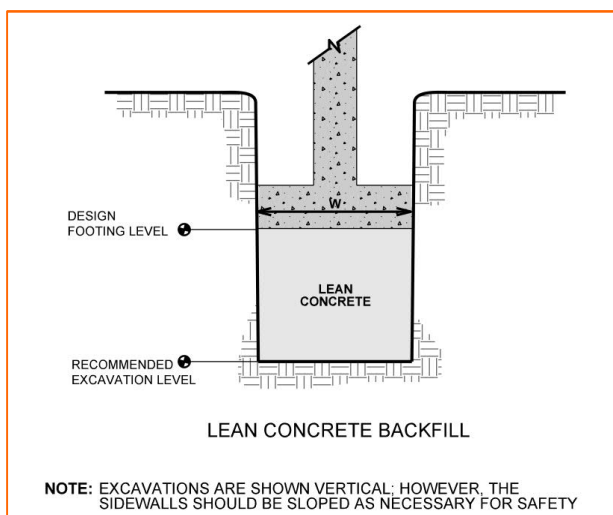
All footing bearing surfaces should be observed and tested by Terracon. If unsuitable conditions are encountered, footing excavations should be extended deeper to suitable bearing materials. Footings can bear directly on suitable soils at the lower level or on lean concrete backfill as shown in the following figure.

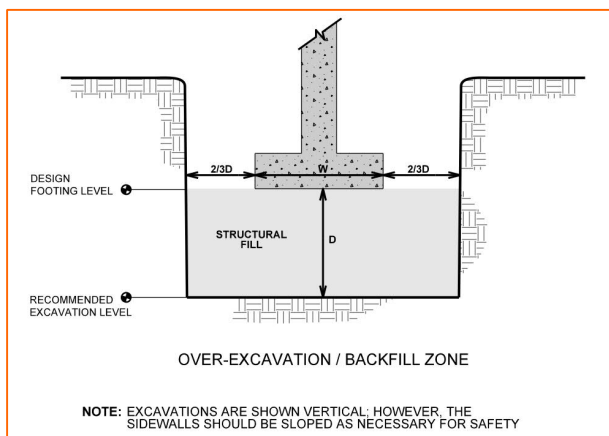
The footings could also bear on properly compacted backfill extending down to suitable soils as shown in the following figure. Overexcavation for compacted engineered fill placement below footings should extend laterally beyond all edges of the footings at least 8 inches per foot of overexcavation depth below footing elevation. The overexcavation should then be backfilled up

to the footing base elevation with well graded granular material (e.g., MoDOT Type 5 aggregate or an approved alternate gradation) placed and compacted as recommended in **Earthwork**.

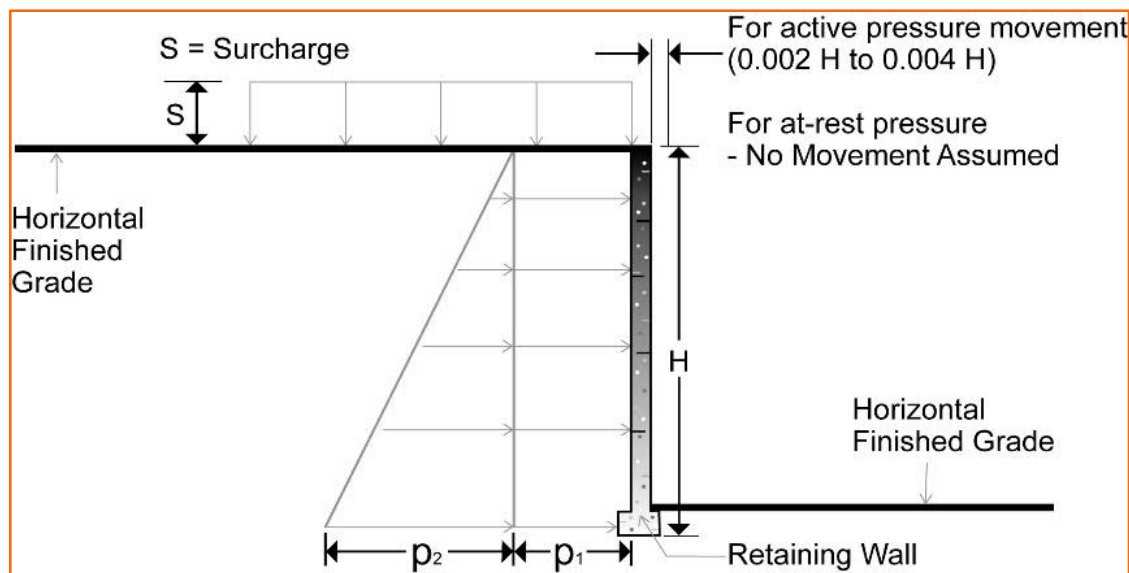
### Lateral Earth Pressure Parameters

Below grade swimming pool walls and cast-in-place concrete, cantilever-type retaining walls with unbalanced backfill levels on opposite sides should be designed for earth pressures at least equal to those indicated in the following table. Earth pressures will be influenced by structural design of the walls, conditions of wall restraint, methods of construction, and/or compaction and the strength of materials being restrained. Two wall restraint conditions are shown. Active earth pressure is commonly used for design of free-standing cantilever retaining walls where wall movement is permitted. The at-rest condition considers no wall movement is permitted. The recommended design lateral earth pressures do not include a factor of safety and do not provide for possible hydrostatic pressure on the walls.

Earth Pressure Conditions	Coefficient for Backfill Type	Equivalent Fluid Unit Weight (pcf)	Surcharge Pressure, $p_1$ (psf)	Earth Pressure, $p_2$ (psf)
Active ( $K_a$ )	Granular - 0.3	40	(0.3)S	(40)H
	Clay - 0.42	50	(0.42)S	(50)H
At-Rest ( $K_o$ )	Granular - 0.47	60	(0.47)S	(60)H
	Clay - 0.60	70	(0.60)S	(70)H
Passive ( $K_p$ )	Granular - 3.3	420	---	---
	Clay - 2.4	290	---	---

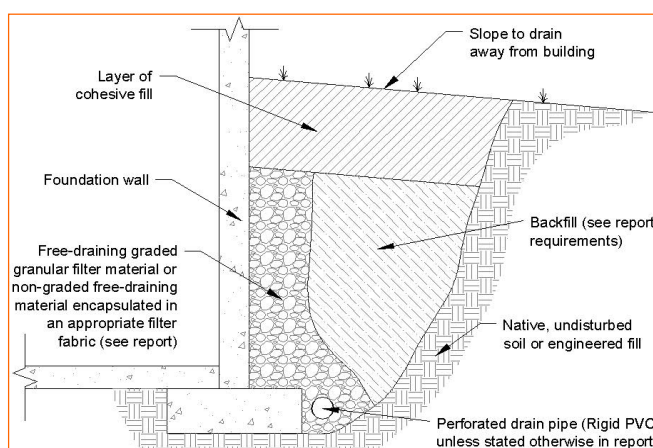
To prevent hydrostatic pressure on below-grade walls, we recommend drains be installed at the foundation level. Each drain line should be sloped to provide positive gravity drainage and should be surrounded by free-draining granular material graded to prevent the intrusion of fines, or an alternative free-draining granular material encapsulated with suitable filter fabric. At least a 2-foot wide section of free-draining granular fill should be used for backfill above the drain line and adjacent to the wall. The free-draining granular fill should extend to within 2 feet of final grade and should be capped with compacted cohesive fill to minimize infiltration of surface water into the drain system.

As an alternative to free-draining granular fill, a pre-fabricated drainage structure may be used. A pre-fabricated drainage structure is a plastic drainage core or mesh which is covered with filter fabric to prevent soil intrusion, and is fastened to the wall prior to placing backfill.

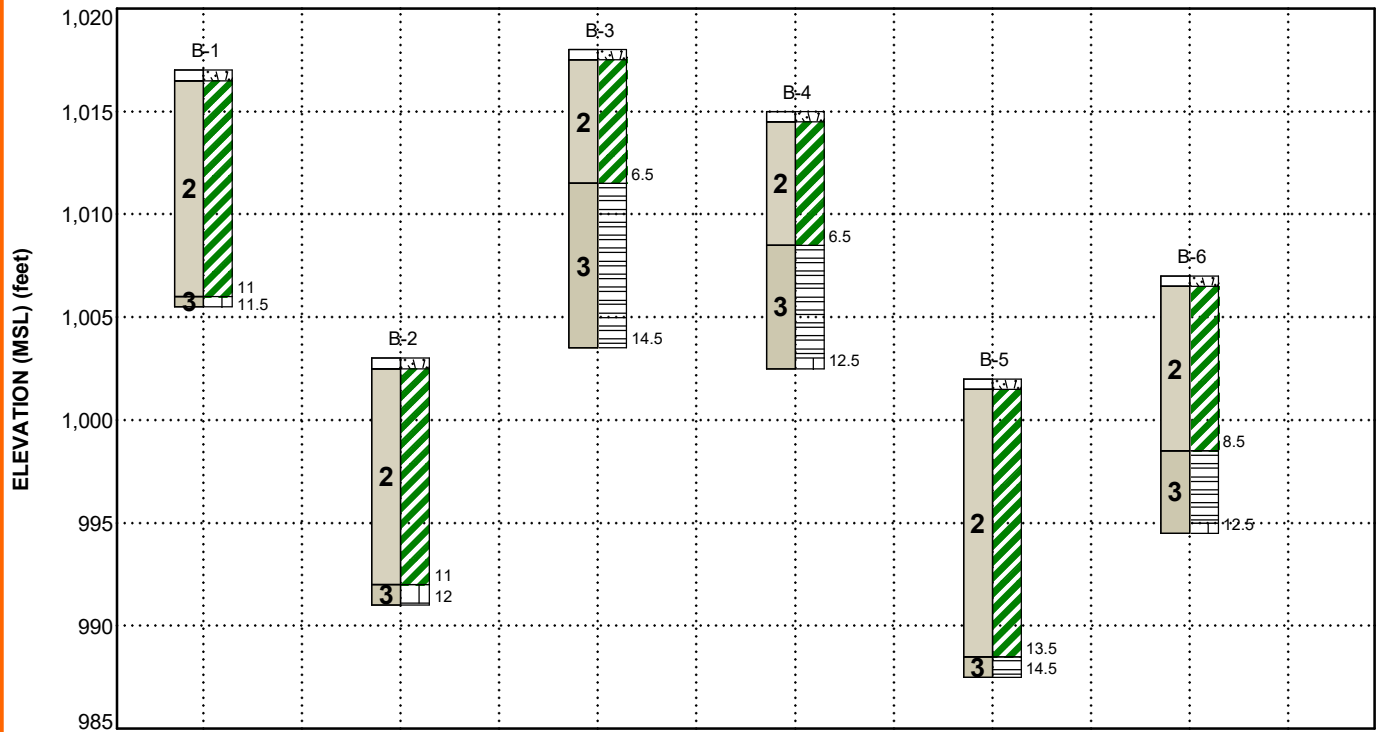
## GEOMODEL

This is not a cross section. This is intended to display the Geotechnical Model only. See individual logs for more detailed conditions.

Model Layer	Layer Name	General Description
1	Existing Fill	Fat clay with gravel
2	Residual Clay	Fat clay, medium stiff to very stiff
3	Bedrock	Highly to slightly weathered shale and limestone

We have developed a general characterization of the subsurface conditions based on the subsurface exploration, laboratory data, geologic setting and our understanding of the project. This characterization, termed GeoModel, forms the basis of our geotechnical evaluation. Conditions encountered at each boring location are indicated on the individual logs. The individual logs are in the **Exploration Results** section and the GeoModel is in the **Figures** section of this report.

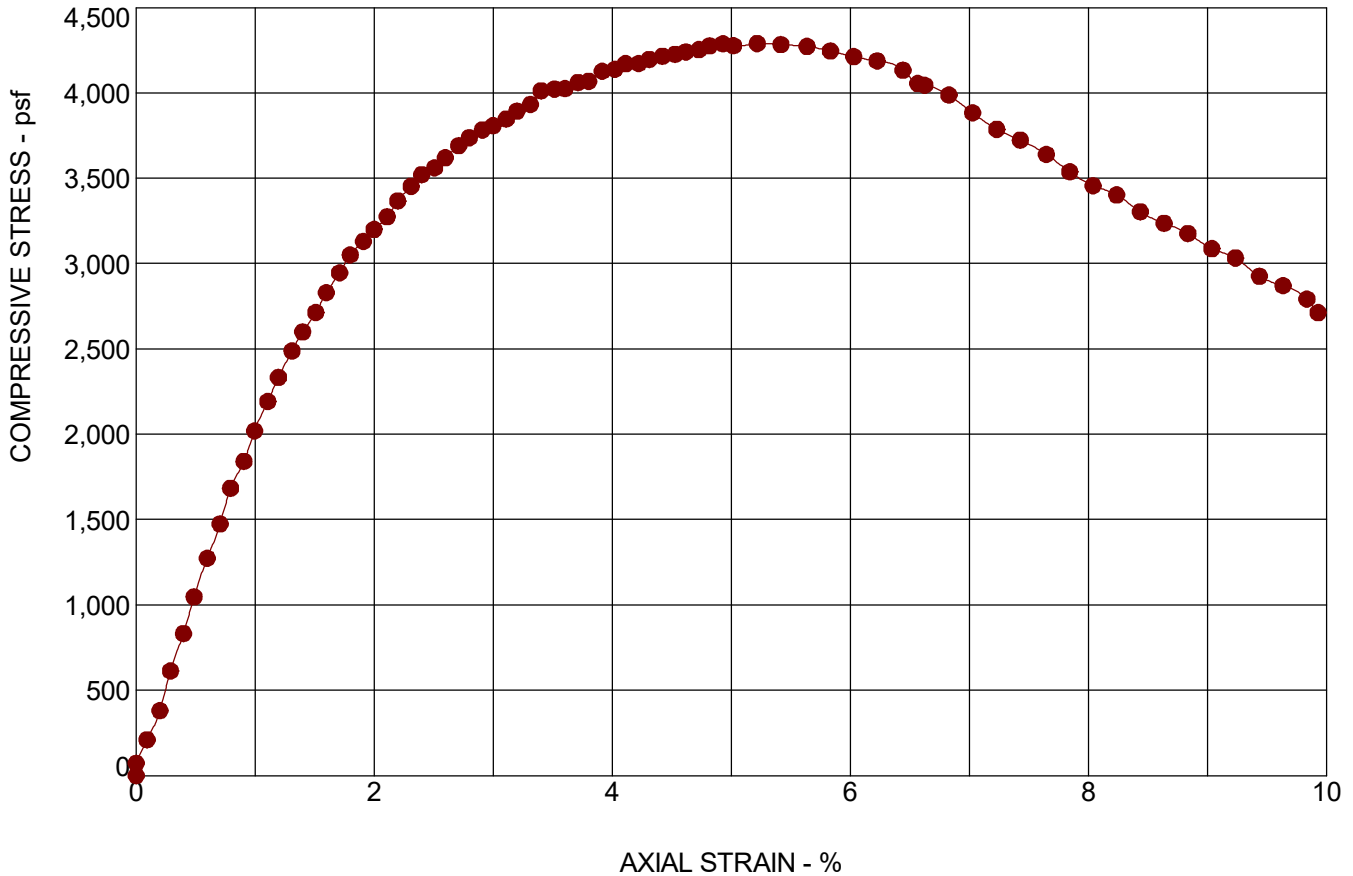
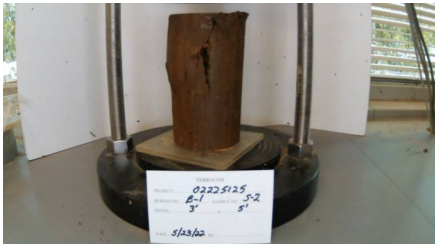
# UNCONFINED COMPRESSION TEST

ASTM D2166

Moisture Content:	%	25.9
Dry Density:	pcf	100
Diameter:	in.	2.80
Height:	in.	5.81
Height / Diameter Ratio:		2.08
Calculated Saturation:	%	
Calculated Void Ratio:		
Assumed Specific Gravity:		
Failure Strain:	%	5.22
Unconfined Compressive Strength	(psf)	4289
Undrained Shear Strength:	(psf)	2144
Strain Rate:	in/min	0.1158
Remarks:

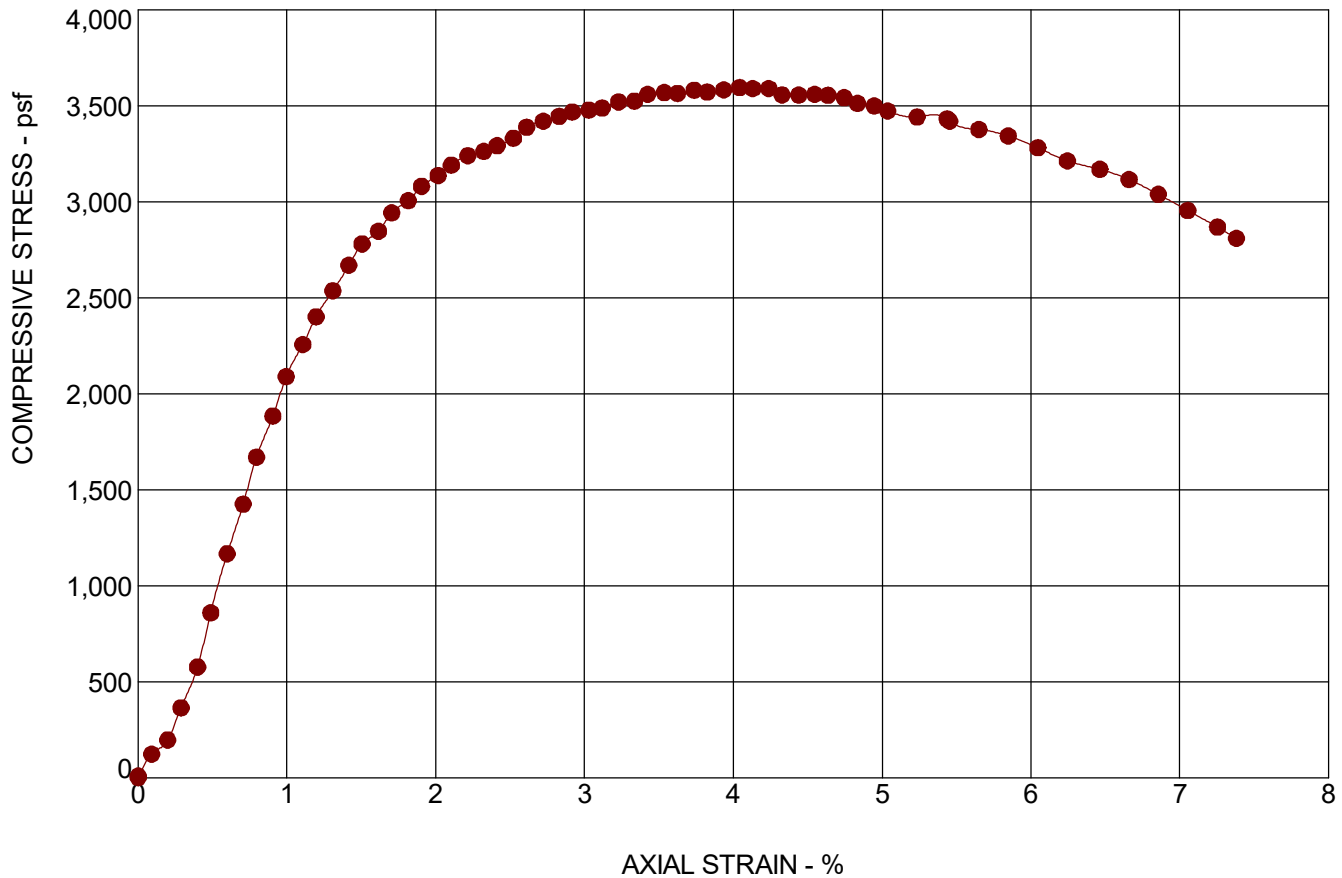
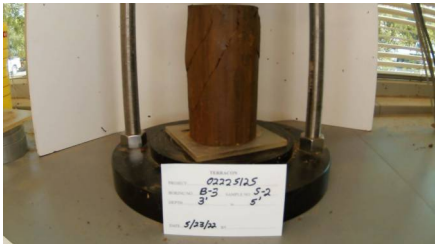
# UNCONFINED COMPRESSION TEST

ASTM D2166

Moisture Content:	%	30.3
Dry Density:	pcf	96
Diameter:	in.	2.84
Height:	in.	5.88
Height / Diameter Ratio:		2.07
Calculated Saturation:	%	
Calculated Void Ratio:		
Assumed Specific Gravity:		
Failure Strain:	%	4.04
Unconfined Compressive Strength	(psf)	3594
Undrained Shear Strength:	(psf)	1797
Strain Rate:	in/min	0.1173
Remarks:

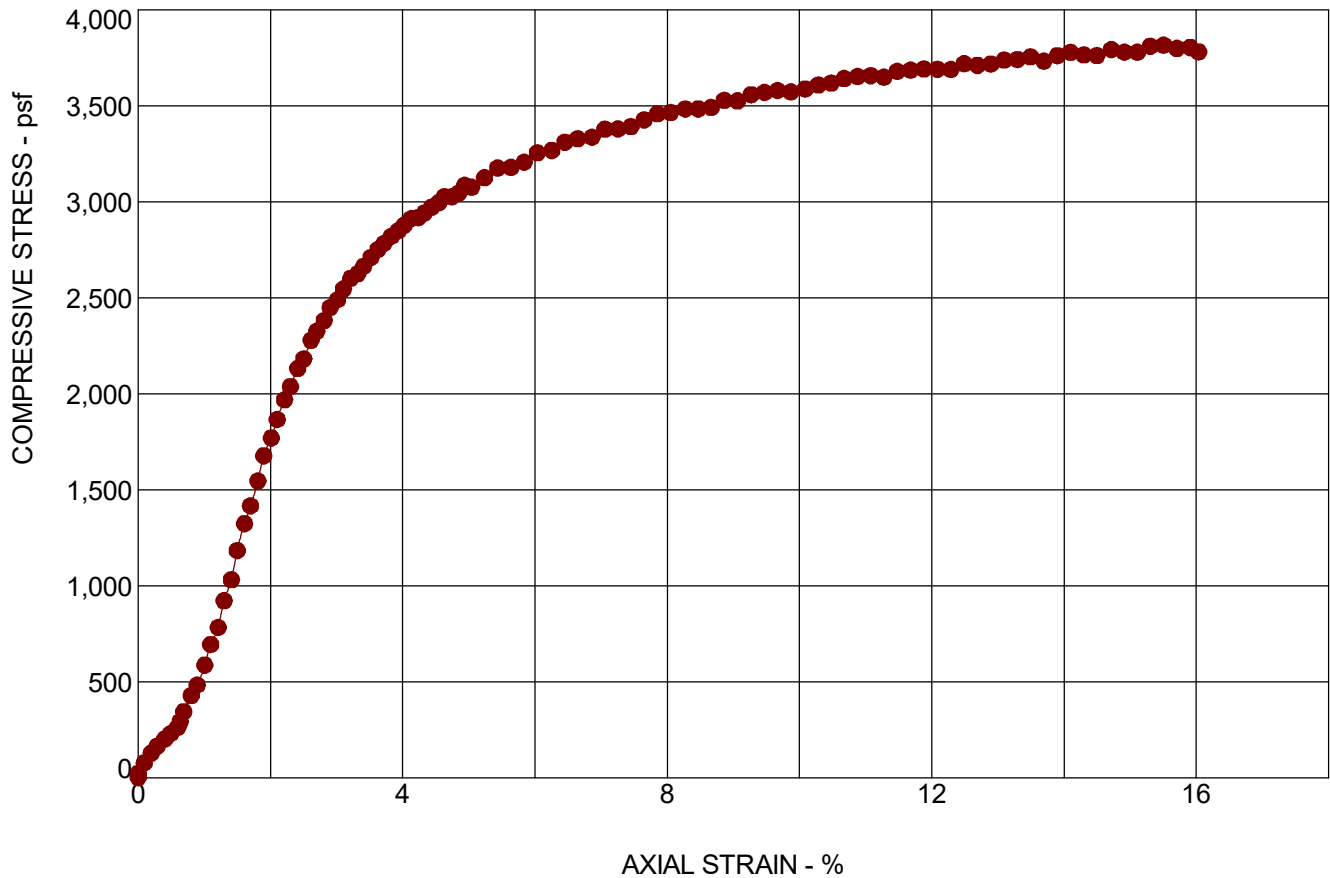
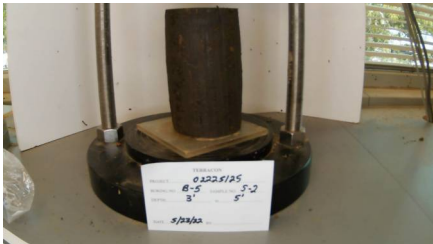
# UNCONFINED COMPRESSION TEST

ASTM D2166

Moisture Content:	%	26.3
Dry Density:	pcf	99
Diameter:	in.	2.81
Height:	in.	5.76
Height / Diameter Ratio:		2.05
Calculated Saturation:	%	
Calculated Void Ratio:		
Assumed Specific Gravity:		
Failure Strain:	%	14.72
Unconfined Compressive Strength	(psf)	3792
Undrained Shear Strength:	(psf)	1896
Strain Rate:	in/min	0.1151
Remarks:

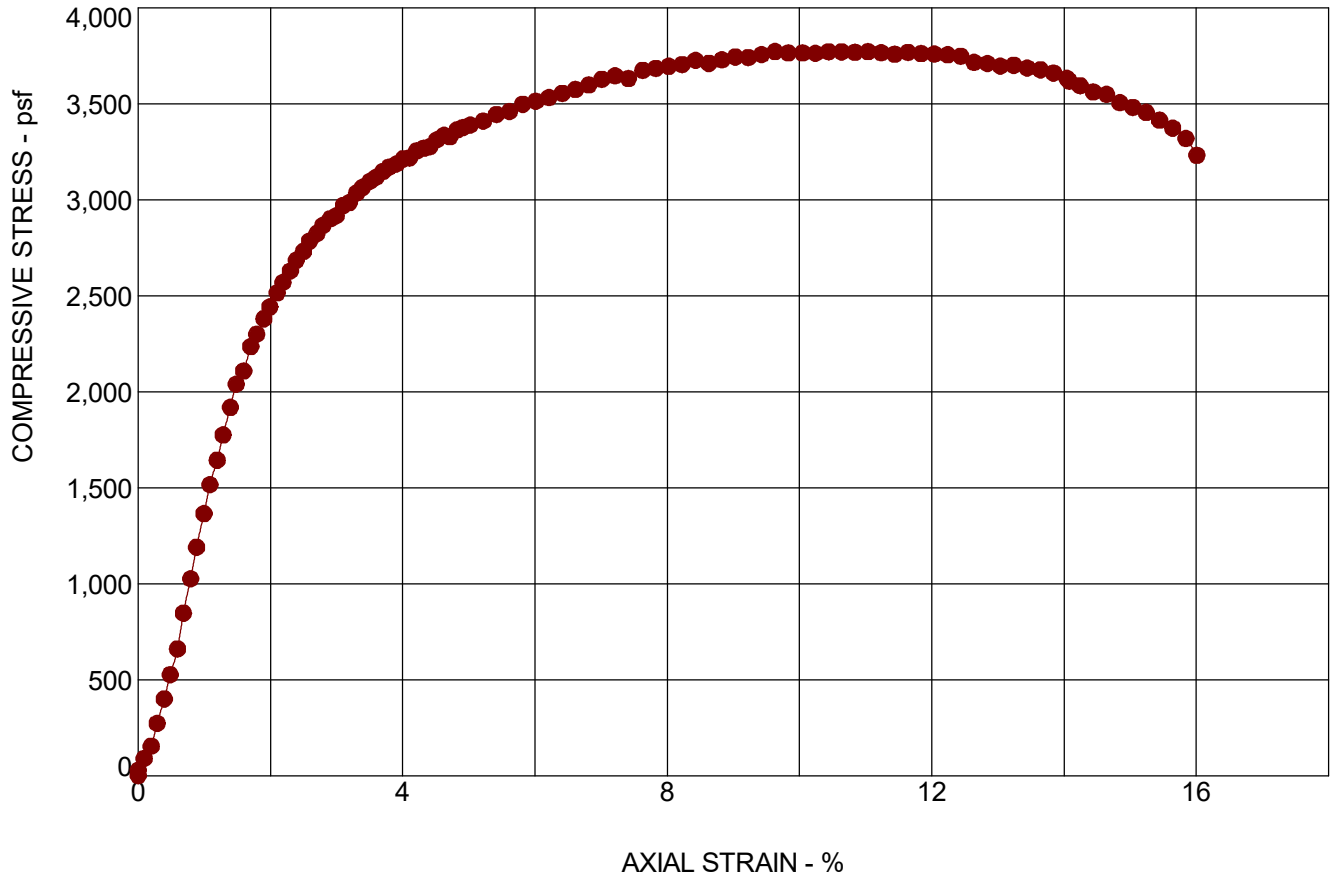
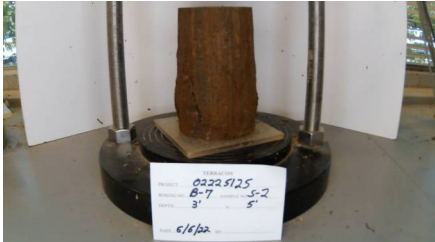
# UNCONFINED COMPRESSION TEST

ASTM D2166

Moisture Content:	%	27.9
Dry Density:	pcf	94
Diameter:	in.	2.84
Height:	in.	5.73
Height / Diameter Ratio:		2.02
Calculated Saturation:	%	
Calculated Void Ratio:		
Assumed Specific Gravity:		
Failure Strain:	%	9.63
Unconfined Compressive Strength	(psf)	3771
Undrained Shear Strength:	(psf)	1885
Strain Rate:	in/min	0.1147
Remarks:

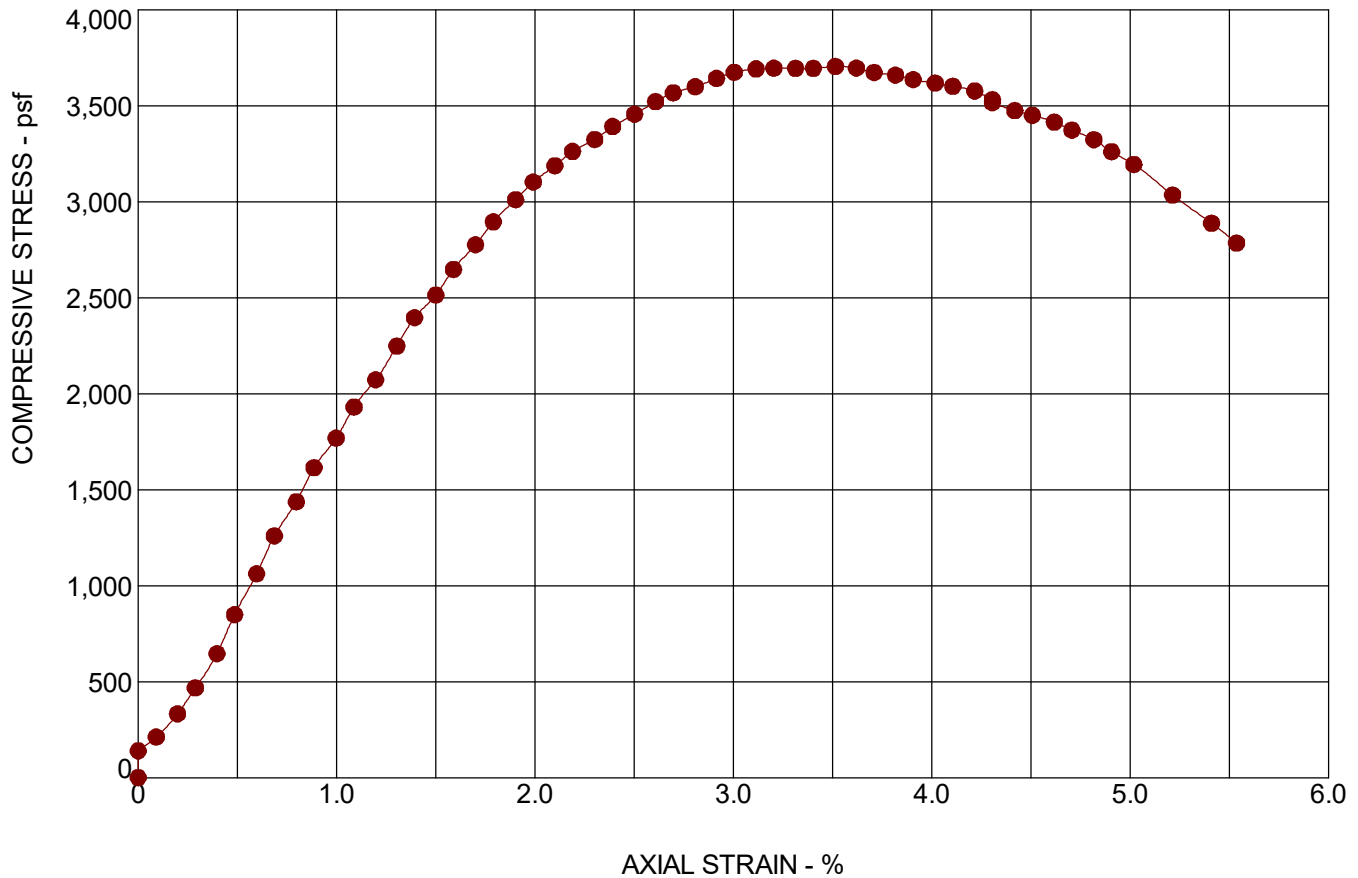
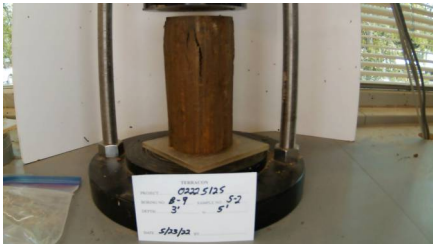
# UNCONFINED COMPRESSION TEST

ASTM D2166

Moisture Content:	%	24.6
Dry Density:	pcf	100
Diameter:	in.	2.82
Height:	in.	5.81
Height / Diameter Ratio:		2.06
Calculated Saturation:	%	
Calculated Void Ratio:		
Assumed Specific Gravity:		
Failure Strain:	%	3.51
Unconfined Compressive Strength	(psf)	3704
Undrained Shear Strength:	(psf)	1852
Strain Rate:	in/min	0.1163
Remarks:

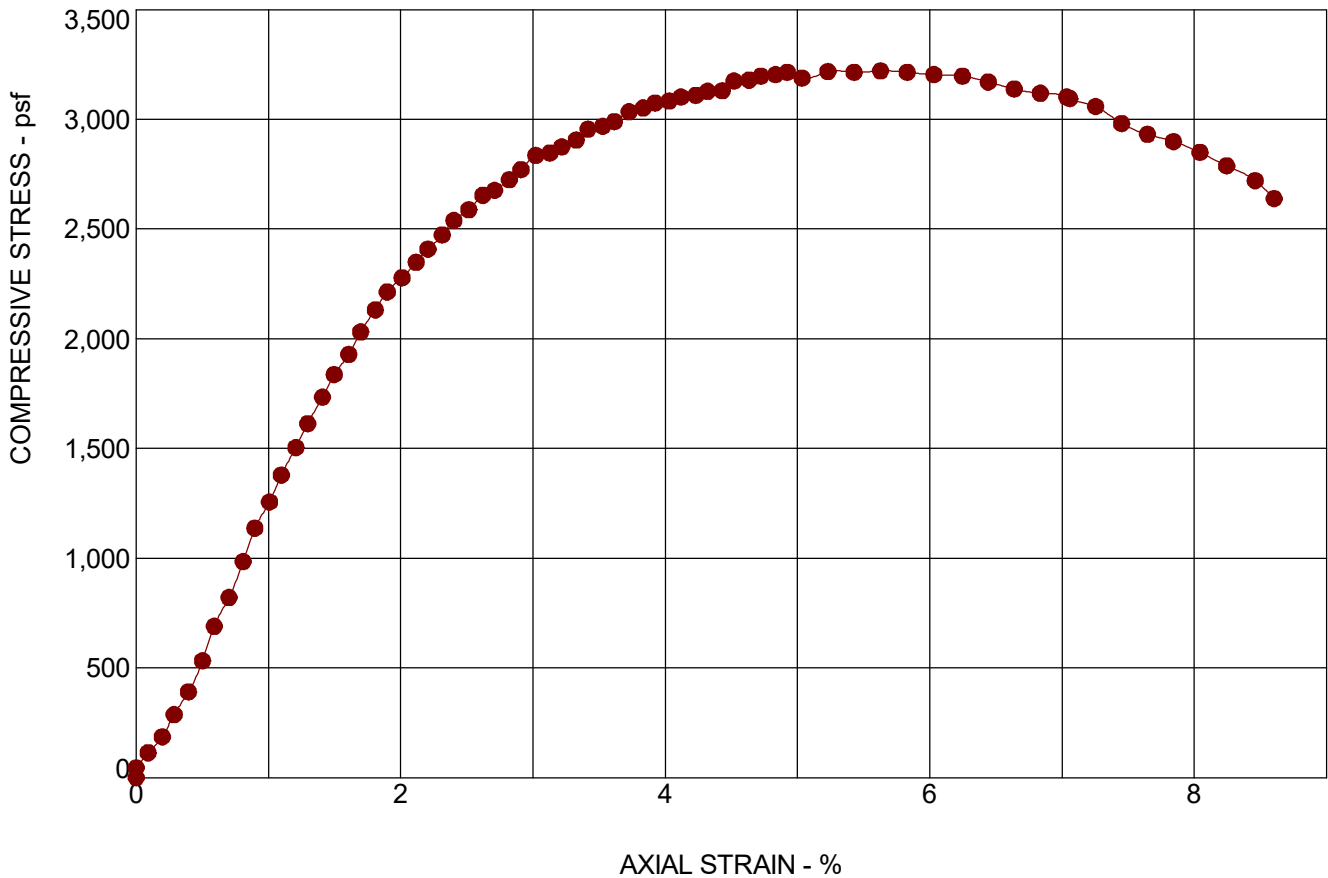
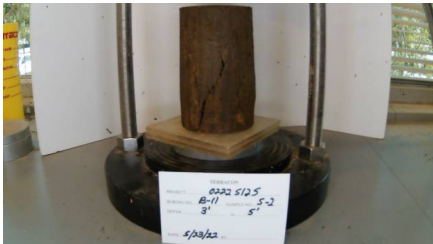
# UNCONFINED COMPRESSION TEST

ASTM D2166

Moisture Content:	%	30.9
Dry Density:	pcf	91
Diameter:	in.	2.83
Height:	in.	5.15
Height / Diameter Ratio:		1.82
Calculated Saturation:	%	
Calculated Void Ratio:		
Assumed Specific Gravity:		
Failure Strain:	%	5.63
Unconfined Compressive Strength	(psf)	3220
Undrained Shear Strength:	(psf)	1610
Strain Rate:	in/min	0.1031
Remarks:

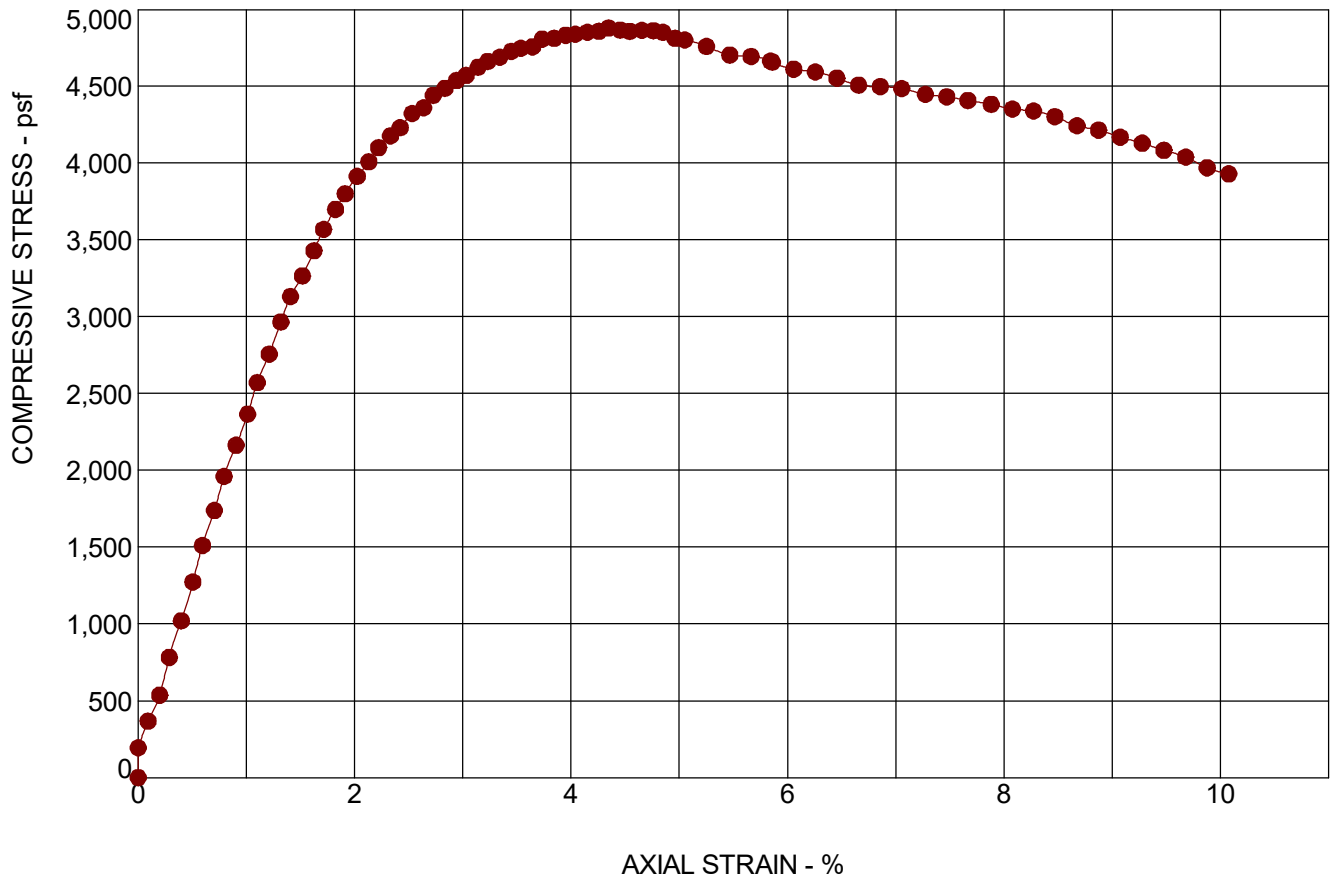
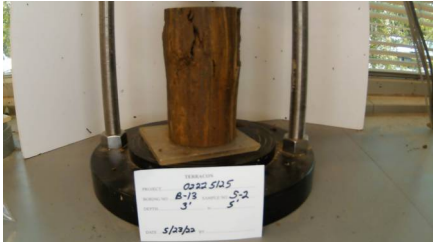
# UNCONFINED COMPRESSION TEST

ASTM D2166

Moisture Content:	%	23.0
Dry Density:	pcf	102
Diameter:	in.	2.82
Height:	in.	5.85
Height / Diameter Ratio:		2.07
Calculated Saturation:	%	
Calculated Void Ratio:		
Assumed Specific Gravity:		
Failure Strain:	%	4.35
Unconfined Compressive Strength	(psf)	4879
Undrained Shear Strength:	(psf)	2440
Strain Rate:	in/min	0.1171
Remarks:

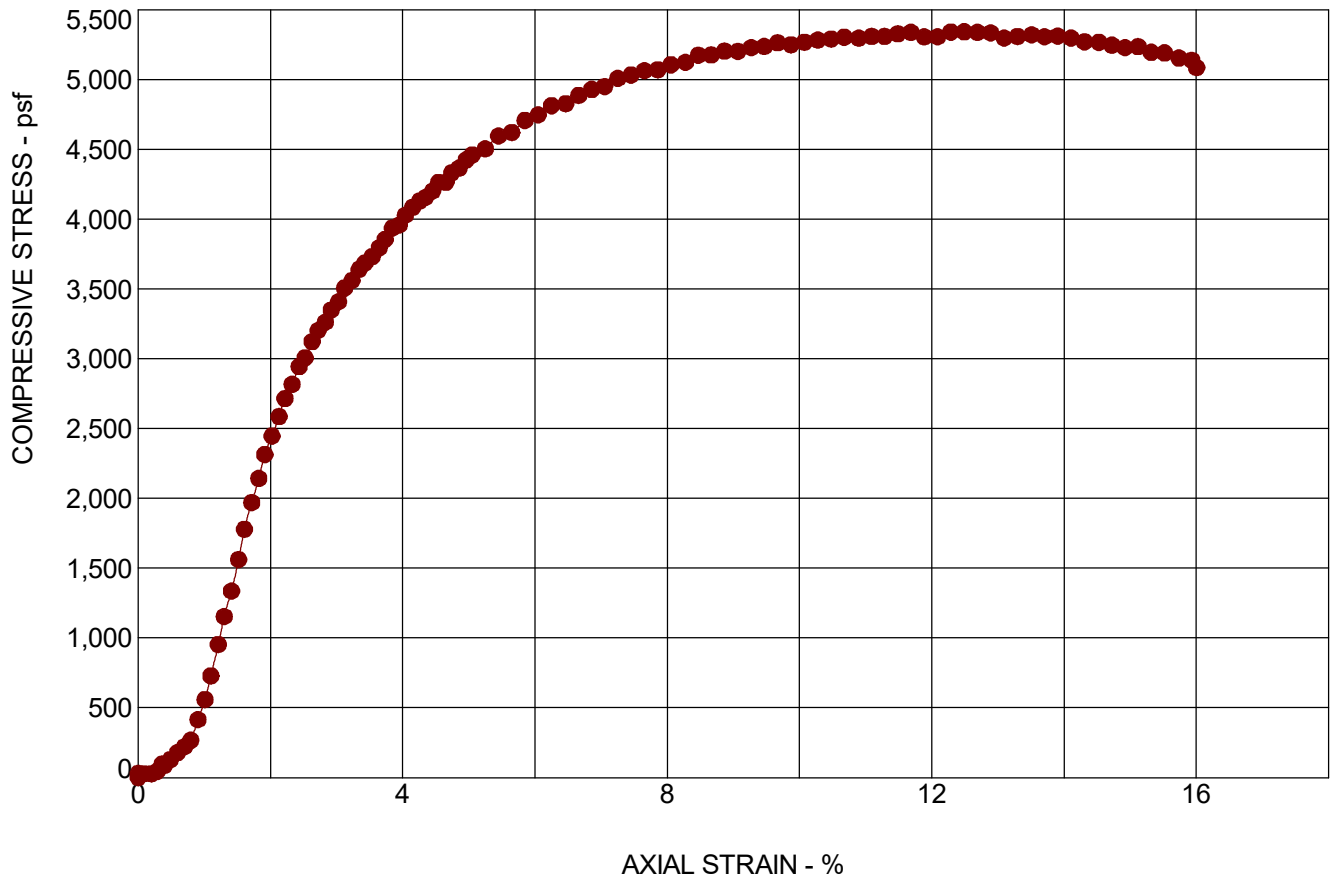
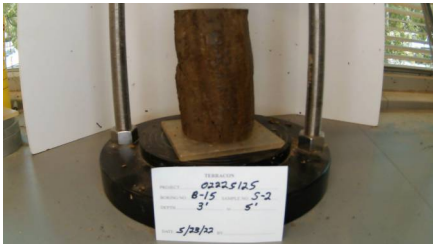
# UNCONFINED COMPRESSION TEST

ASTM D2166

Moisture Content:	%	27.3
Dry Density:	pcf	98
Diameter:	in.	2.74
Height:	in.	5.75
Height / Diameter Ratio:		2.10
Calculated Saturation:	%	
Calculated Void Ratio:		
Assumed Specific Gravity:		
Failure Strain:	%	12.49
Unconfined Compressive Strength	(psf)	5341
Undrained Shear Strength:	(psf)	2670
Strain Rate:	in/min	0.1148
Remarks:
