# **OSAGE DEVELOPMENT STORMWATER MANAGEMENT FACILITY-BEST MANAGEMENT PRACTICES OPERATION AND MAINTENANCE PLAN**

**Prepared for:**

Clayton Properties Group, Inc. dba Summit Homes

July 2021

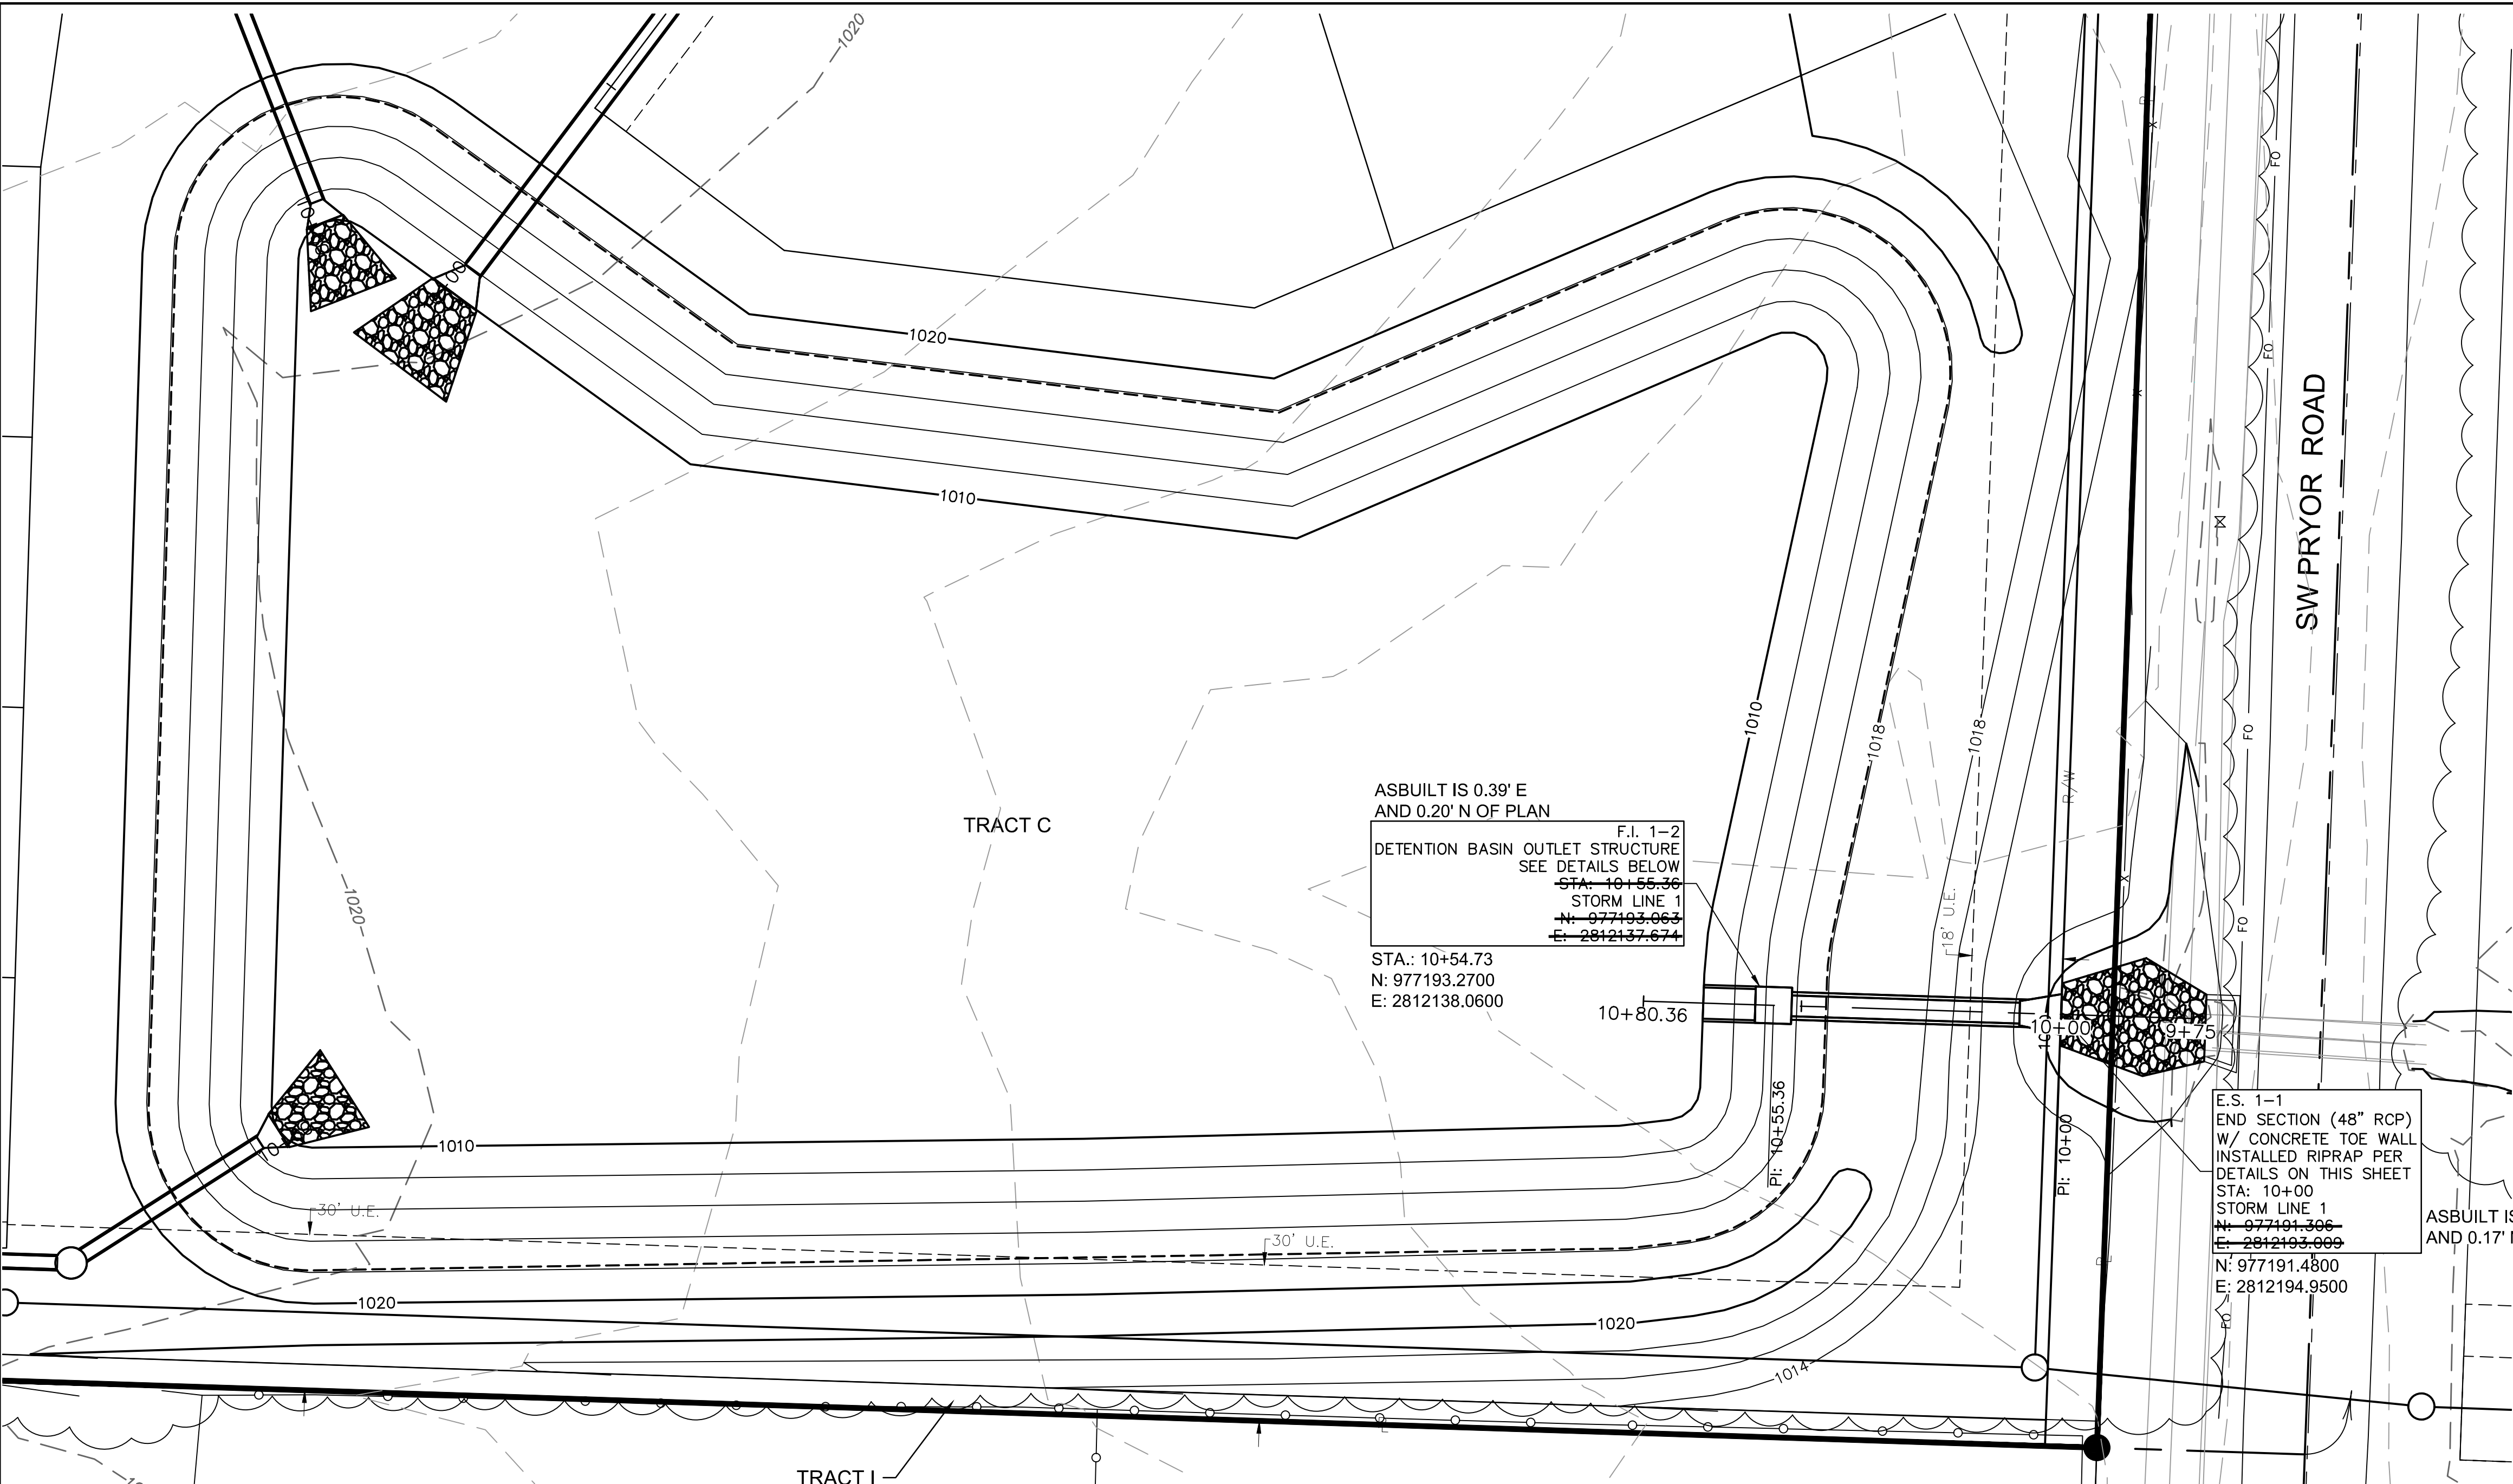
### Detention Basin As-Built Plan

| Riprap Calculations | | | | | | |
| End Section | Q <sub>100</sub><br>(cfs) | Pipe<br>Diameter<br>(ft) | Class* | D50*<br>(in) | Apron<br>Length<br>(ft) | Apron<br>Depth<br>(ft) |
| E.S. 1-1 | 56.3 | 4 | 2 | 6 | 16 | 1.65 |
| *Per Table 10.1 HEC 14-FHWA-Energy Dissipators Pg. 10-18 | | | | | Minimum<br>Area<br>(SY) | 30.8 |

| BASIN SPILLWAY DETAILS | |
| TYPE | RECTANGULAR<br>BROAD CRESTED WEIR |

| AS-BUILT BASIN DETAILS | |
|--|---|
| DESIGN STORAGE | 528,652 CF |
| AS-BUILT STORAGE | 513,200 CF |

AS-BUILT

REFER TO MASTER  
DRAINAGE PLAN  
FOR UPDATED GRADING
