ATC TOWER INSPECTION FORM

ATC Site Number	: 306035	ATC Site Name, State	: Unity Village MO 2
Site Address	: 2150 NW LOWENSTEIN	Number of Compounds	:
City/State	: Lees Summit, MO 64081	Date of Inspection	: 2/19/20
Contractor Name	: TOWER ENGINEERING PROFESSIONAL	Tower Elevation Photo	: Unity Village MO 2 (306035) 143.JPG
Inspection Completed By	: Sky Rimmille, Max Wagner	SC Tagged Out?	: Yes

Structure Type	: Self-Supporting	# of Tower Legs	: 3
Tower Height	: 189'	Safety Climb Installed?	: Yes      Location: AB Face
Overall Structure Height	: 189.54'	Safety Climb Manuf.	: DBI Sala      Climbing Facil. Ladder
Tower Manufacturer	: CNR	AM Detuning ?	: No

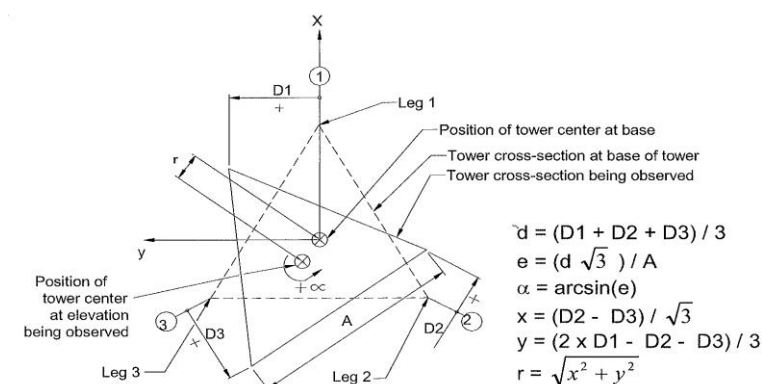
### Tower Plumb and Twist Measurements

The transit is to be set up on each leg azimuth at the base of the tower. The corresponding tower leg at the base of the tower is used to set the vertical baseline.

OBSERVED LEG DISPLACEMENTS										CALCULATED TWIST			CALCULATED OUT-OF-PLUMB		
Data Point	Mast Elev. * See Note (Ft)	A - Face Width (In)	Leg Width (In)	D1**	i1	D2	i2	D3	i3	d (In)	e	α (Deg)	x (In)	y (In)	r (In)
1	20.00	184.66	4.57	0.00	-0.38	0.00	-0.38	0.00	0.00	-0.58	-0.01	-0.31	-0.50	-0.29	0.58
2	40.00	165.32	4.35	0.00	-0.38	0.00	-0.38	0.00	-0.38	-0.83	-0.01	-0.50	0.00	0.00	0.00
3	60.00	145.98	4.05	0.06	-0.38	0.06	-0.38	0.00	-0.38	-0.69	-0.01	-0.47	0.07	0.04	0.08
4	80.00	126.64	3.83	0.13	-0.38	0.13	-0.38	0.00	-0.25	-0.48	-0.01	-0.38	0.00	0.00	0.00
5	100.00	107.30	3.70	0.25	-0.25	0.25	-0.25	0.13	-0.25	-0.07	0.00	-0.07	0.13	0.07	0.15
6	120.00	87.96	3.30	0.25	-0.13	0.25	-0.13	0.25	-0.25	0.13	0.00	0.15	0.11	0.07	0.13
7	140.00	68.62	3.05	0.50	-0.06	0.50	-0.06	0.25	-0.25	0.45	0.01	0.65	0.39	0.22	0.45
8	160.00	49.28	2.50	0.50	-0.06	0.50	-0.06	0.38	-0.13	0.47	0.02	0.95	0.14	0.08	0.16
9	180.00	29.94	1.85	0.75	-0.06	0.75	-0.06	0.63	0.00	0.62	0.04	2.05	0.03	0.02	0.04

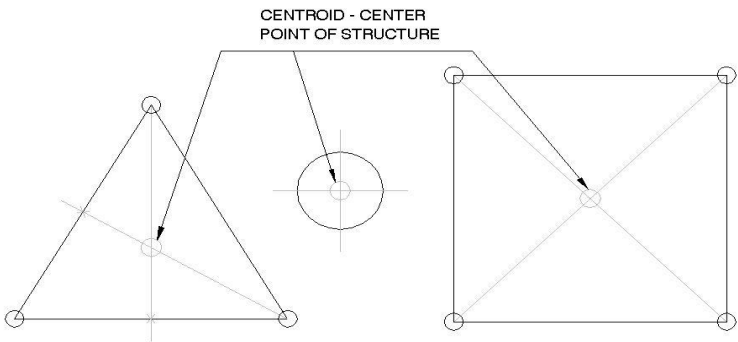
HEIGHT of FOUNDATION (F) = 0.54 (feet)  
(Measure from ground at center of tower to top of baseplate)

HEIGHT with APPURTENANCE (F+S+A) = 189.54 (feet)

Distance From Centroid At Base Of Structure To Laser Tripod = (feet)
