WOODSIDE RIDGE DEVELOPEMNT STORMWATER MANAGEMENT FACILITY-BEST MANAGEMENT PRACTICES OPERATION AND MAINTENANCE PLAN

Clayton Properties Group, Inc. dba Summit Homes

Lee's Summit, Missouri

September 2023

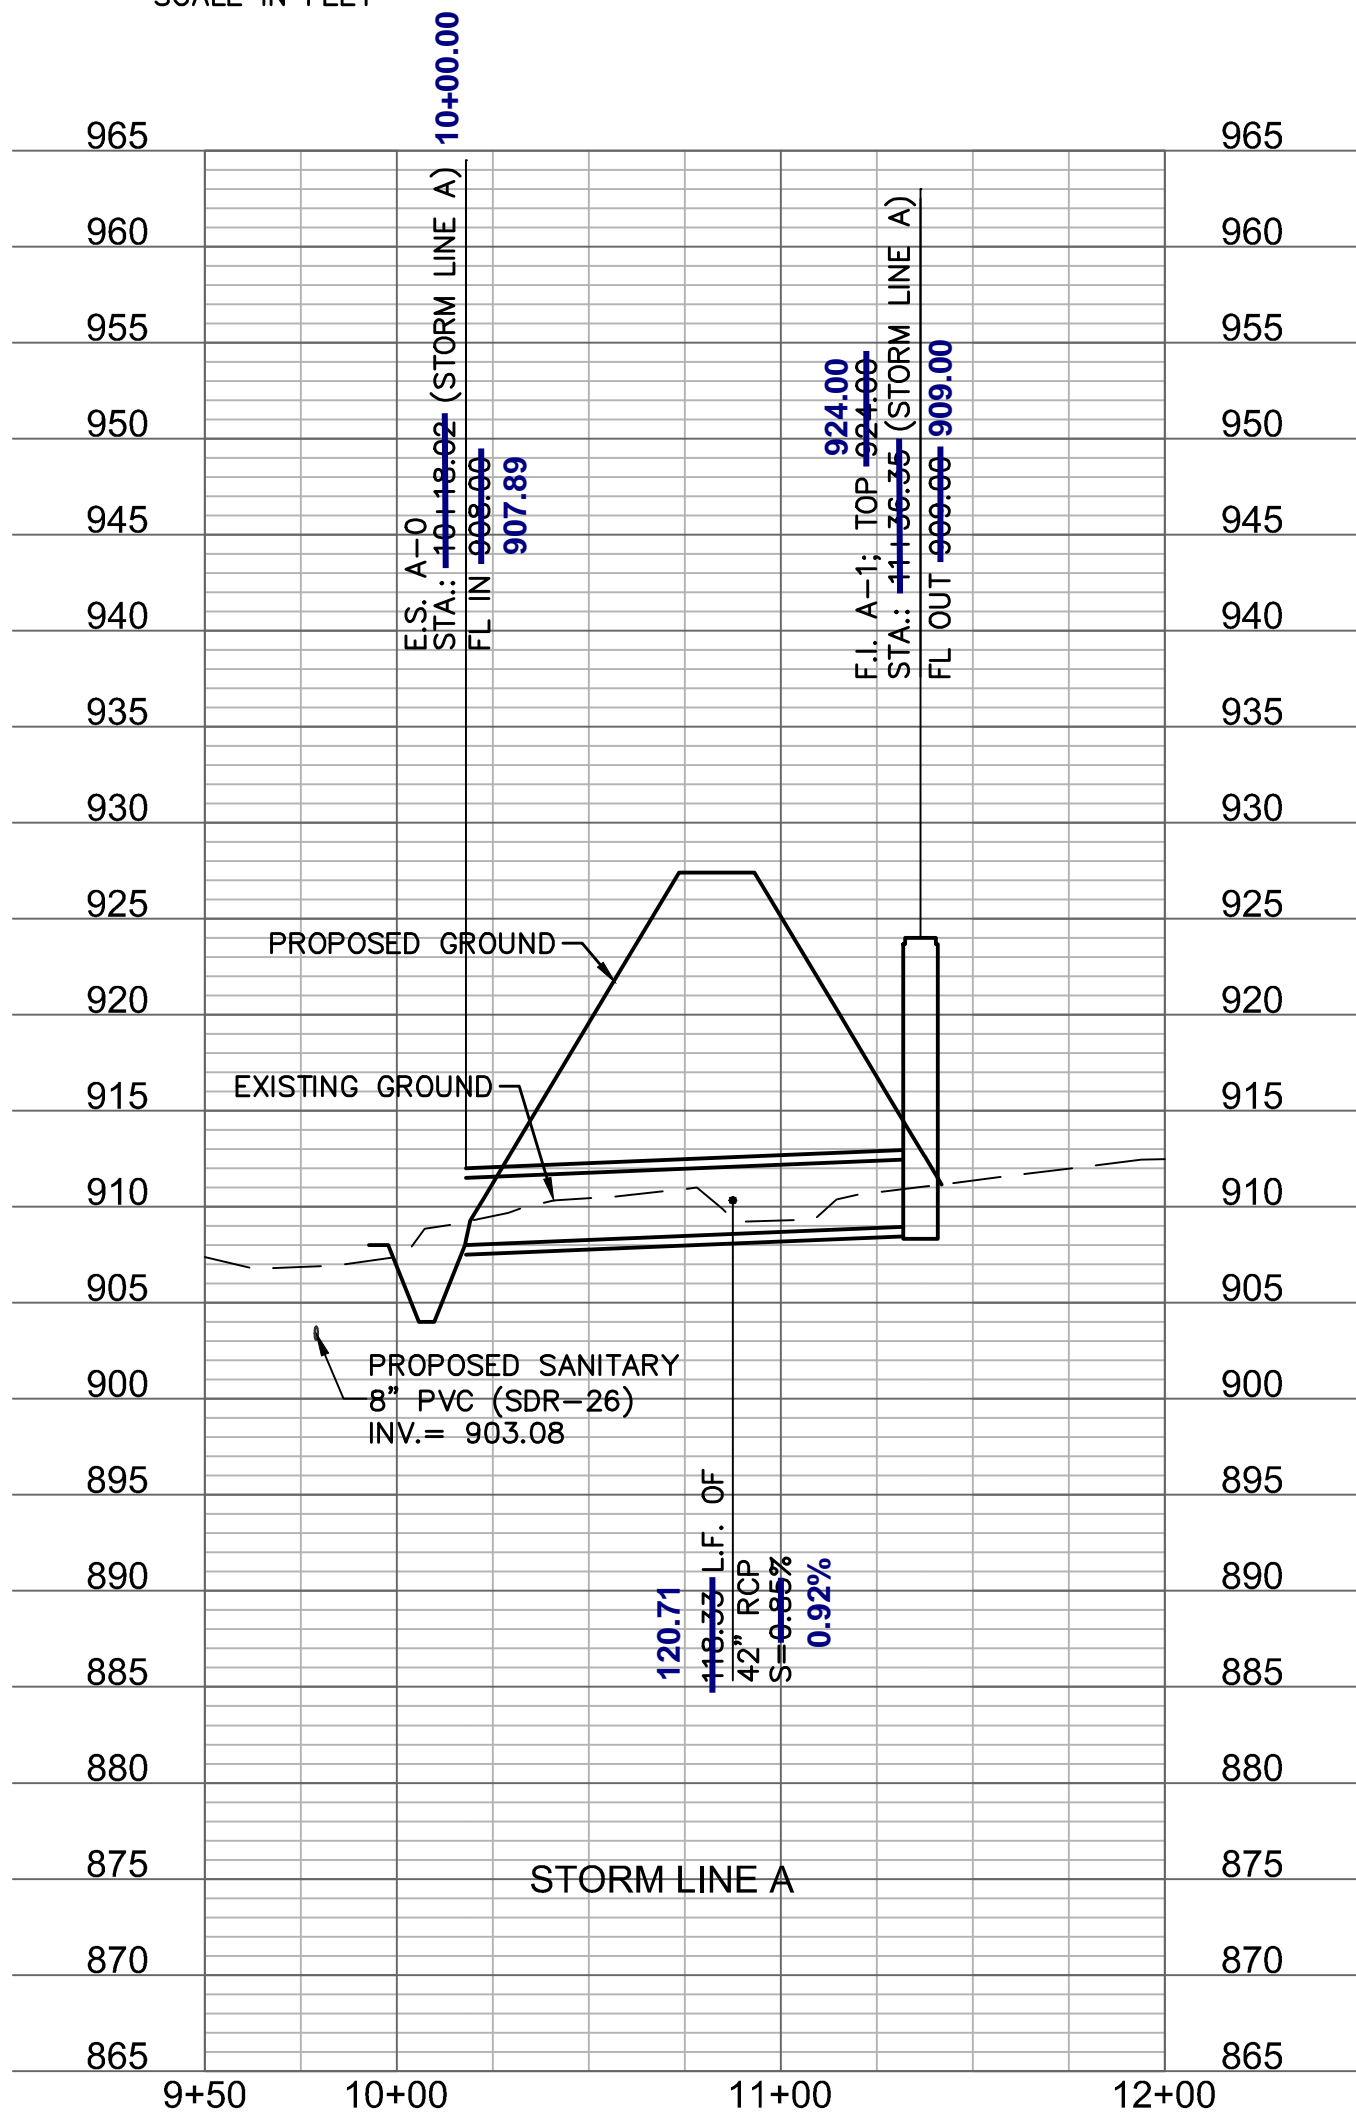
Record Drawing

EARTHWORK QUANTITIES	
CUT (C.Y.)	FILL (C.Y.)
25	5410
10yr. W.S.E.	100yr. W.S.E.
923.65	925.96

As-built is 0.39' N
and 0.31' W of plan

F.I. A-1, CONST. STD.
FIELD INLET (8'X8' INSIDE)
PER DETAIL THIS SHEET
STA.: ~~11+36.35~~ (STORM LINE A)
N: ~~1,001,110.7203~~ **1,001,111.11**
E: ~~2,811,738.0925~~ **2,811,738.41**

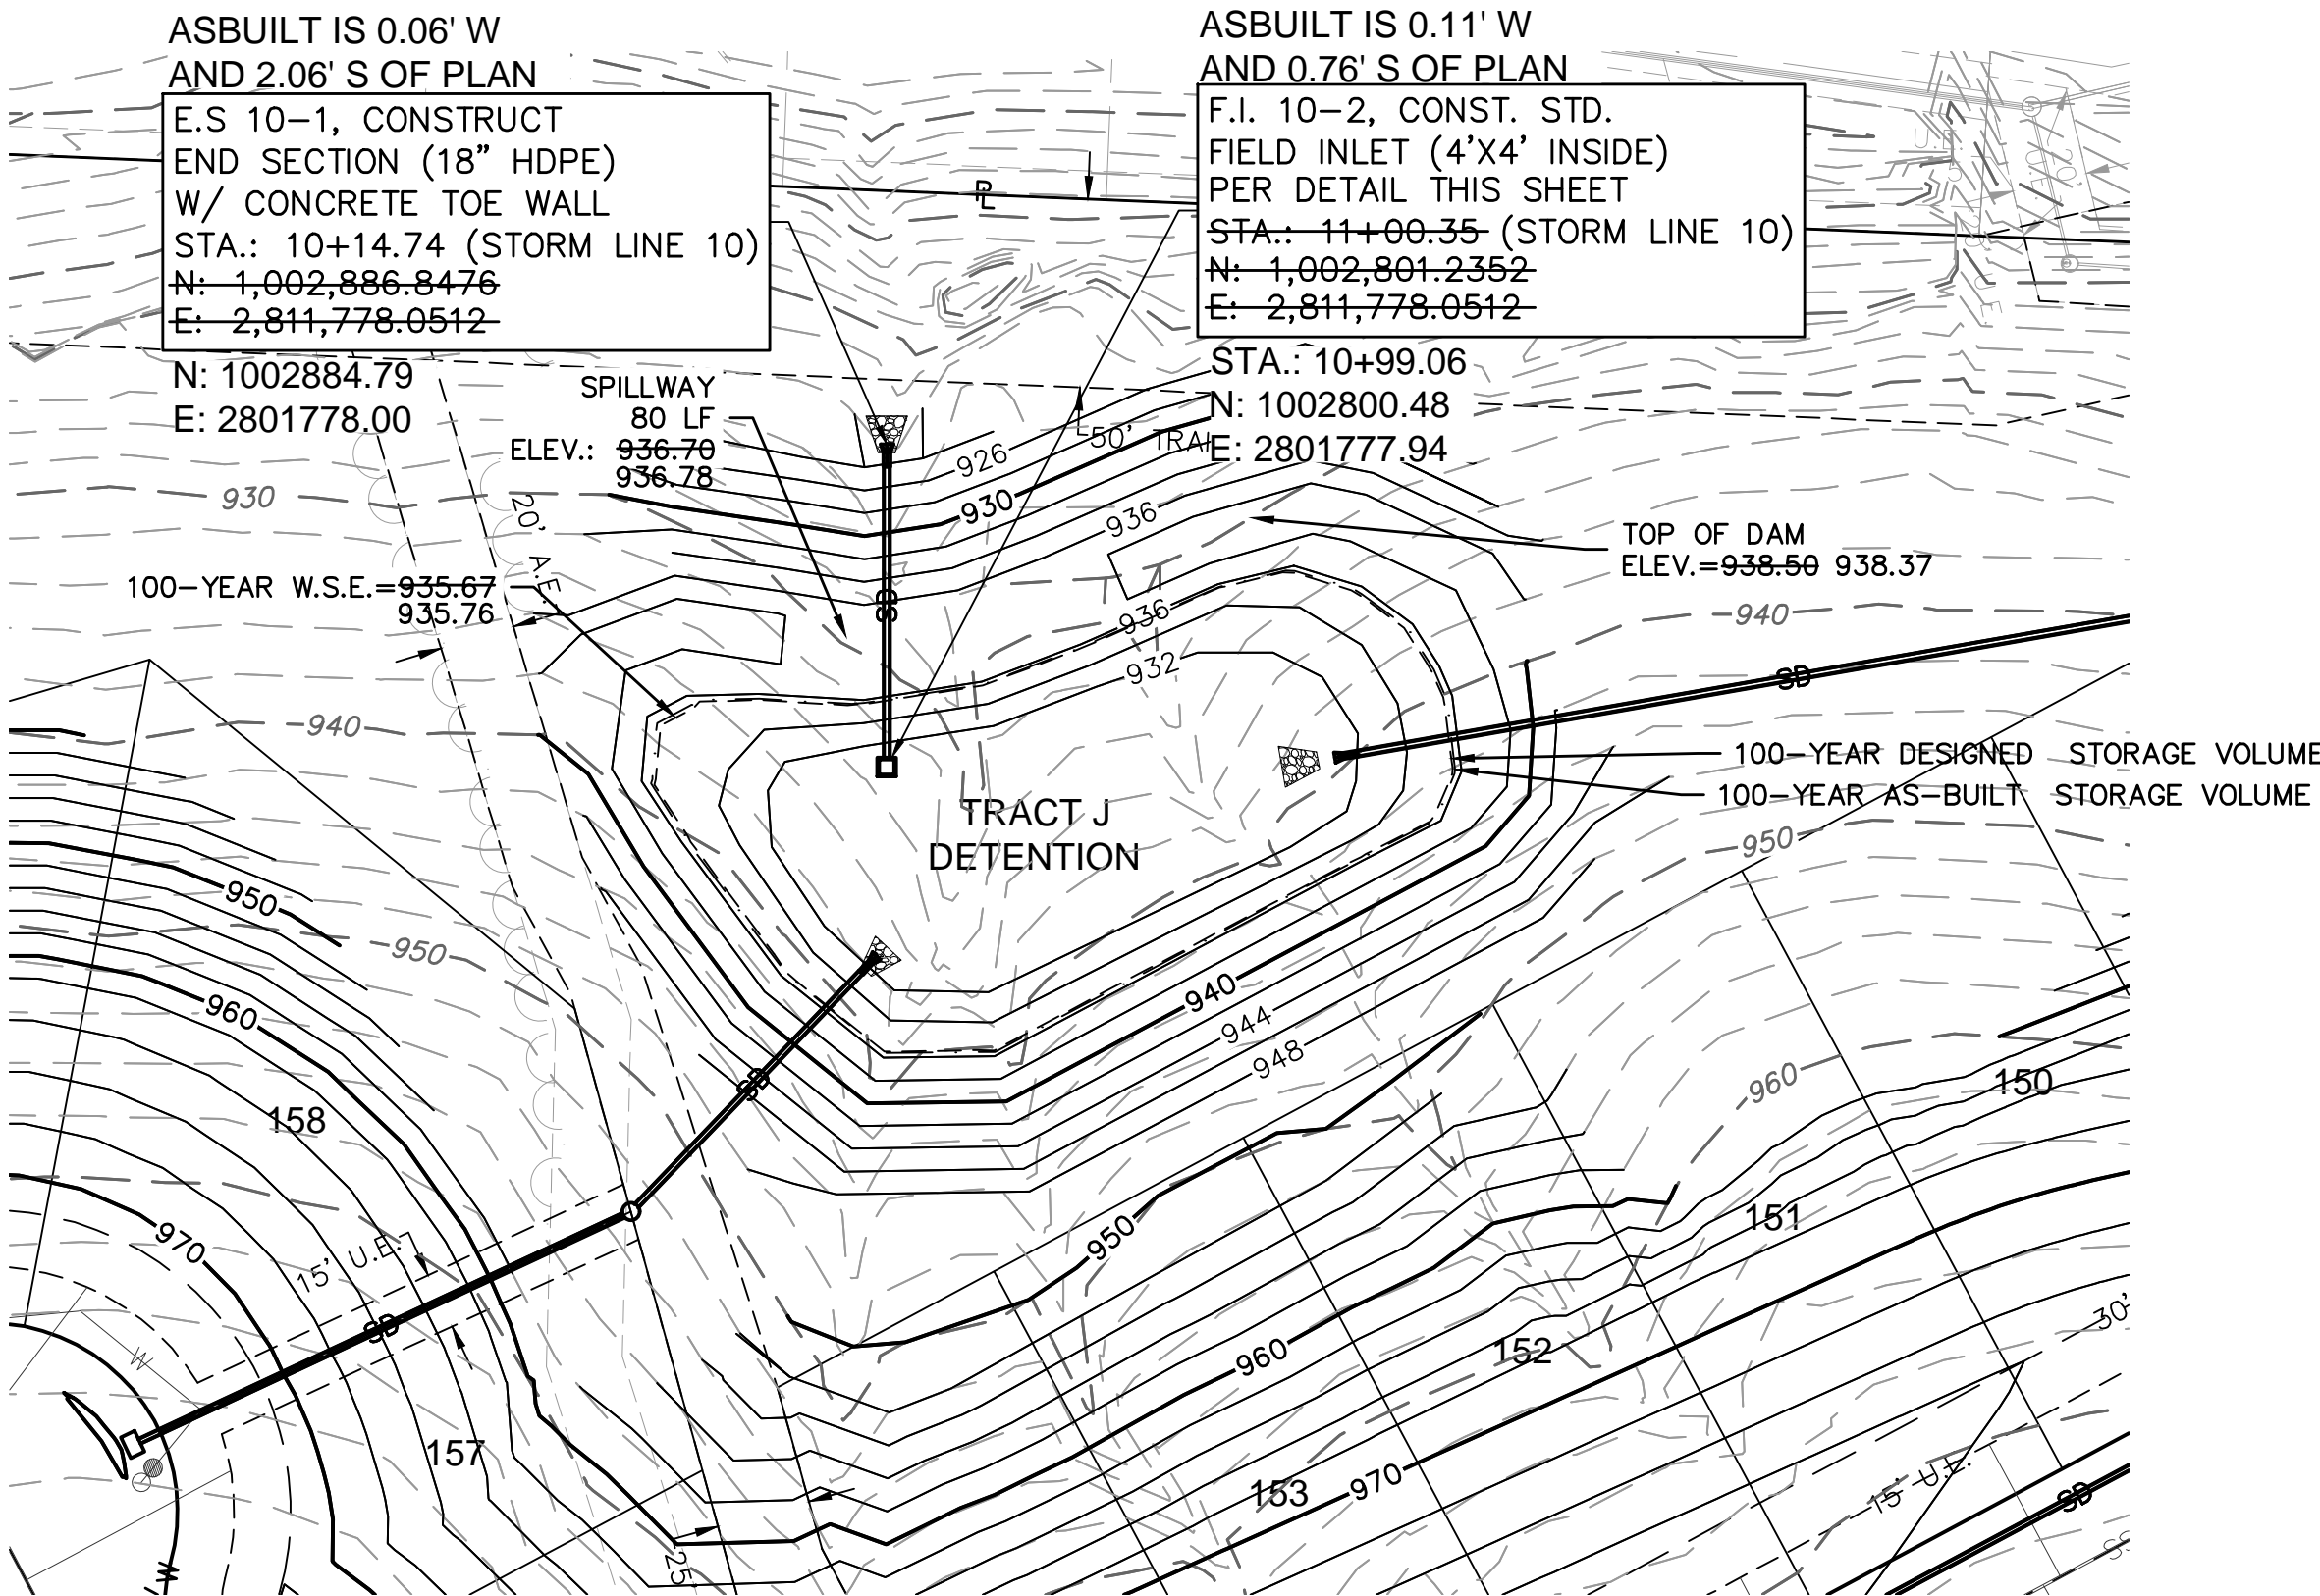
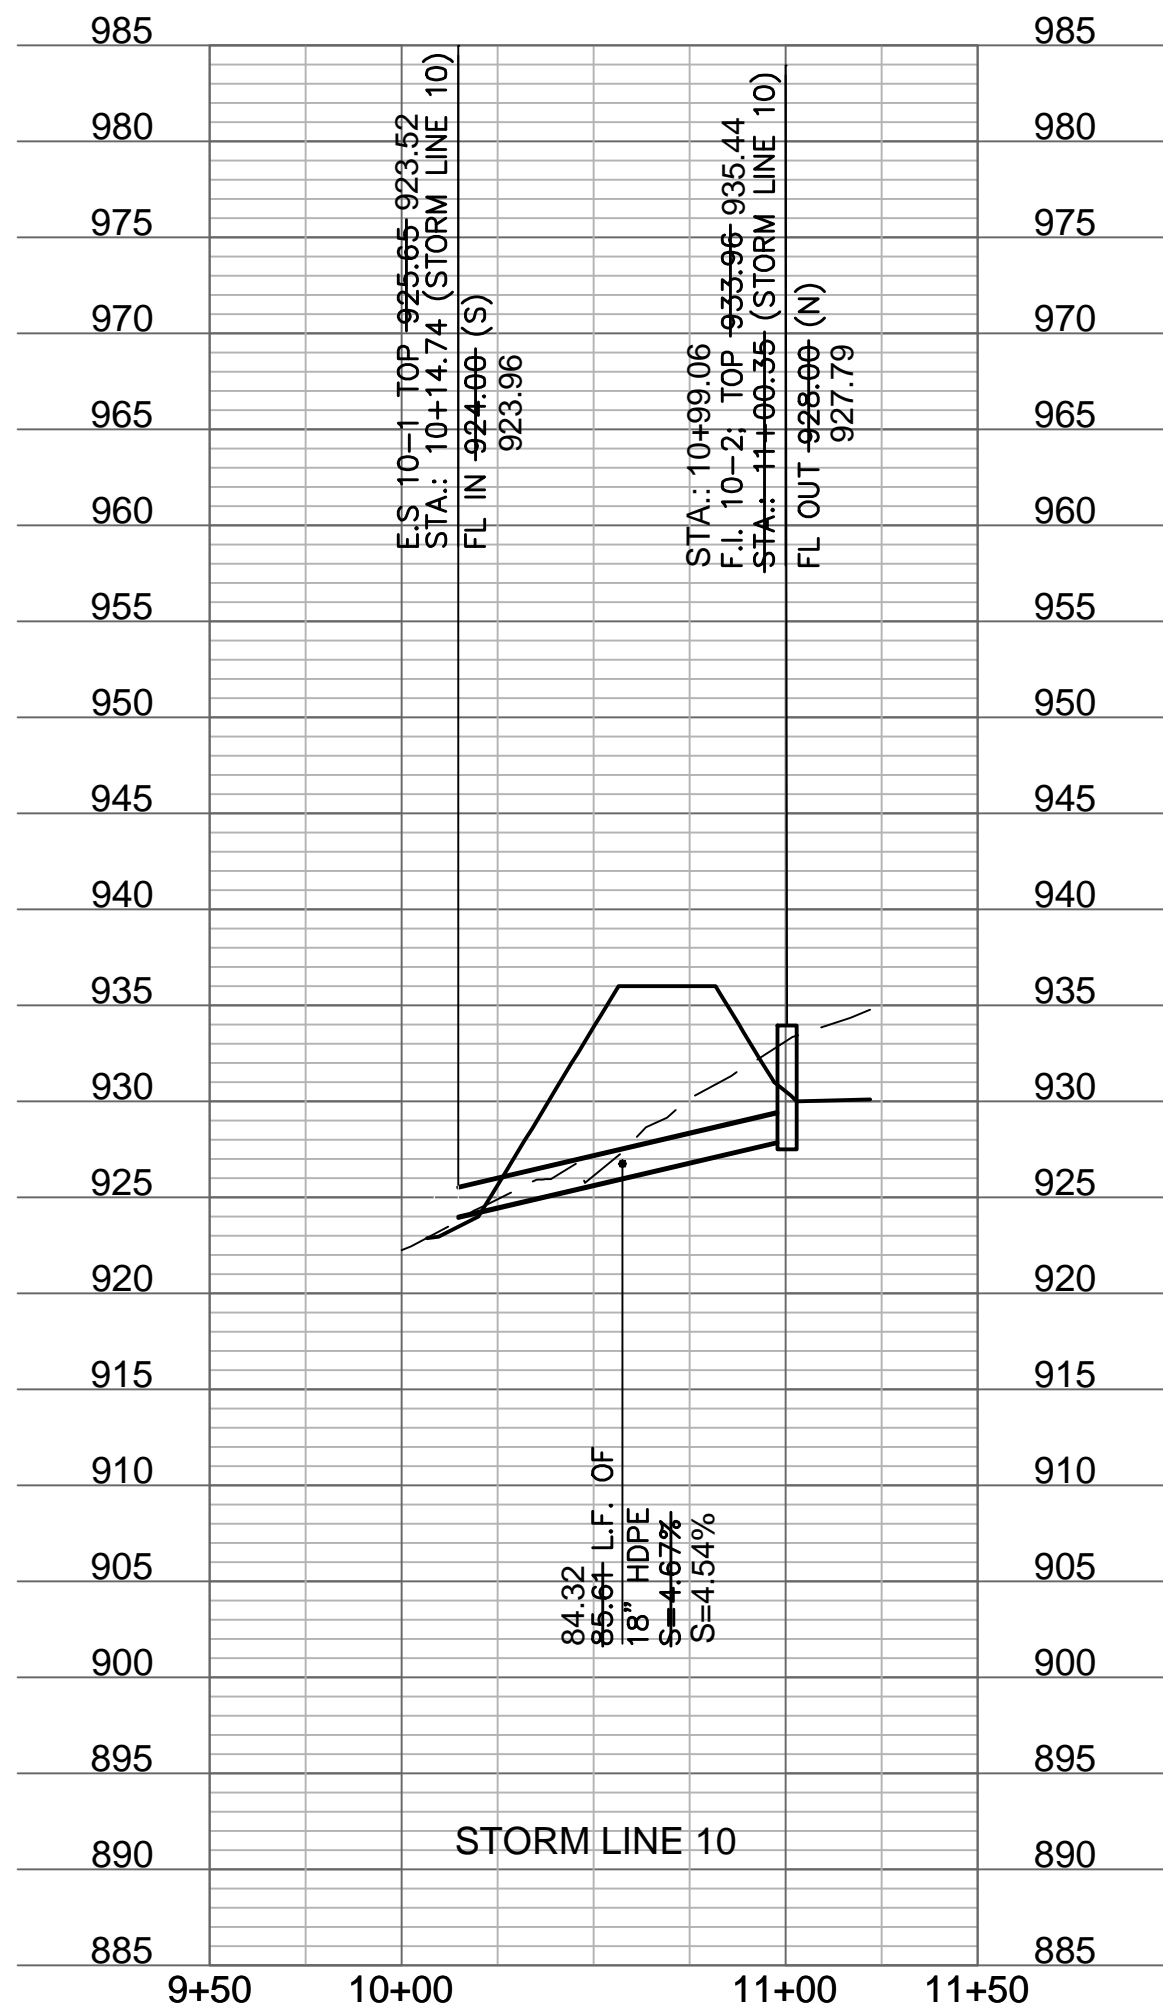
EARTHWORK QUANTITIES	
CUT (C.Y.)	FILL (C.Y.)
4,012	2,535

10yr. W.S.E.	100yr. W.S.E.
934.36	935.67

Riprap Calculations						
End Section	Q ₁₀₀ (cfs)	Pipe Diameter (ft)	Class*	D50* (in)	Apron Length (ft)	Apron Depth (ft)
E.S. 10-1	18.41	1.5	3	10	7.5	2.00
						27.4

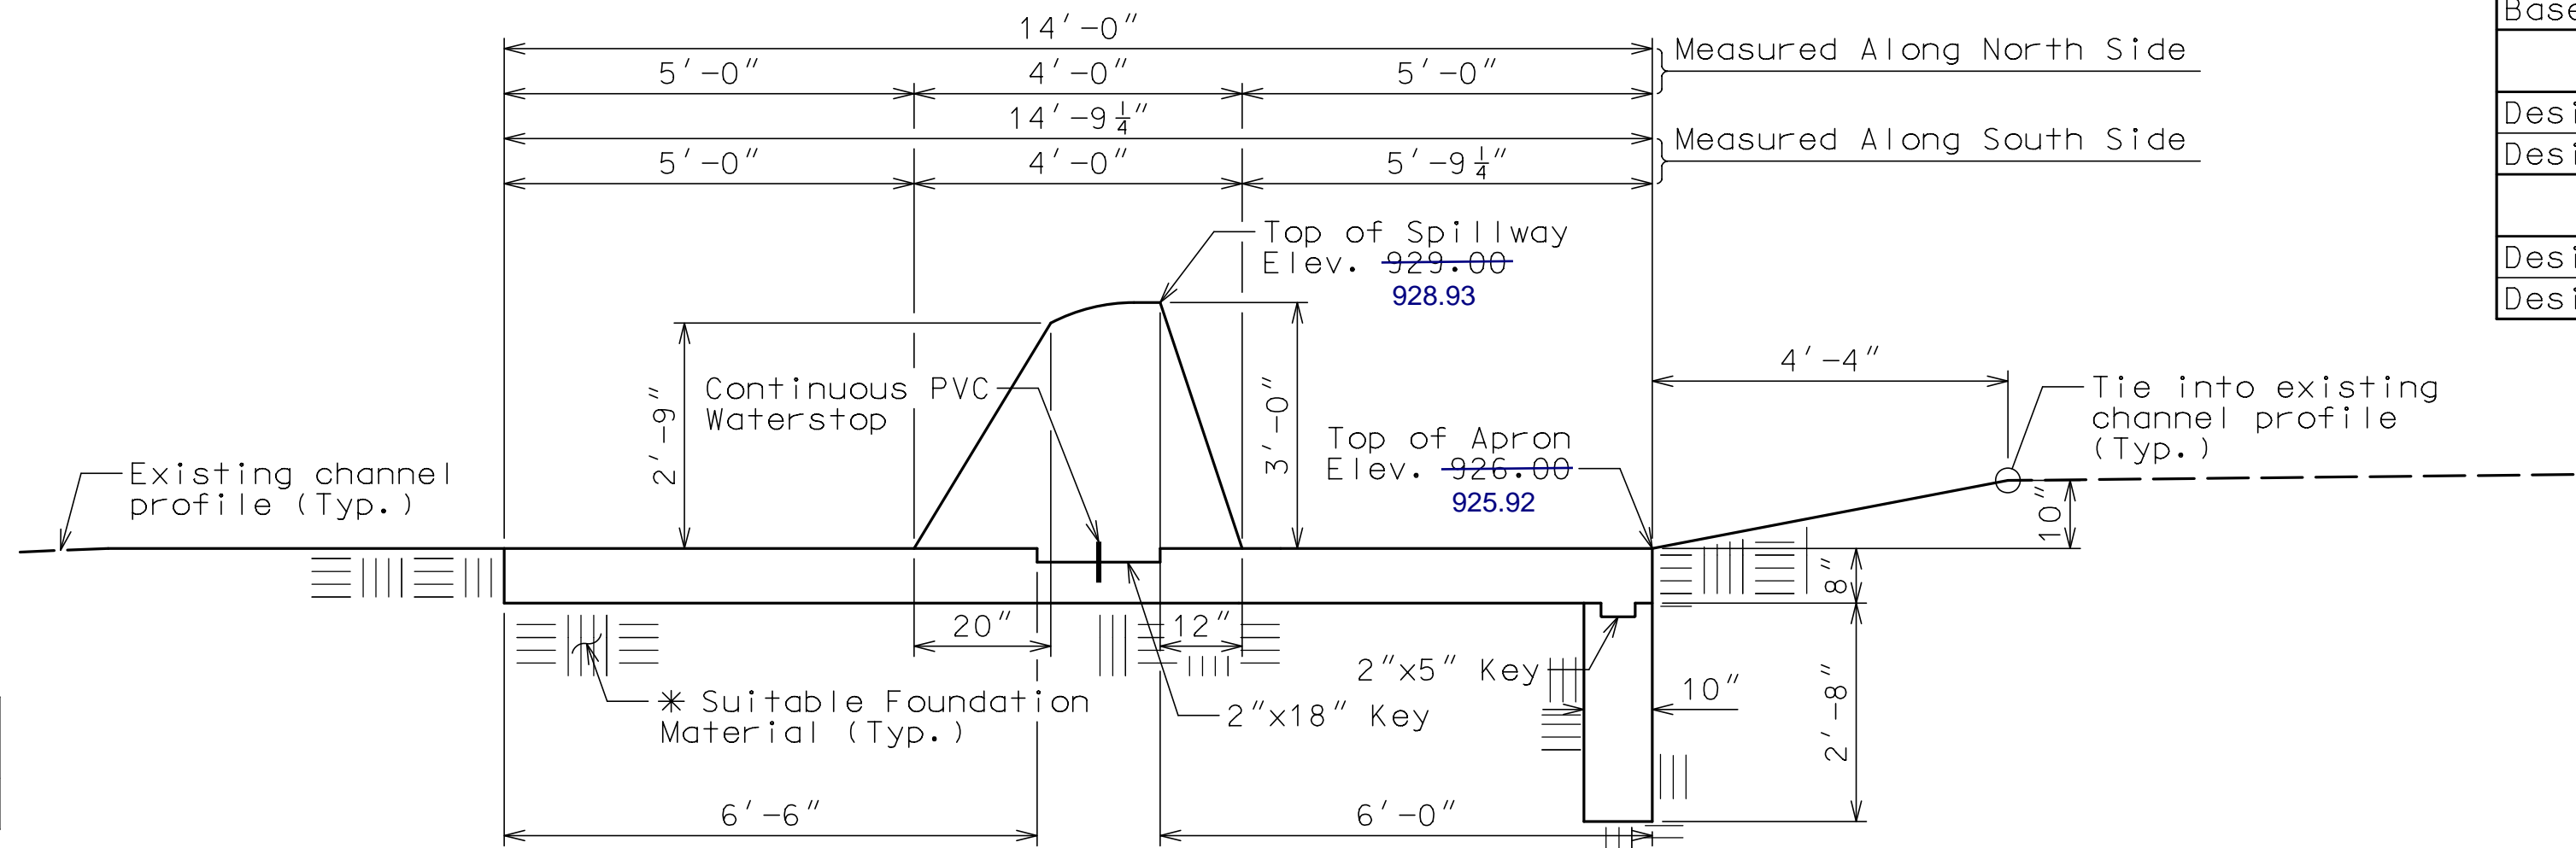
Hydrologic Data	
Design Storm (2-year)	
Base Flood Elevation =	931.83
Base Flood Discharge =	453 cfs
Design Storm (10-year)	
Design Flood Elevation =	932.94
Design Flood Discharge =	739 cfs
Design Storm (100-year)	
Design Flood Elevation =	934.36
Design Flood Discharge =	1,176 cfs

Note:
For View A-A, Section B-B, & Section C-C,
see Sheet 5504.

SPILLWAY GENERAL PLAN AND ELEVATION	WOODSIDE RIDGE FIRST PLAT	2020
LEE'S SUMMIT, MO
