Site ID: 877803 > Site Name: LEE'S SUMMIT FIRE STATION

## TIA CONDITION ASSESSMENT Read Only

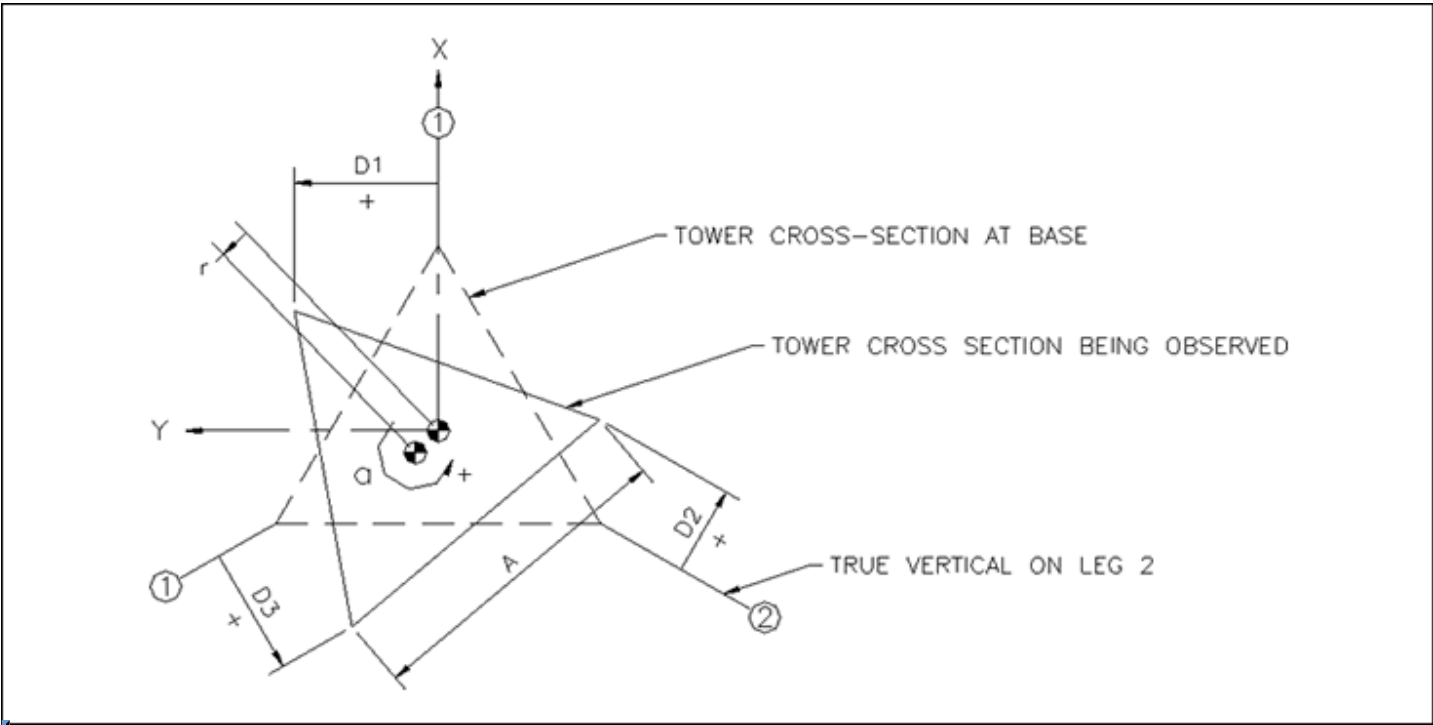
Observed Mast Data    Calculated Twist    Calculates Out-of-Plumb

Mast ElevA	D1	D2	D3	d	ea	x	y	r
(ft)	(in)	(in)	(in)	(in)	(in)	(degrees)	(in)	(in)
