# Stormwater BMP Operation & Maintenance (O&M) Manual

## Orchard Woods

1204 Ne Woods Chapel Road  
Lee's Summit, Jackson County, Missouri

**PEI #211142**  
**October 5, 2023**  
**Revised: January 23, 2024**

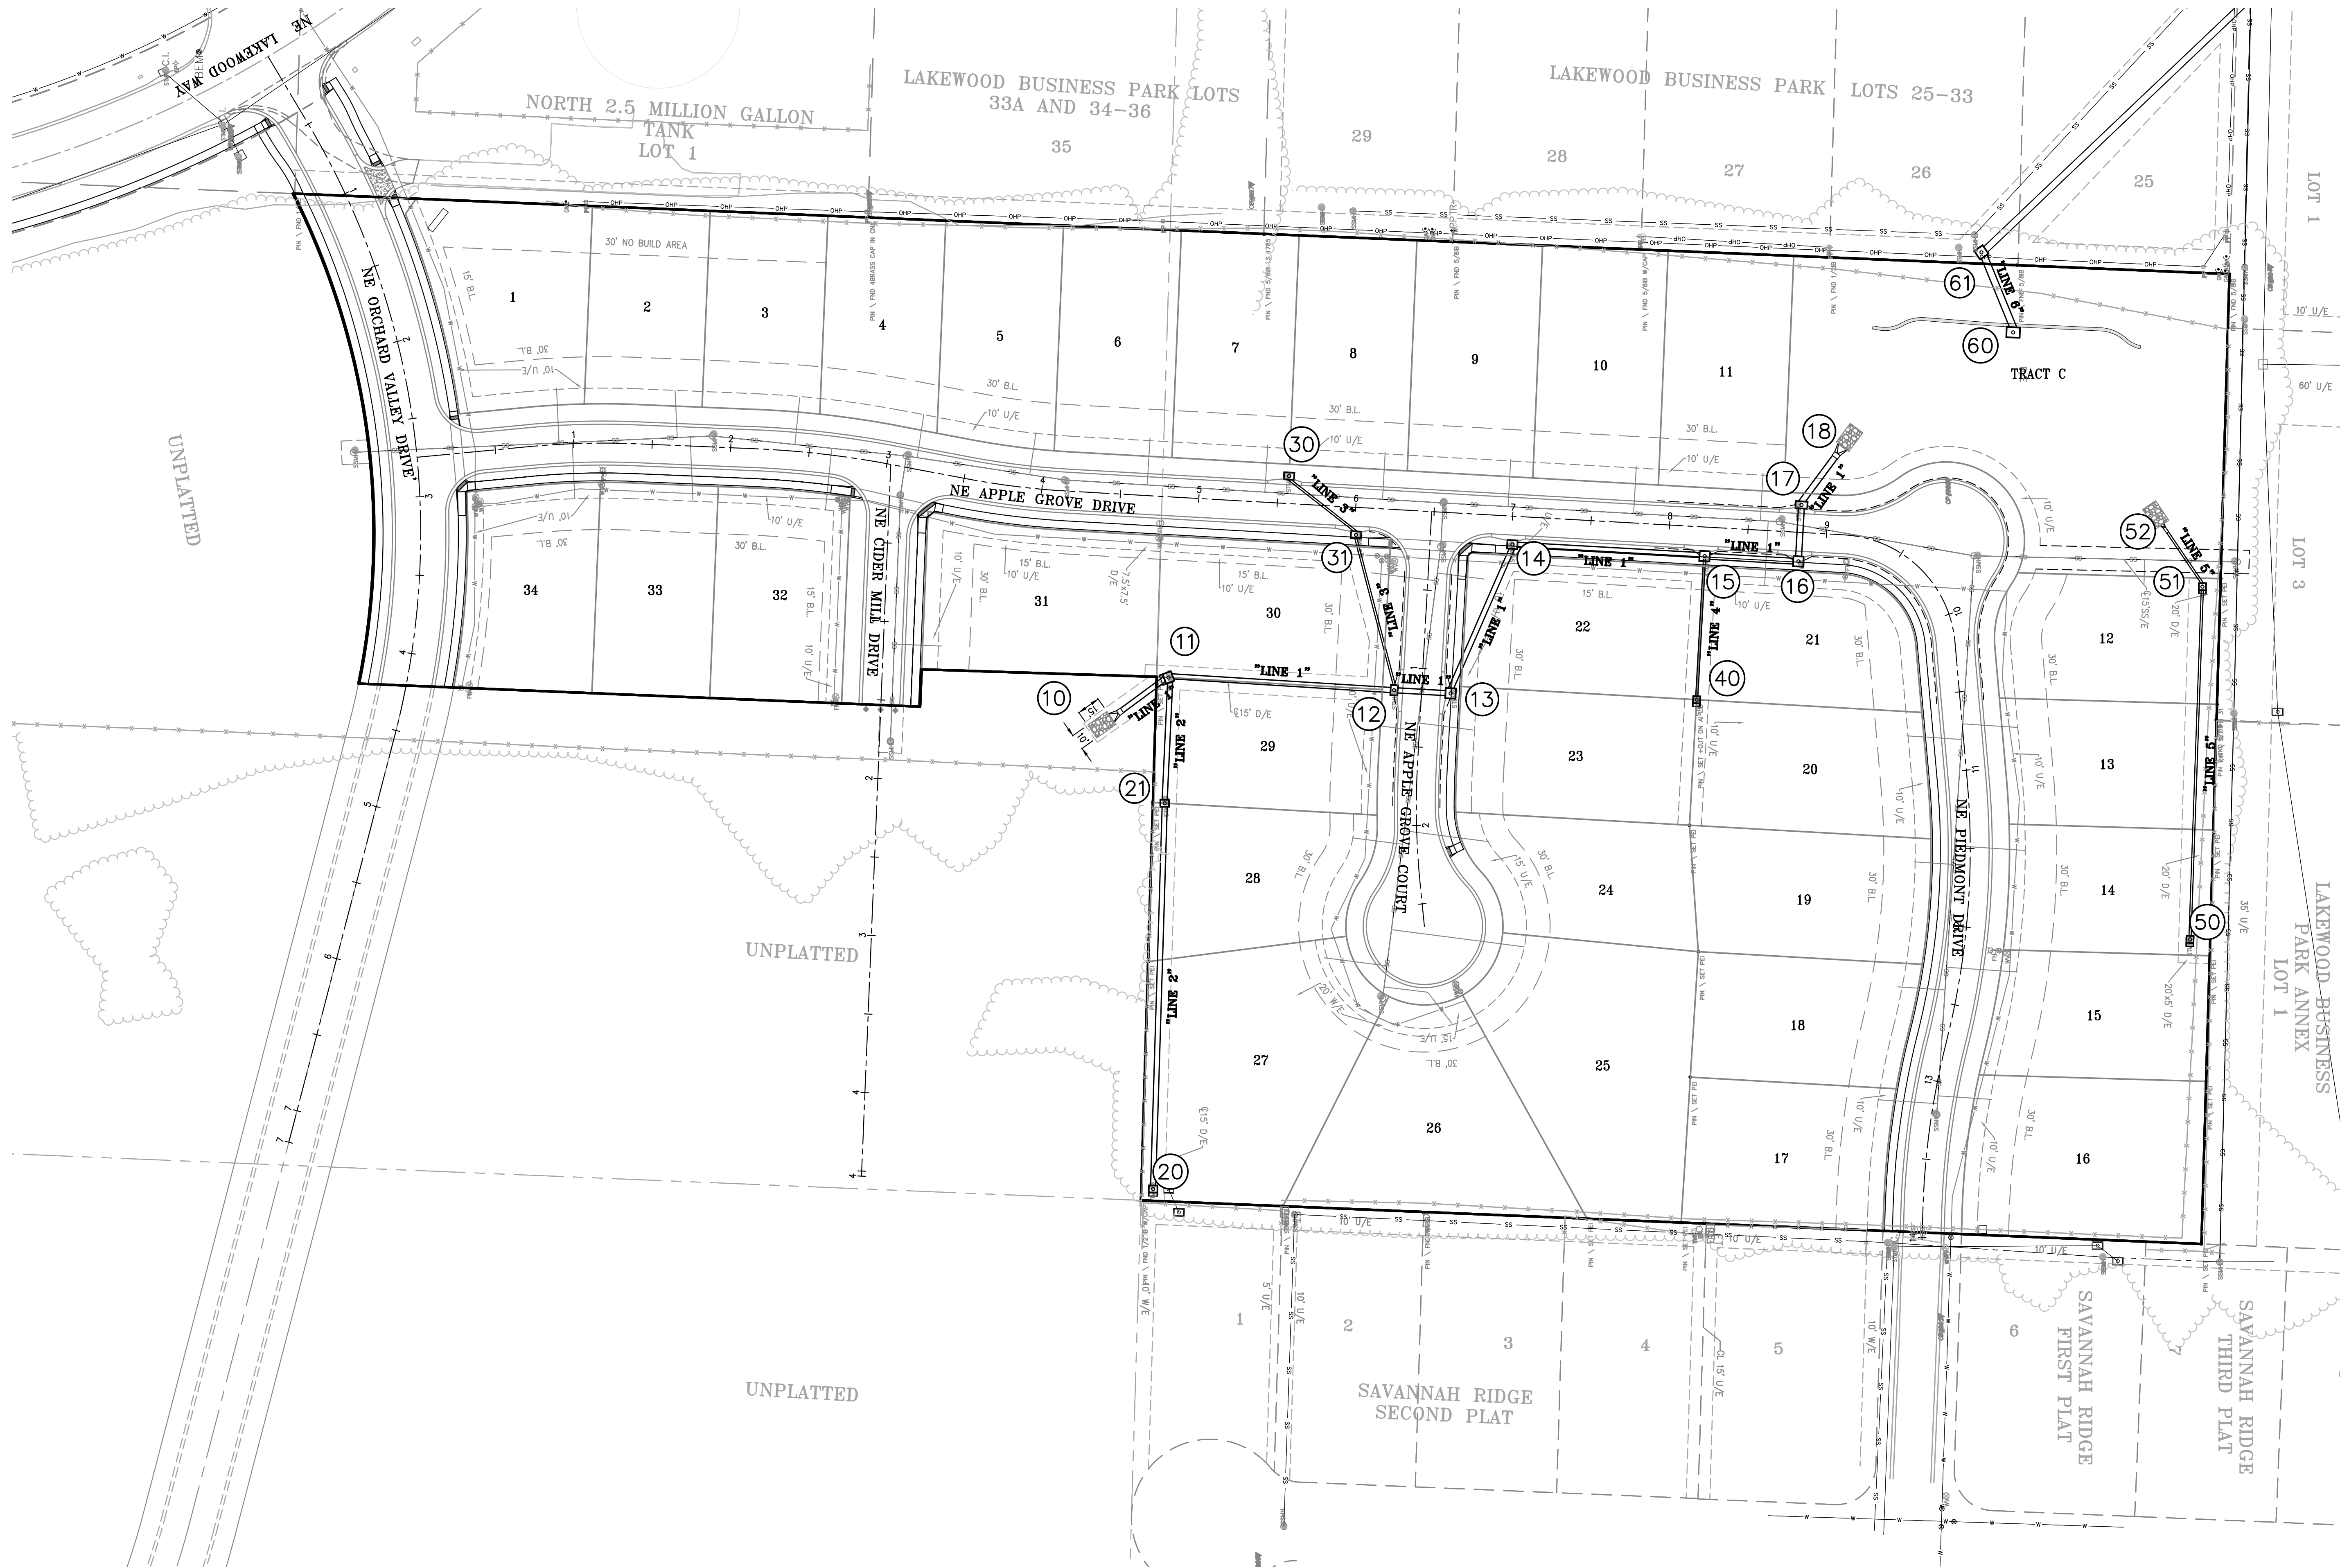
SHEET  
**12**

**"AS-BUILT"**  
DATED: 11-13-23 BY: JTK

**STORM SEWER GENERAL LAYOUT**  
ORCHARD WOODS  
LEE'S SUMMIT, JACKSON COUNTY, MISSOURI

The extended dry detention basin is proposed within the northwest corner of the site, see attached site plan for the location of each BMP.
