Geotechnical Evaluation Report

QuikTrip Store No. 183R
1001 SW Blue Parkway
Lee's Summit, Missouri

Project B2311165

Re: Geotechnical Evaluation
QuikTrip Store No. 183R
1001 SW Blue Parkway
Lee's Summit, Missouri

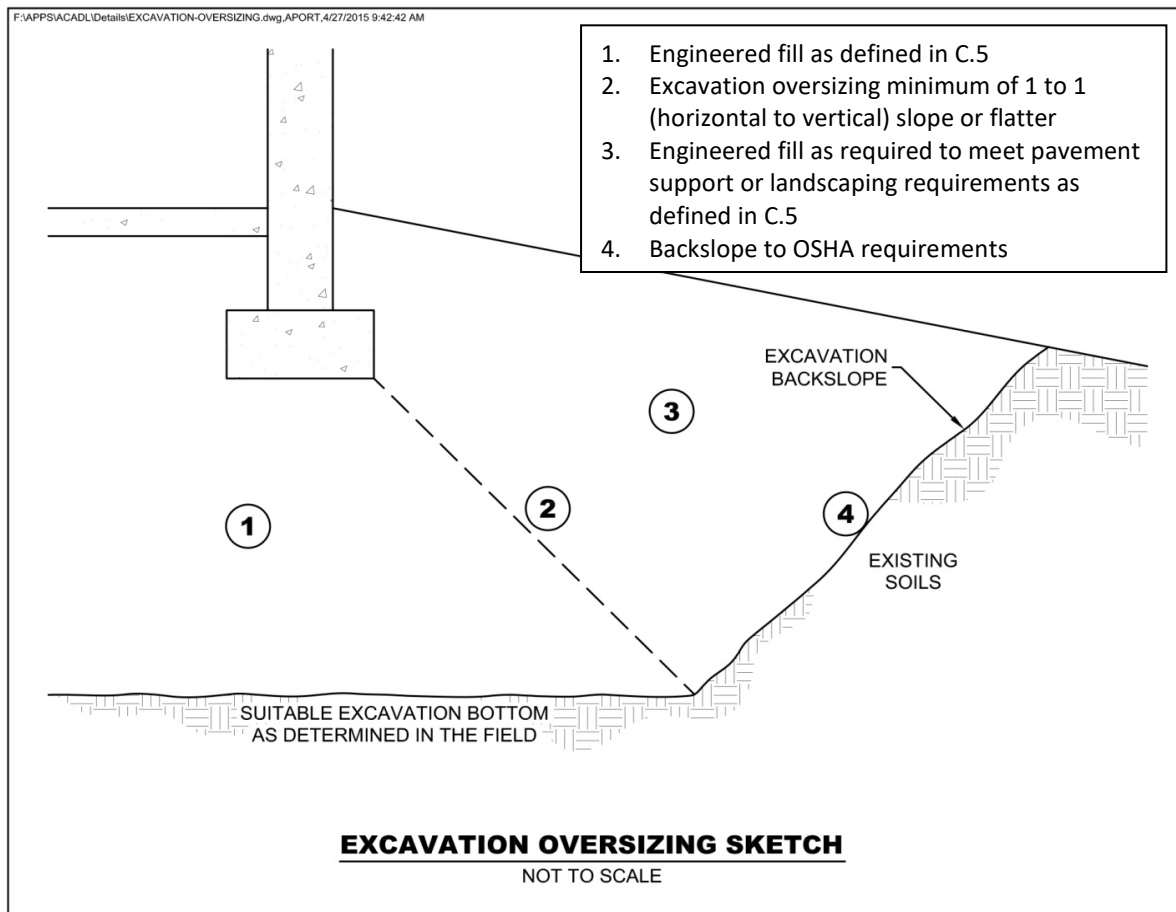
Figure 1. Generalized Illustration of Oversizing

If fill material remains after initial site grading and undercutting to allow for the placement of LVC material below the floor slab, we recommend a geotechnical engineer or senior engineering technician (engineering representative) evaluate the remaining existing fill prior to new fill placement. The geotechnical representative should evaluate the fill material by appropriate methods, such as hand auger probes, observation of test pits, and observation of proofrolls where feasible. The contractor should remove soft or unsuitable material identified by the geotechnical representative and replace it with new engineered fill. Where unsuitable material is encountered below structure foundations, the undercutting shall be oversized as illustrated below in Figure 1.

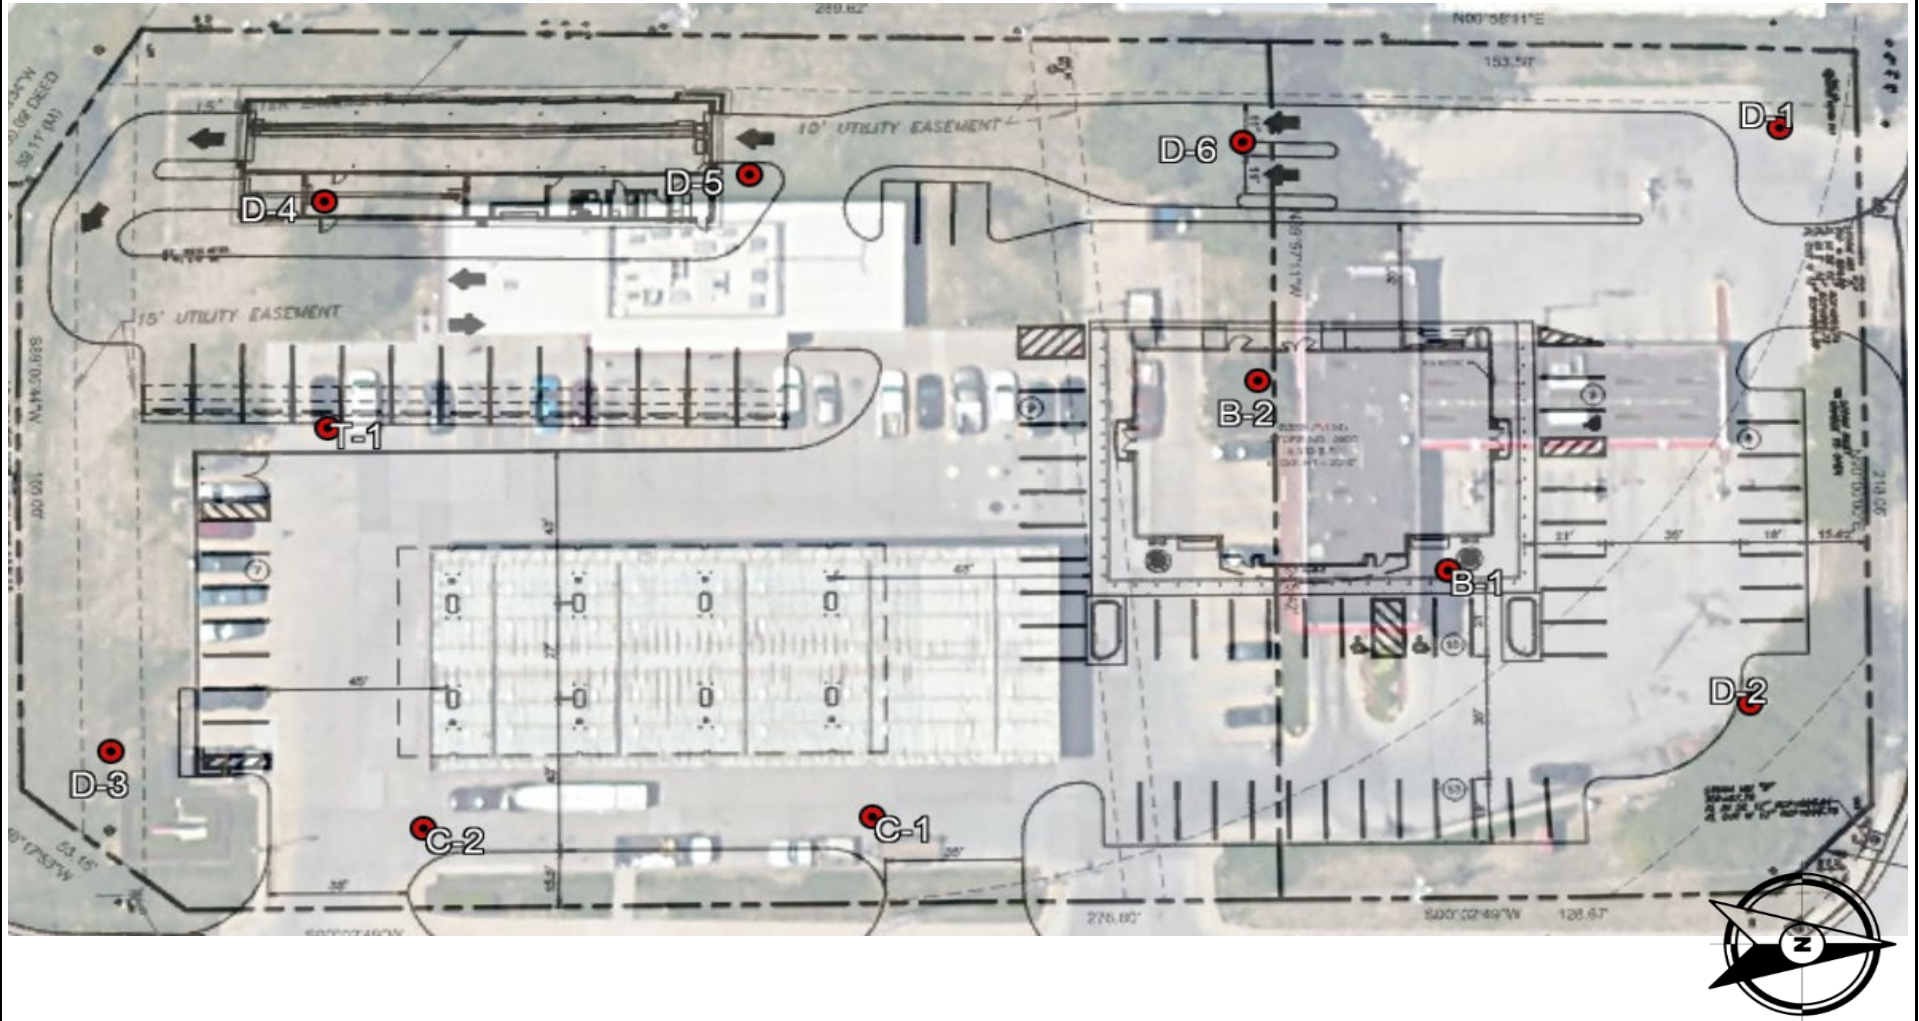
FIGURE
A-2

Site Plan with Boring Locations
QuikTrip Store No. 183R 1001 SW Blue Parkway Lee's Summit, MO

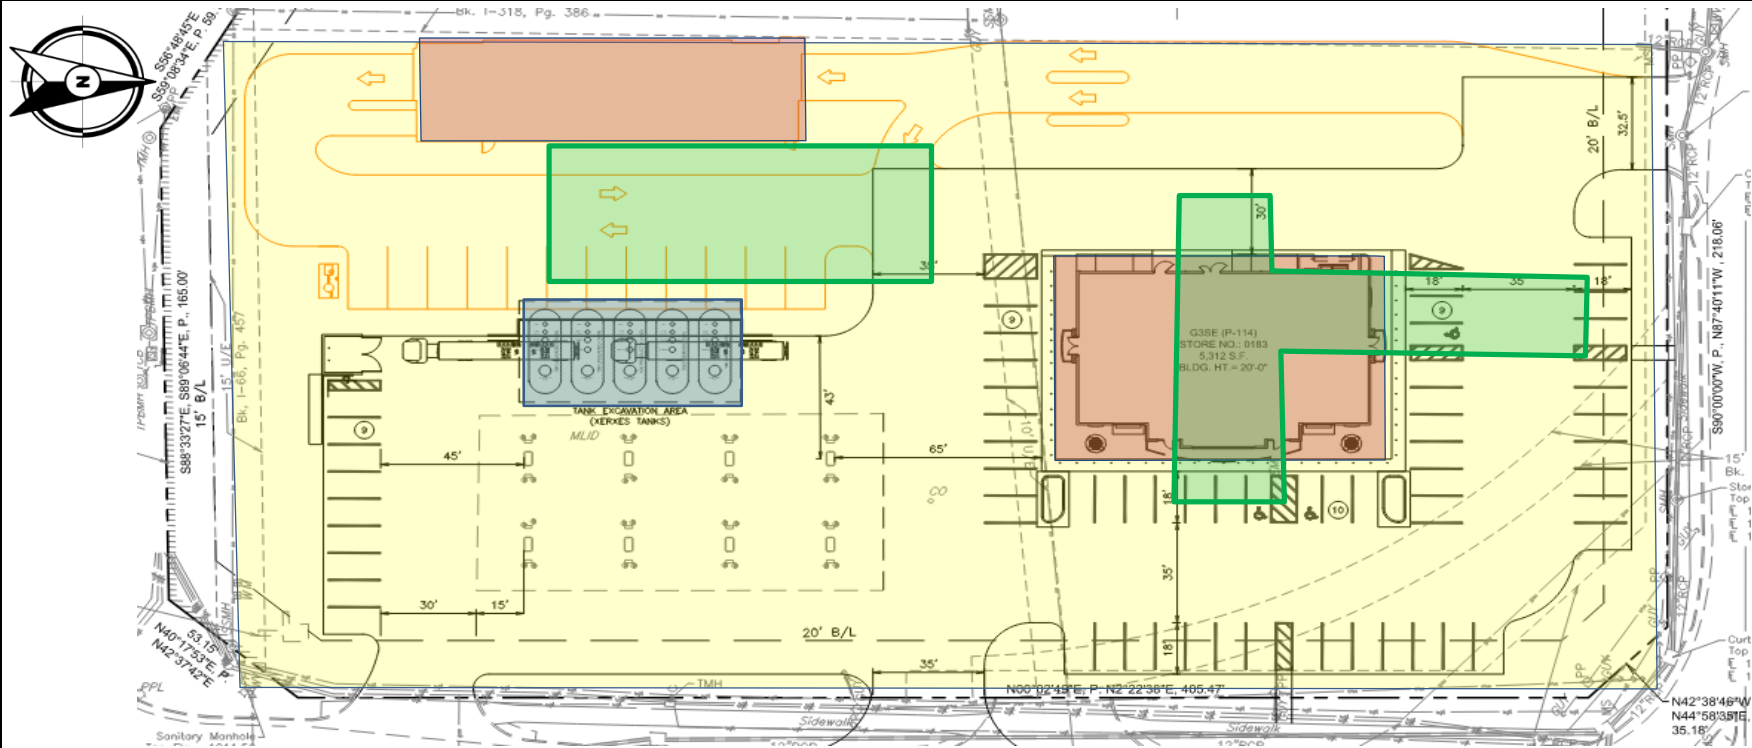
A-3

- The contractor shall undercut within the planned building footprint, allowing for the placement of a minimum of 42 inches of LVC material. The LVC fill should extend a minimum of 3 feet outside the wall lines.
- After initial grading, a geotechnical representative shall evaluate any remaining existing fill. The contractor shall remove unsuitable fill and replaced with new engineered fill.
- Tank pit excavation will likely extend through overburden clay soils and into underlying bedrock comprised of shale with limestone seams. The contractor will likely require pneumatic breakers to complete the tank excavation.
- Approximate location of existing structures. Following demolition, a geotechnical representative should evaluate the exposed subgrade for the presence of debris and disturbed soils.

The clay soils encountered across the project site have a moderate to high volume change potential, characterized by their ability to undergo volume change (shrink/swell) with changes in moisture content. Changes in soil moisture may cause unacceptable settlement or heave of on-grade slabs supported on these materials. Per QuikTrip's standard construction procedures, we recommend placing a minimum of 42 inches (6 inches below foundation bearing elevation) of low volume change (LVC) soil below the proposed footing of the QuikTrip building and carwash. The contractor should place the LVC fill in accordance with Section C.5, extending the LVC fill a minimum of 3 feet outside the building wall lines.

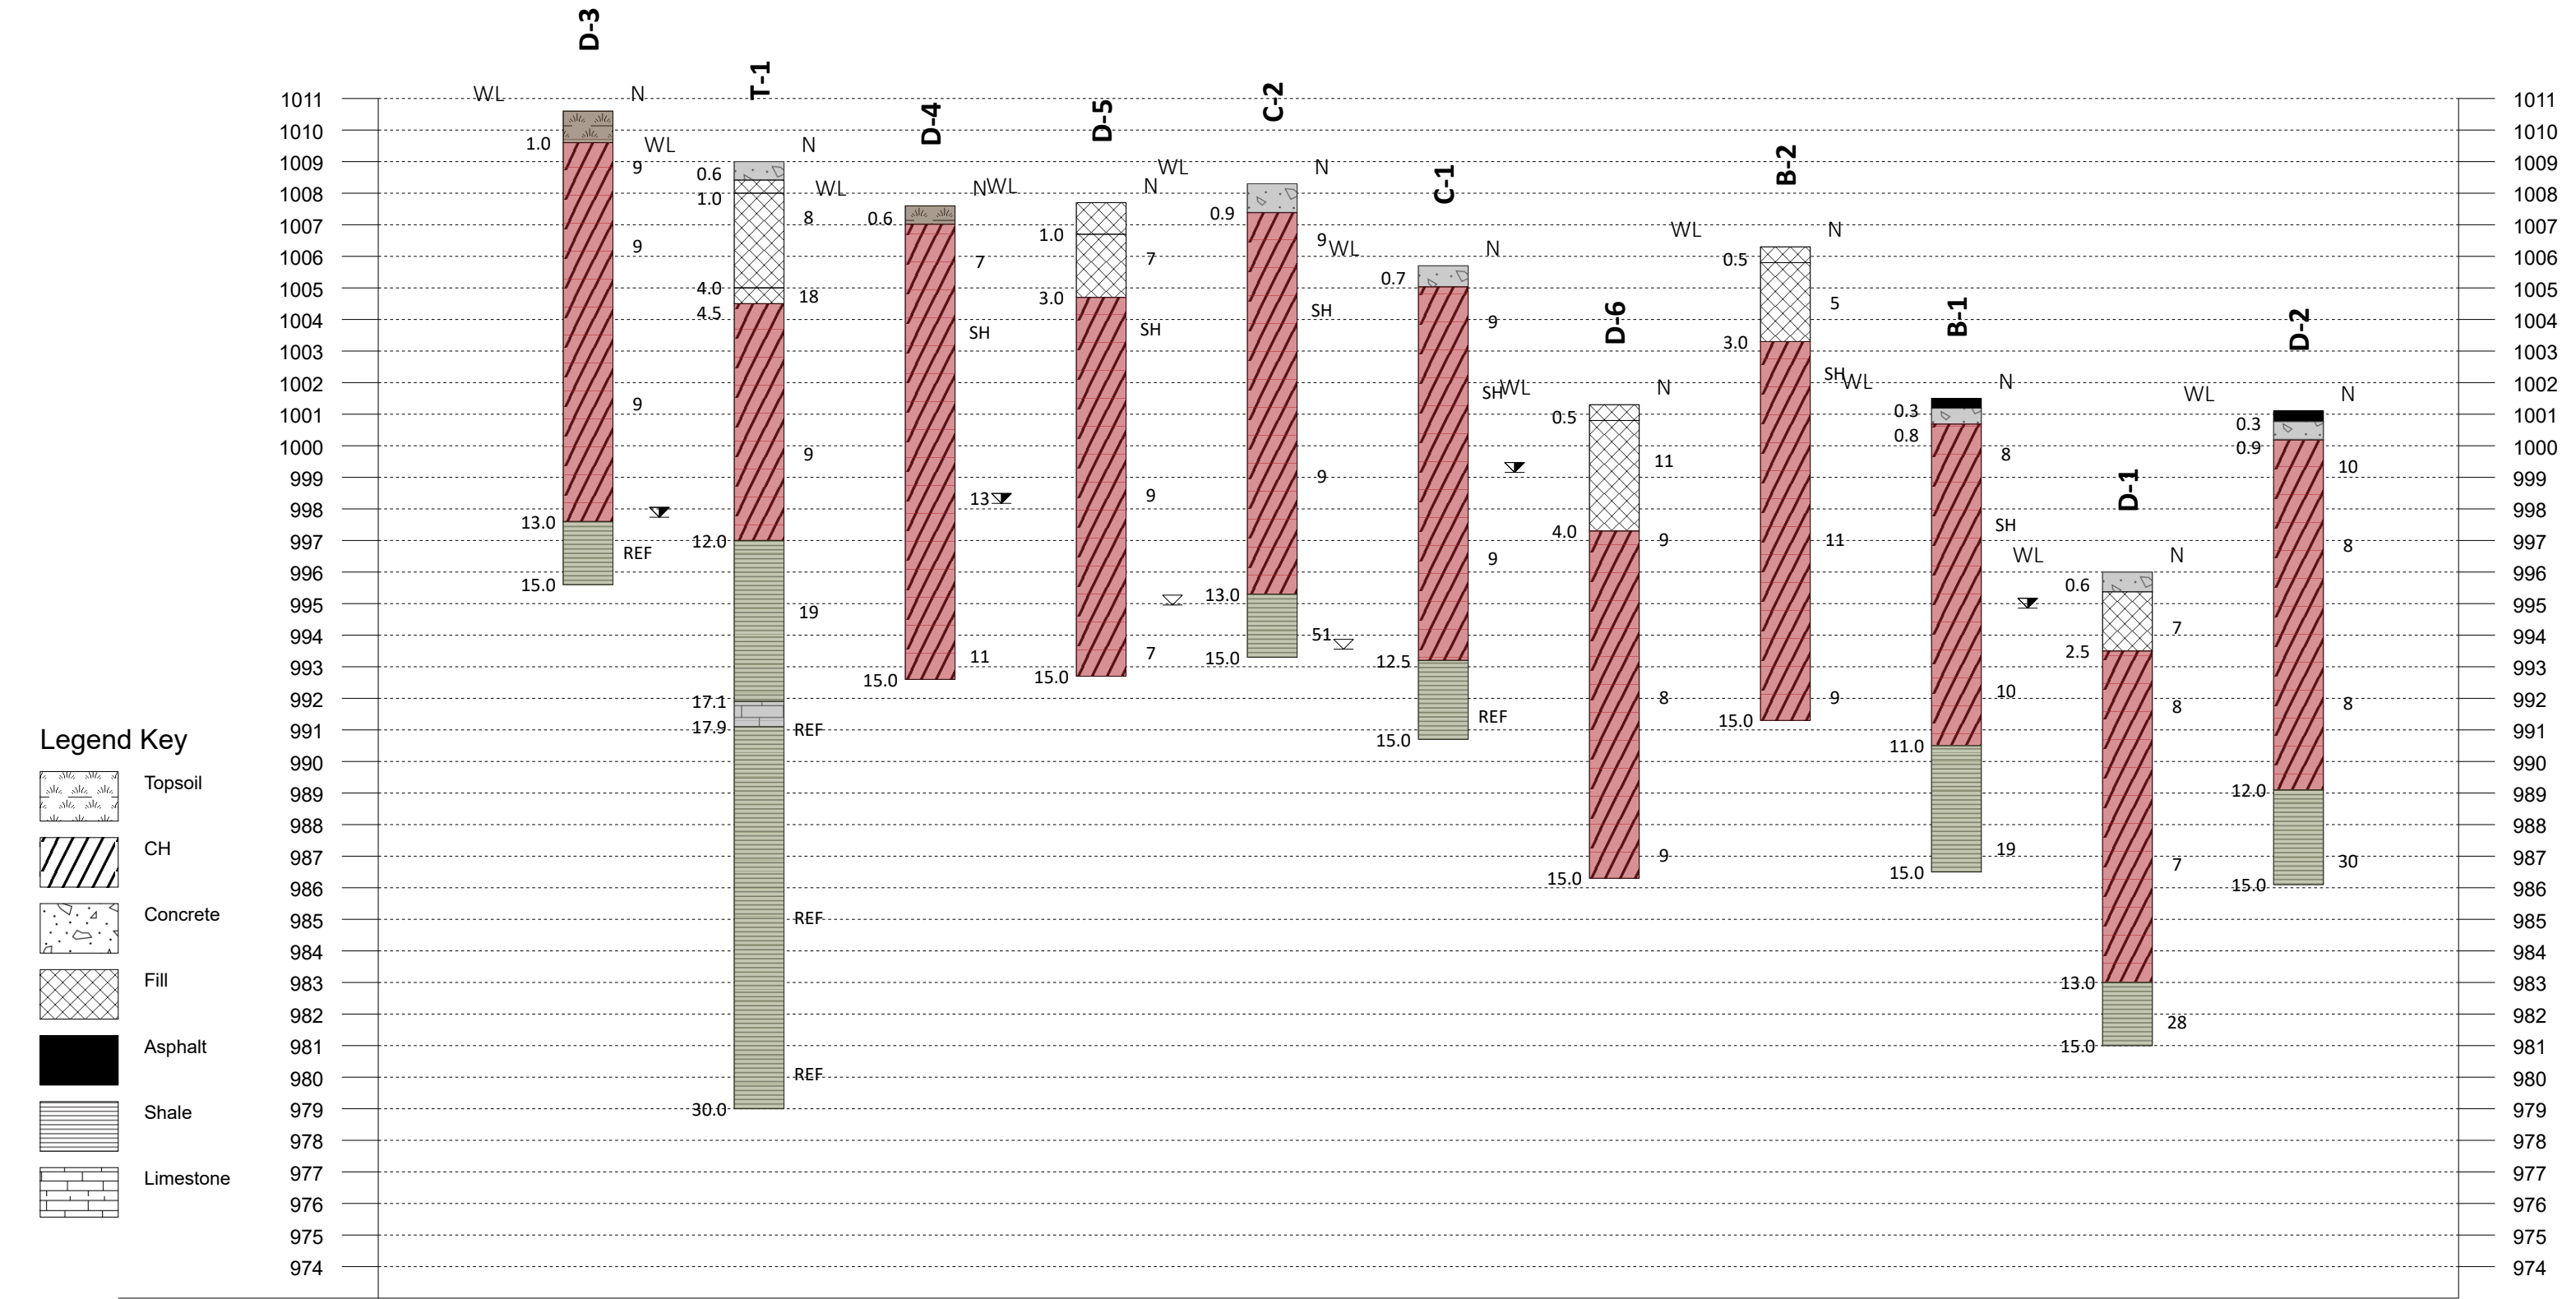
Figure A-4: Subsurface Profile

Strata	Soil Type - ASTM Classification	Test Results	Commentary and Details
Native Clay	CH	N-value = 7 to 13 bpf MC = 19 to 31% UCS = 0.9 to 3.3 tsf DD = 92 to 104 pcf	<ul style="list-style-type: none"> Encountered below existing fill or surficial material in all borings Continued to termination depths at Borings B-2, D-4, D-5, and D-6 Generally exhibited medium to stiff consistencies Moisture condition moist
Shale	N/A	N-value = 19 bpf to 50 for 3 inches MC = 12 to 23%	<ul style="list-style-type: none"> Encountered below native soils at depths of 11 to 13 feet at Borings B-1, C-1, C-2, D-1 through D-3, D-6, and T-1 Top of rock elevation appears to slope down from south to north, ranging from approximate elevation 997 1/2 feet to 983 feet Highly weathered and soft near interface with overburden soils, generally becoming less weathered and harder with depth Approximate 9-inch thick limestone seam encountered in Boring T-1 at approximate depth of 17 feet Shale continued to boring termination depths

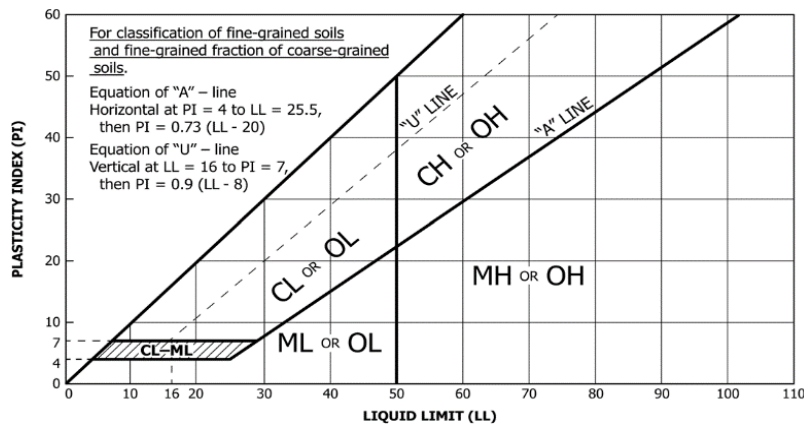
L. If soil contains $\geq 30\%$ plus No. 200, predominantly sand, add "sandy" to group name.
M. If soil contains $\geq 30\%$ plus No. 200 predominantly gravel, add "gravelly" to group name.

N. PI ≥ 4 and plots on or above "A" line.
O. PI < 4 or plots below "A" line.
P. PI plots on or above "A" line.
Q. PI plots below "A" line.
