Stormwater Pollution Prevention Plan Inspection Report

Project Name and Location: Blackwell

Weather: 47	<input type="checkbox"/> Cloudy <input checked="" type="checkbox"/> Sunny <input type="checkbox"/> Rain <input type="checkbox"/> Snowing/ Snow cover
Date of inspection: 10/30/25	
Inspectors Name: Jessica Ekster	
Type of Inspection: <input type="checkbox"/> Regular <input checked="" type="checkbox"/> Rain event <input type="checkbox"/> Other:	
Rain in last 24 hrs (inches): .79"	
Owner/Permittee: Griffin Riley	
Current Site Condition: Active

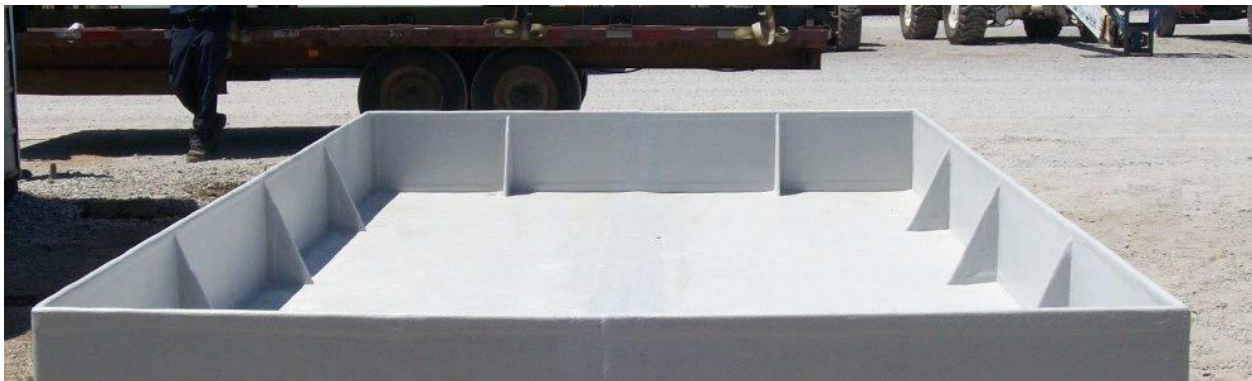
Examples of fuel tanks in secondary containments.

BMP	Location	Observation, Effectiveness, & Corrective Actions Ordered
Silt fence/EC	Residential	Need to install silt fence or wattles along curb
Fuel Tank	On SE Wood Lane	Is fuel tank onsite double walled? If not, the tank needs to be removed from the site or placed in a secondary containment. An example is pictured below. ALSO fuel tanks can not be near stormboxes
Porta Potty	On Inlets	Porta Pottys on top of inlets need removed and placed 20' away from any inlet.
