Stormwater Pollution Prevention Plan Inspection Report

Project Name and Location: Blackwell

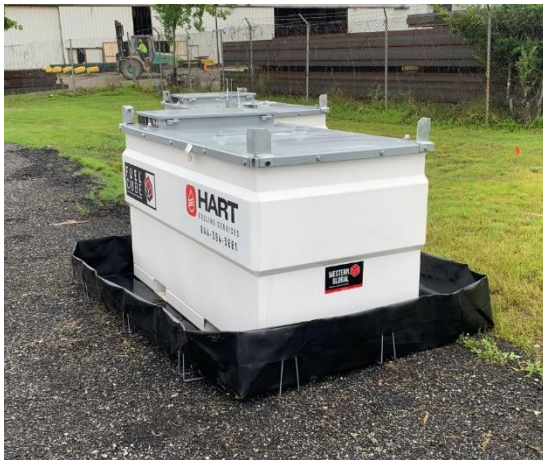
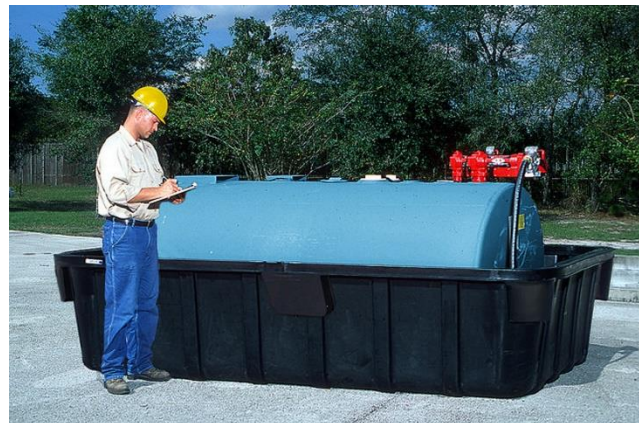
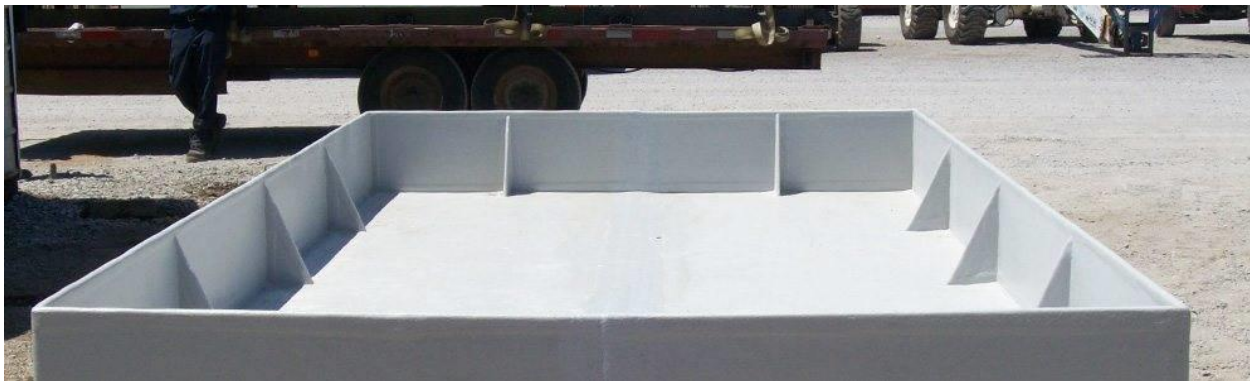
Examples of fuel tanks in secondary containments.

BMP	Location	Observation, Effectiveness, & Corrective Actions Ordered
Silt fence/EC	Residential	Need to install silt fence or wattles along curb
Fuel Tank	On SE Wood Lane	Is fuel tank onsite double walled? If not, the tank needs to be removed from the site or placed in a secondary containment. An example is pictured below. ALSO fuel tanks can not be near stormboxes
Porta Potty	On Inlets	Porta Pottys on top of inlets need removed and placed 20' away from any inlet.
Silt fence	Along curbs	Repair silt fence along various areas of curb
