**GEOTECHNICAL EXPLORATION  
PROPOSED JOINT OPERATIONS FACILITY  
NE TUDOR ROAD AND NW SLOAN  
LEE'S SUMMIT, MISSOURI**

Prepared for:  
**CITY OF LEE'S SUMMIT, MISSOURI**

Prepared by:  
**GEOTECHNOLOGY, LLC, DBA UES  
OVERLAND PARK, KANSAS**

UES Project No.:  
**J045326.01**

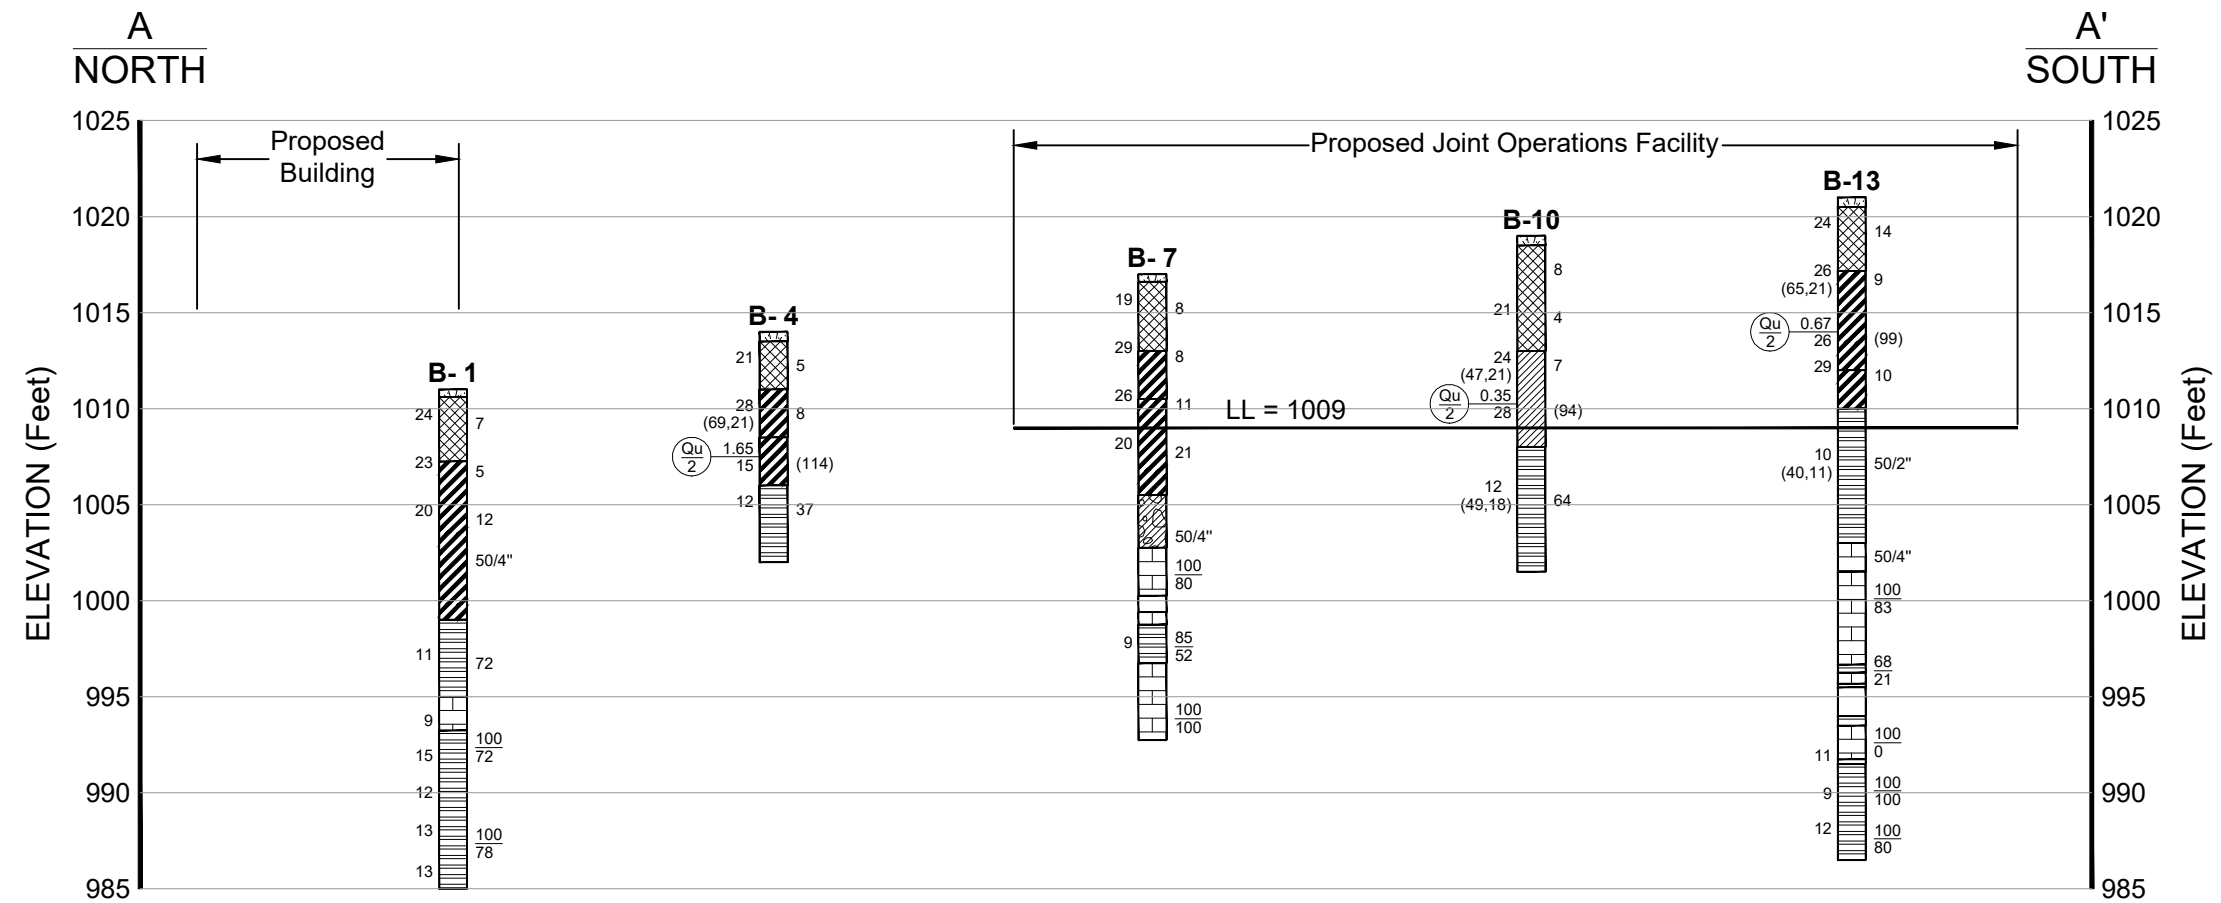
Drawn By: WAH	Ck'd By: MHM	App'vd By: JAW
Date: 5-2-24	Date: 5-3-24	Date: 5-13-24
Joint Operations Facility NE Tudor Road and NW Sloan Lee's Summit, Missouri		
<b>GENERALIZED SUBSURFACE PROFILE A-A'</b>		
Project Number J045326.01	<b>FIGURE 3</b>

- See Figure 2 for location of Generalized Subsurface Profile A-A'.
- Data concerning subsurface conditions were obtained at boring locations only. Actual conditions at locations between borings could differ from the generalized profile shown here.

**SCALE IN FEET**  
 Horizontal 1" = 40'  
 Vertical 1" = 10'

Generalized subsurface profiles are given on Figures 3 through 5. These profiles depict general subsurface conditions across the site from north to south. Actual conditions at locations between the borings might differ from the generalized subsurface profiles.

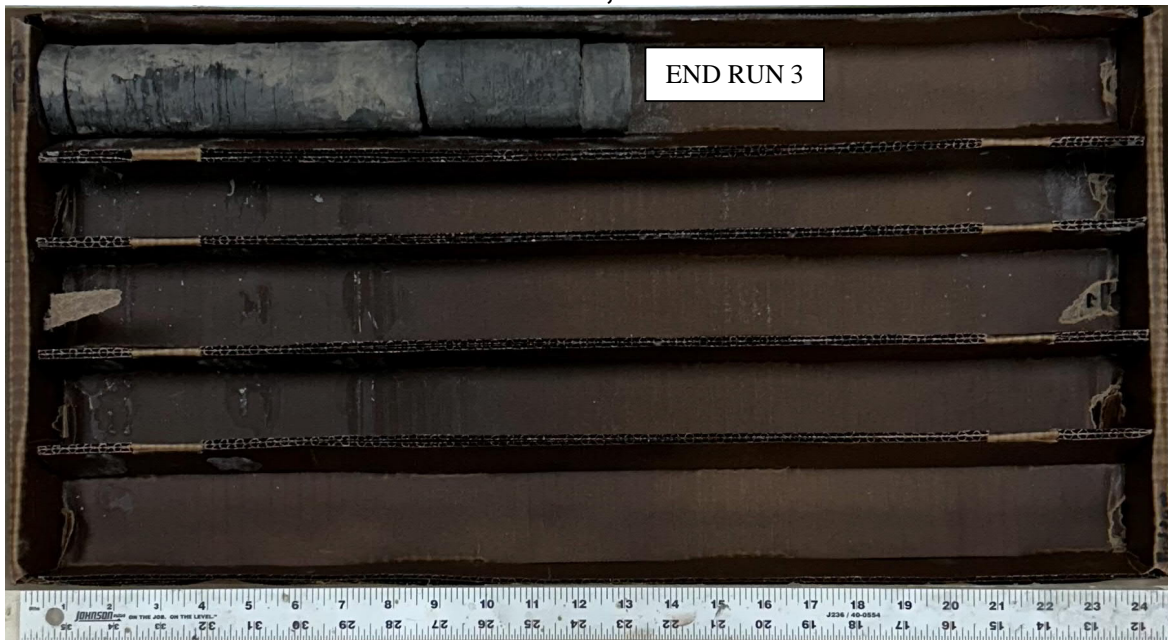
B-7

<u>Run No.</u>	<u>Depth (ft)</u>	<u>Recovery (%)</u>	<u>RQD (%)</u>
3	Cont. – 20.75	100	95

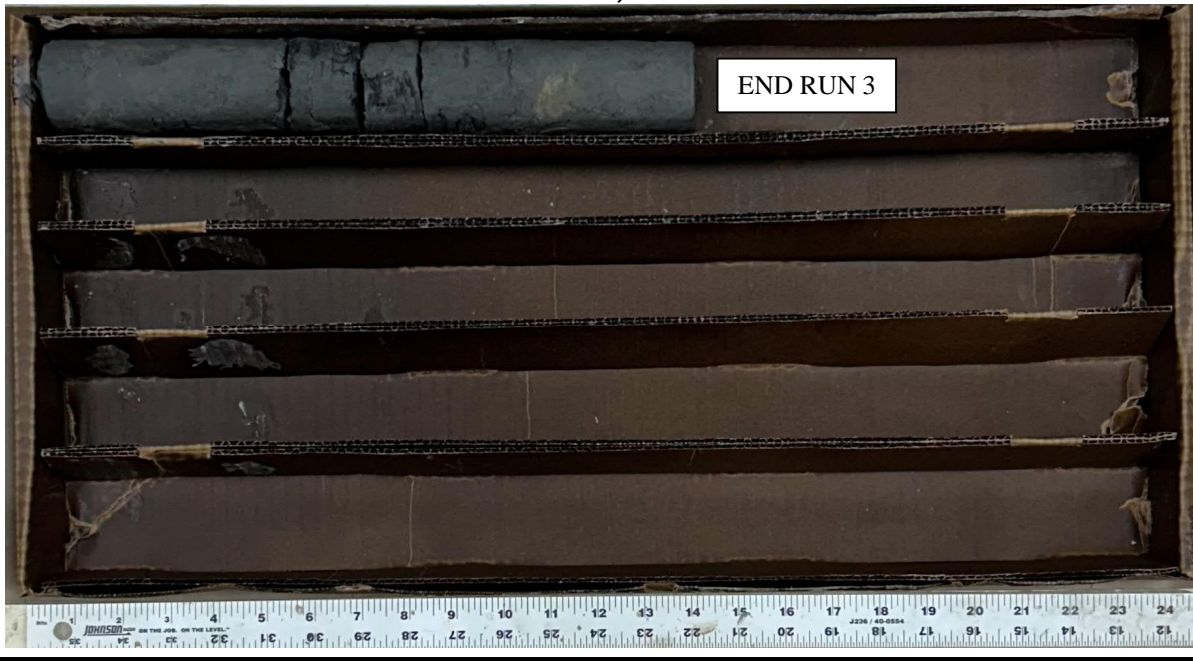
B-11

<u>Run No.</u>	<u>Depth (ft)</u>	<u>Recovery (%)</u>	<u>RQD (%)</u>
3	Cont. – 24.5	100	78
