Re: Property @  
1340 NE Brandywine Road  
Lee's Summit, MO

On August 3, 2017 I inspected the deck framing at the above referenced property. The deck is attached to the rear of the house by attaching a ledger board to the rim board at the rear wall.

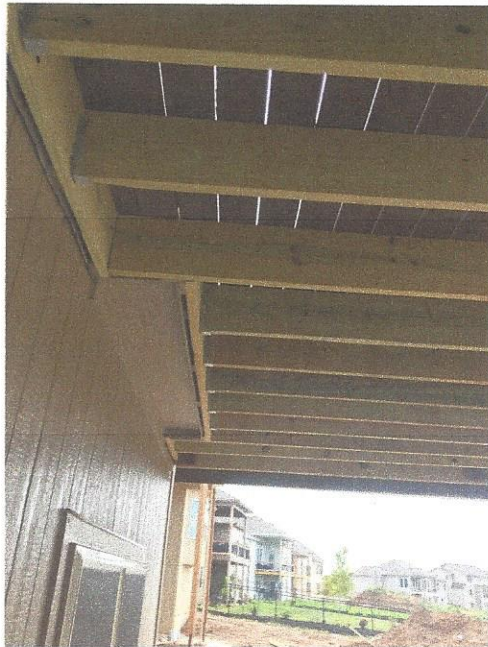
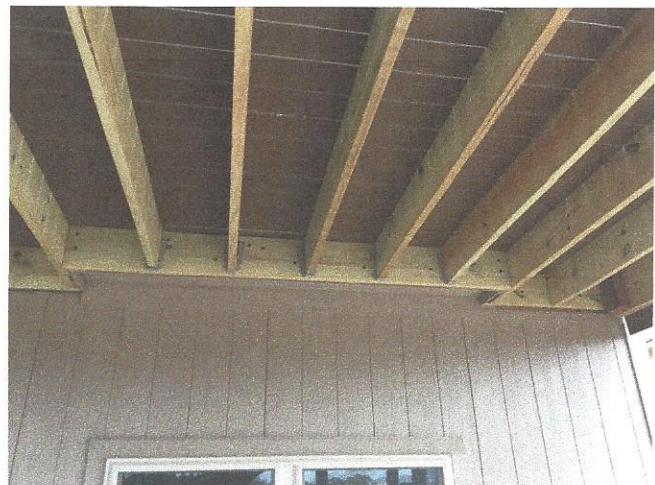
As shown in the photos above, a portion of the deck is attached to a 1' overhang. Generally, decks should not be attached to overhangs because there is no support directly under the rim board and this could cause the rim board to pull away since the only support is nails through the rim board into the overhang joists. In this case, the deck is attached to the rim board with

Ledger-Lok fasteners on both sides of the 8' wide overhang. This prevents the rim board at the overhang from pulling away from the ends of the overhang joists. The nails are adequate to support the vertical load from the deck. I recommend that you install 3 Ledger-Lok fasteners from the joist on each side of the overhang into the ends of the deck ledger board to provide additional support.

With the addition of the Ledger-Lok fasteners as described above, the deck as framed will support the imposed loads. I would recommend that future decks in areas with overhangs be supported either by support posts or by framing an opening around the overhang with double joists on each side and a double "ledger board" framed in between the double joists with joist hangers.
