To: Mark Westhues
From: John Funk, PE
Subject: Structural Inspection Concerns – 3rd Street White Box

**Re: 510 SW 3rd St. -Weld Inspection Report
Lee's Summit, MO**

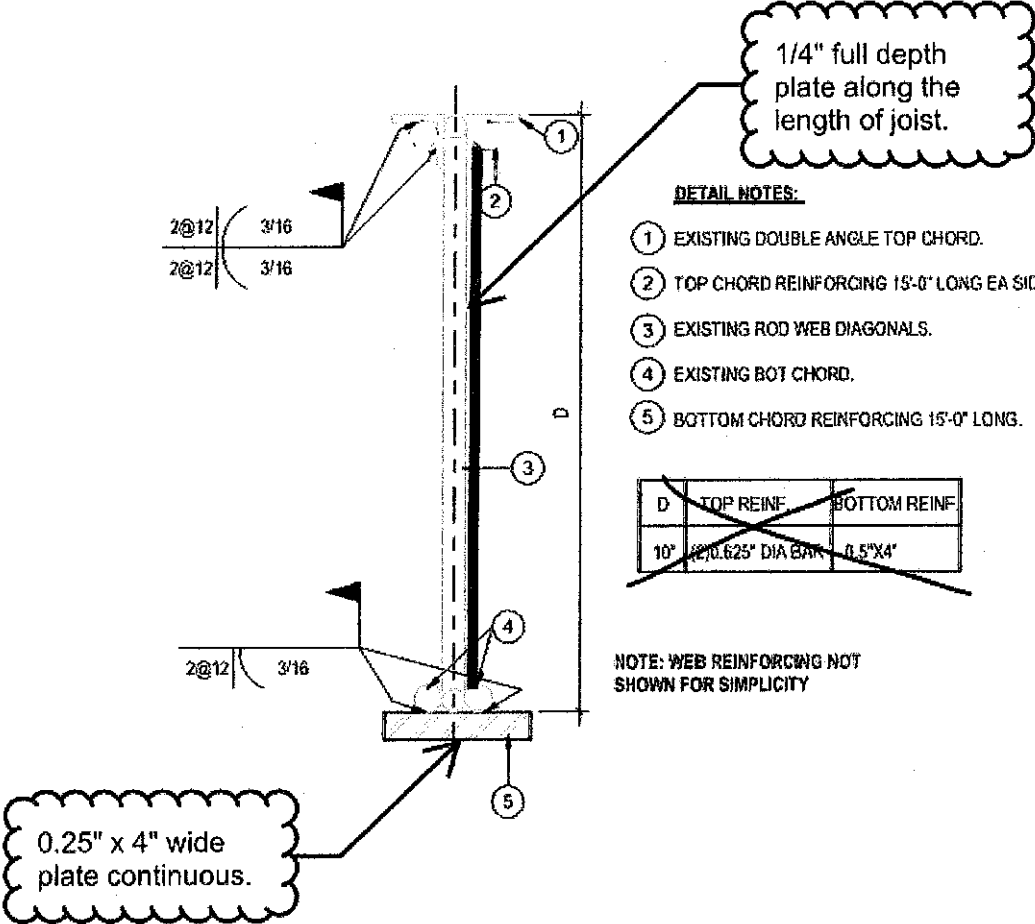
5

JOIST CHORD REINFORCEMENT

We understand that the 3rd party inspector is needing documentation regarding the additional joist web reinforcement shown in details 3/S101 and 6/S101. The steel erector has forwarded pictures for our review. Based on those photos, the channels are located close enough to the joist panel point that the angle reinforcement is not required.
