Re: Property @
153 NW Carson Dr
Lee's Summit, MO.
Framing Issue

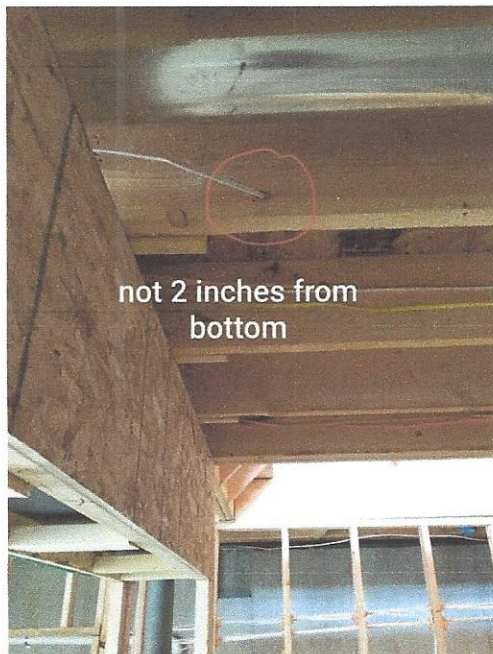
The Building Inspector has pointed out that the electrician has drilled holes in floor joists that are within 2" of the bottom of the joists. A photo of this condition is provided below:

To correct this condition you should install a 1.5" wide x about 18" long metal strap at the bottom of the floor joist approximately centered under the hole that was drilled by the electrician. This will strengthen the bottom of the joist and more than make up for any strength lost by drilling the hole.
