**Client:** Hy-Vee Construction  
**Project:** Hy-Vee – Lee's Summit #2 Remodel

**Re:** Reports and Test Results

## Daily Field Notes

## VISUAL EXAMINATION REPORT

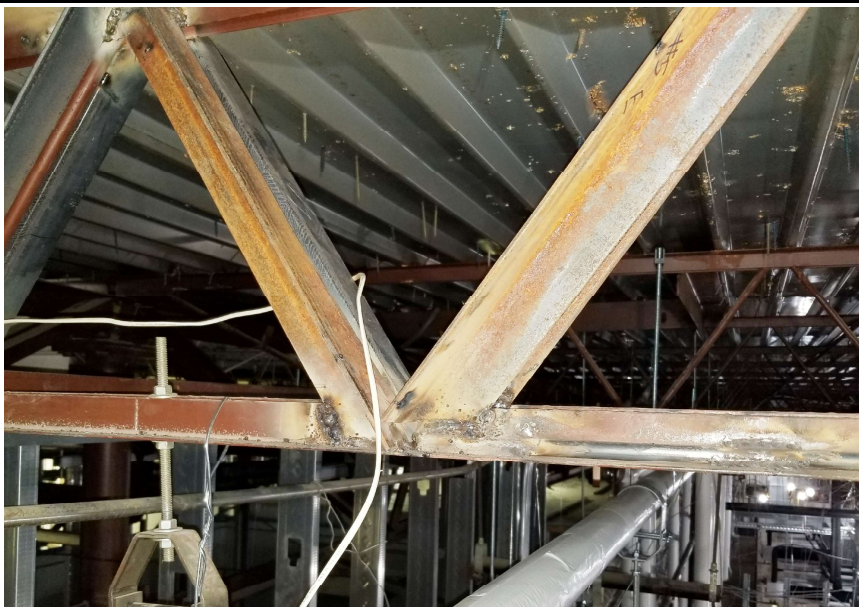
### **Photo 1**

Discrepancy #1: Bar Joist JR5 at grid 5: 1/2" round bar does not extend 8" past panel point but rather stops at the panel point. EOR has approved this discrepancy in attached email=Satisfactory.

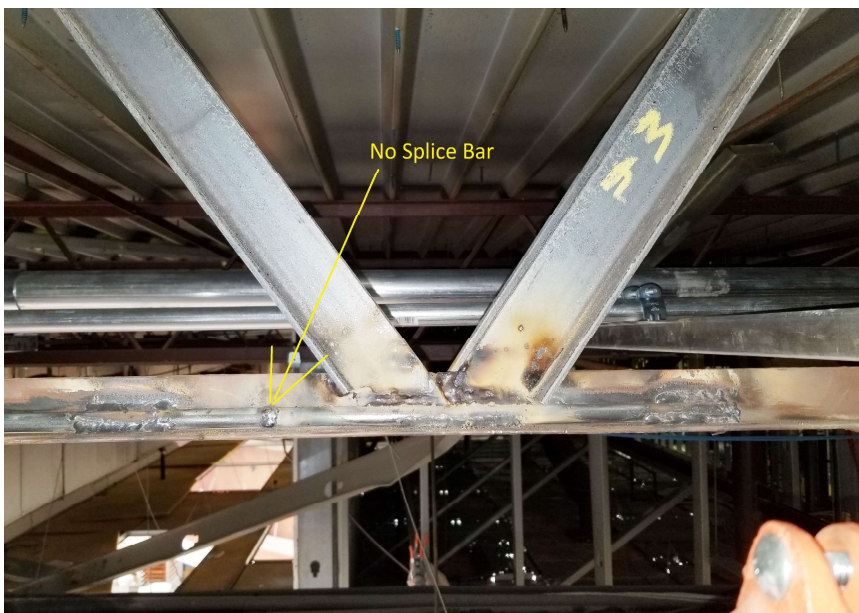
### **Photo 2**

Discrepancy #2: 2-Bar Joist JR5 at grids 4.3 and 4.4 west end. No splice bars were added to splice where additional 1/2" x 12" long round bar was added to bring reinforcing 8" past panel point. Approved drawing requires 12" splice bars at all splices. However, EOR has approved this discrepancy as is=Satisfactory.
