HD Engineering & Design

Re: Solaia (HFR054)
2808 SW Hearthstone Place
Lee's Summit, MO

OVER-CUT RAFTER SEAT REPAIR

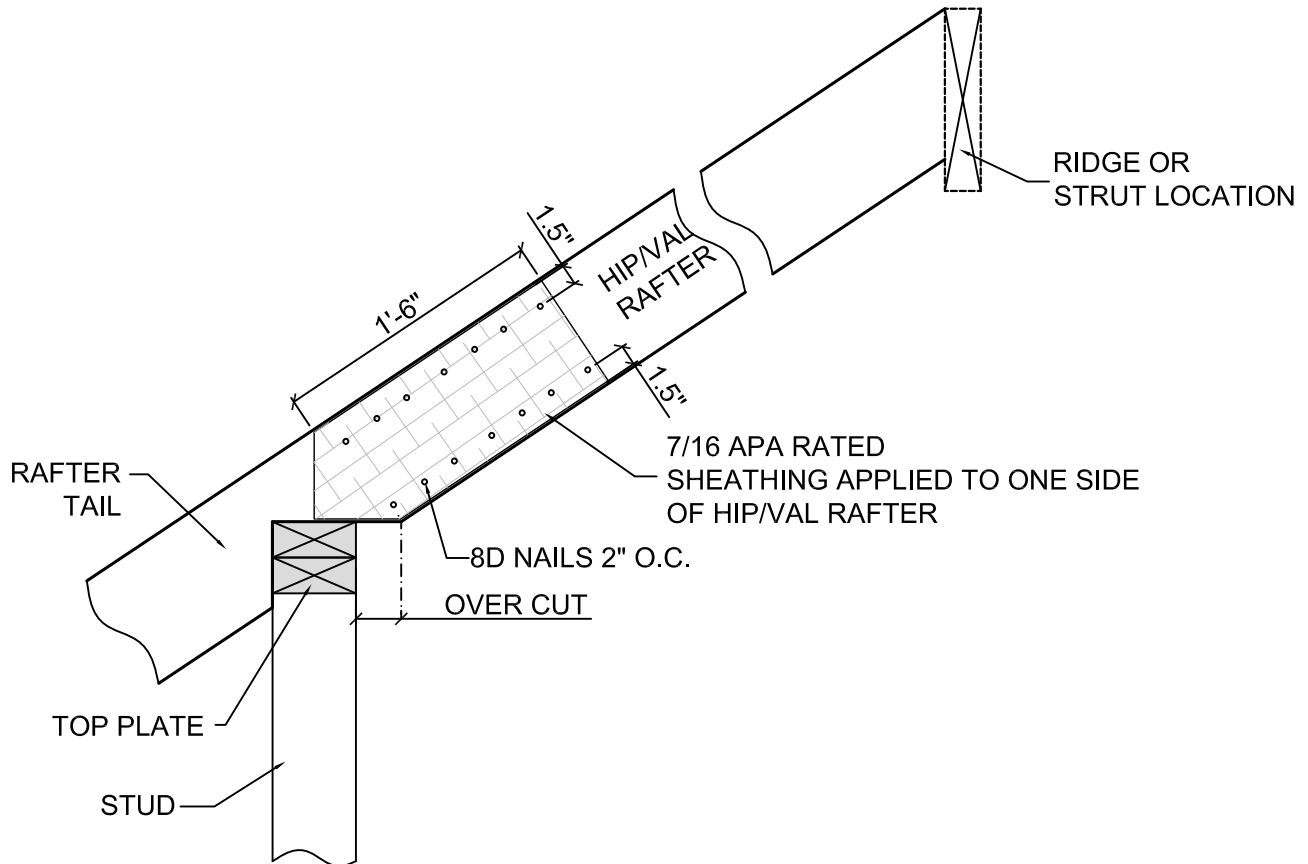
The framer has over-cut the seats of the rafters at the Dining Room box vault and left inadequate bearing at the overframed beam. The unsupported portion of the seat cut requires additional reinforcing per the attached "OVER-CUT RAFTER SEAT REPAIR."

WALL LOCATION: DINING ROOM BOX VAULT
