# HD Engineering & Design

**Re: Solaia (HFR054)**  
**2808 SW Hearthstone Place**  
**Lee's Summit, MO**

## OVER-CUT RAFTER SEAT REPAIR

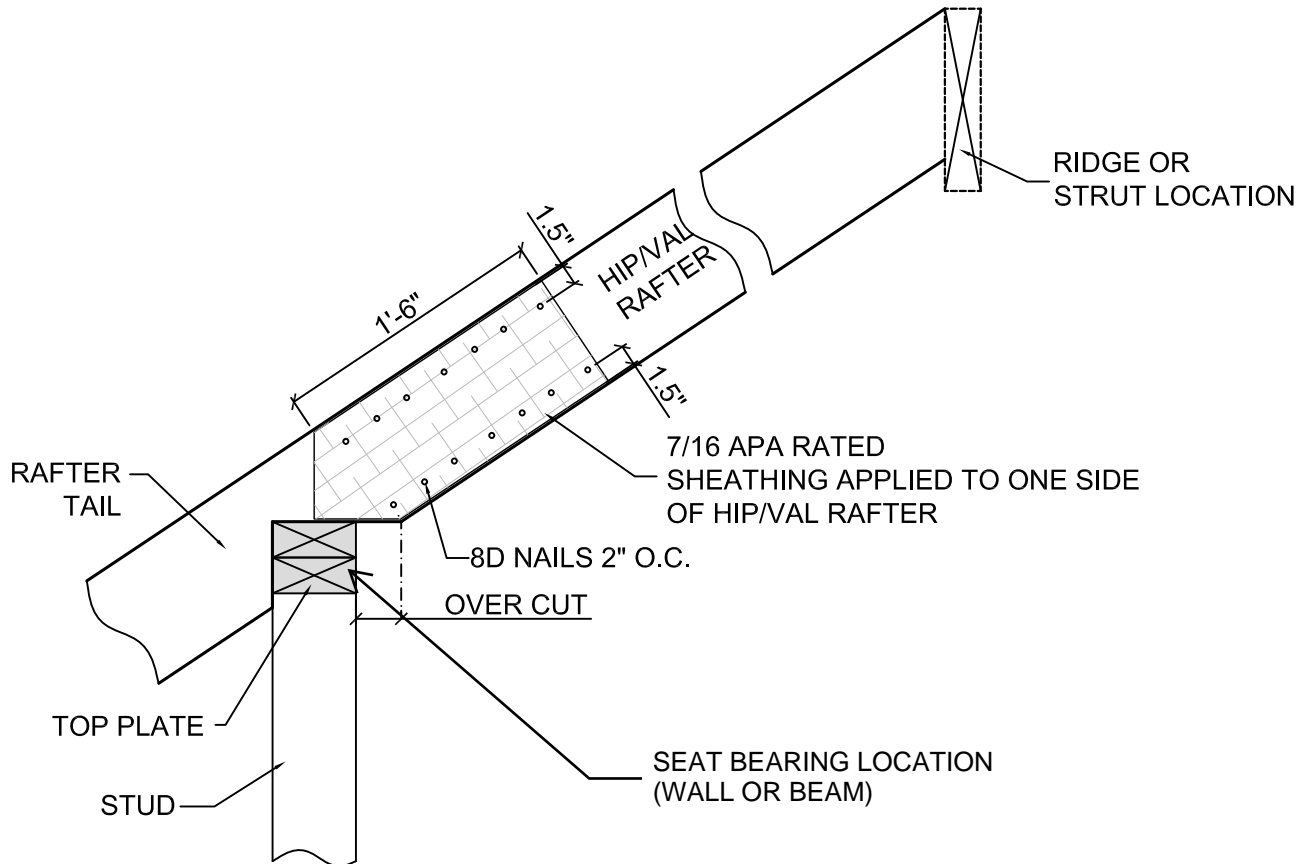
The framer has cut an additional seat cut on the hip and valley rafters at the dining room vault. To allow clearance at the vault the hip and valley now bear on the box vault. The depth of the hip and valley rafter have caused an over-cut seat. To allow the hip and valley rafter to transfer load as intended the rafters will be reinforced at the vault bearing location as shown on the attached repair sketch. The remaining tail section to the wall is adequate as is.
