# HD Engineering & Design

**Re: Solaia (HFR054)**  
**2808 SW Hearthstone Place**  
**Lee's Summit, MO**

### **Over-cut Rafter Seats**

## OVER-CUT RAFTER SEAT REPAIR

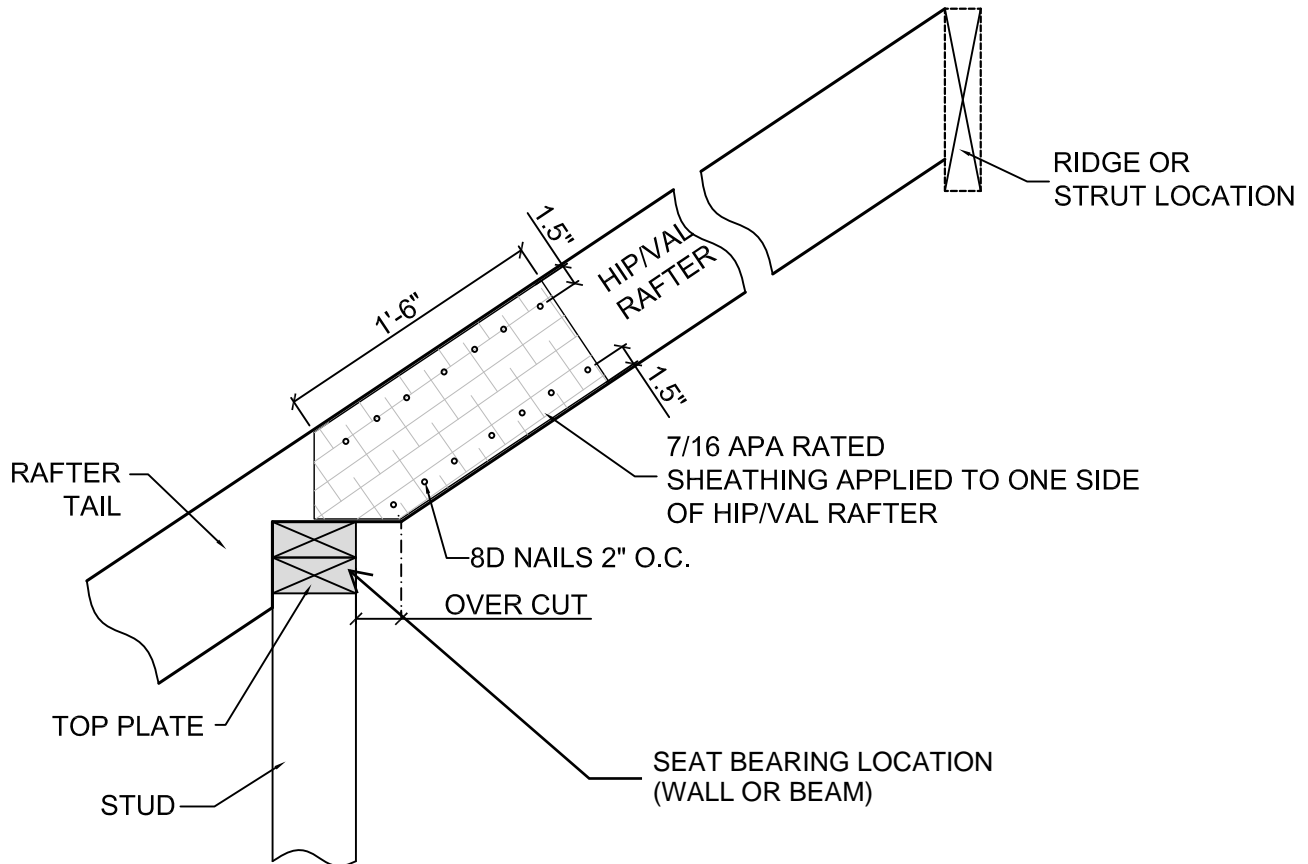
The framer has cut an additional seat cut on the hip and valley rafters at the dining room vault. To allow clearance at the vault the hip and valley now bear on the box vault. The depth of the hip and valley rafter have caused an over-cut seat. To allow the hip and valley rafter to transfer load as intended the rafters will be reinforced at the vault bearing location as shown on the attached repair sketch. The remaining tail section to the wall is adequate as is.
