Re: 2206 SW Red Barn Ln  
Lee's Summit, MO  
Hook Farms Lot 56  
Damaged Concrete @ Garage Door Inspection

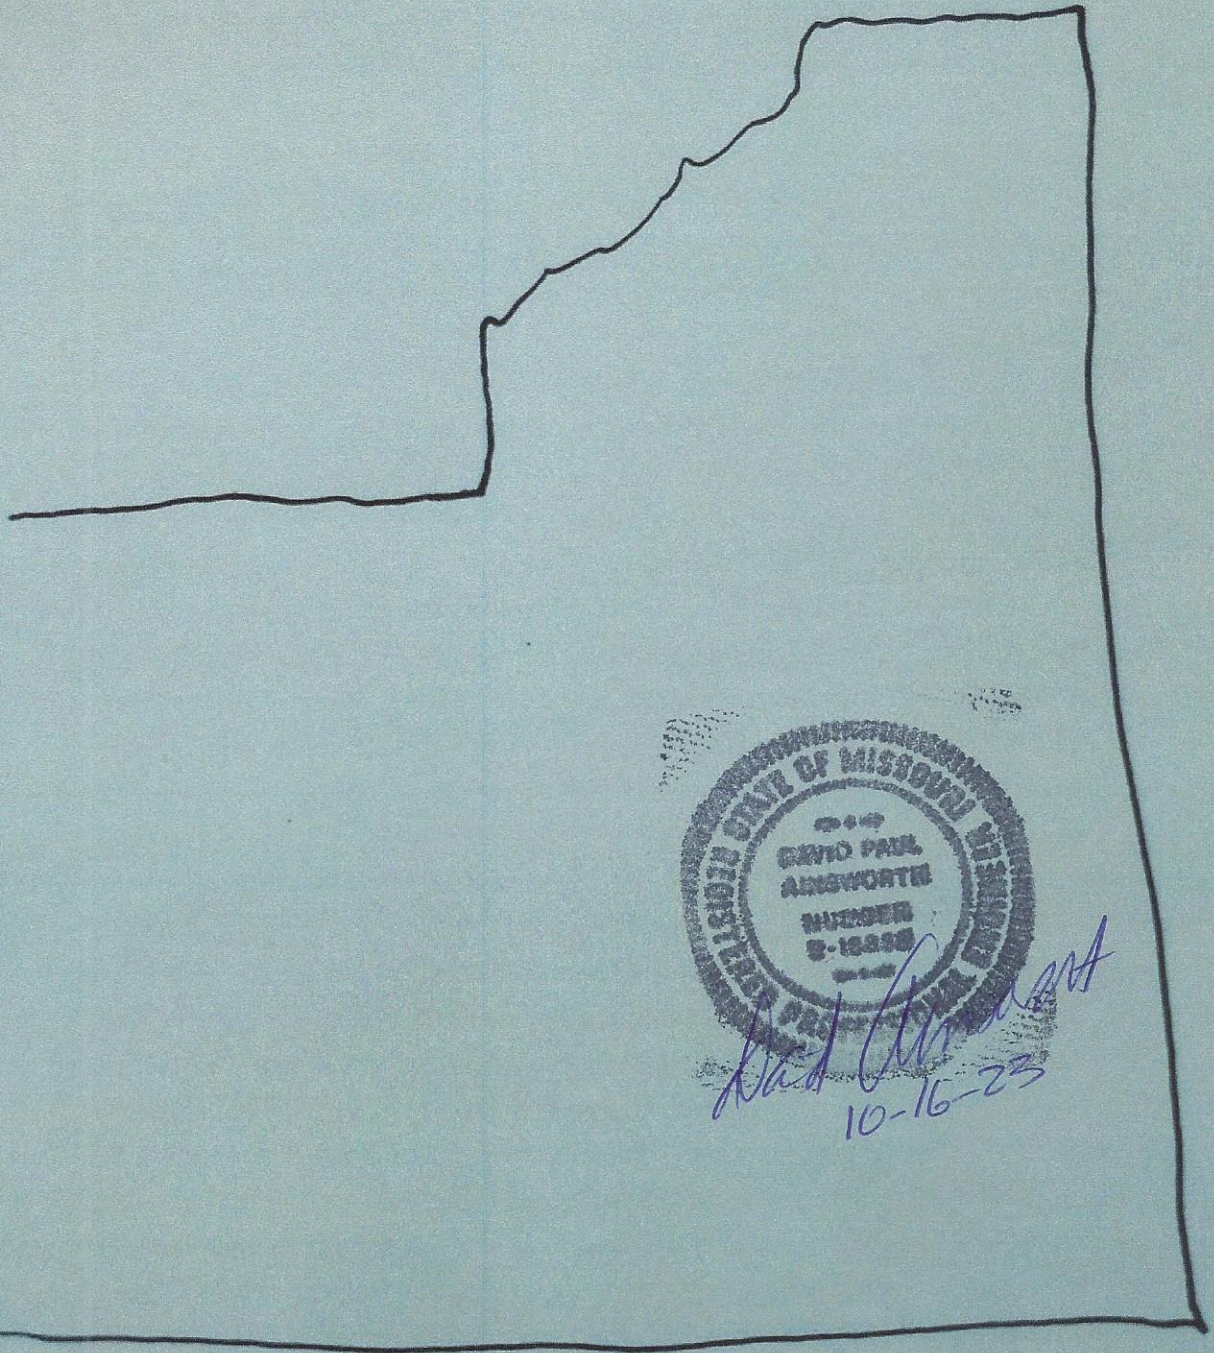
On October 3, 2023, I inspected the damaged concrete at the garage door opening at the above referenced property. When backfilling the garage area the equipment operator hit the lower right hand corner and broke a chunk of concrete off.

BROKE WALL

To repair this damage you should saw cut the sections out and pin #4 rebar into existing form and pour back in accordance with the attached sketches. This repair will provide adequate support for the damaged corner.

Repair

NEW  
Wind Strap

SAW CUT WALL
