## FIELD INSPECTION REPORT

Project: 2120 NW O'Brien Road, Lees Summit, MO 64081

Client: Pfeifer Homes Inc.

Date: 04/23/24 Time: 1:10 p.m. Weather: 80 ° F Clear

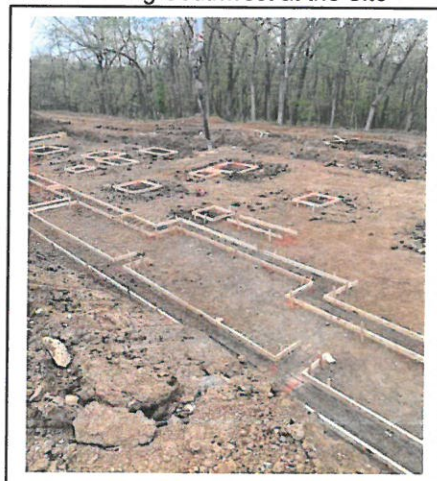
Looking Southwest at the Site

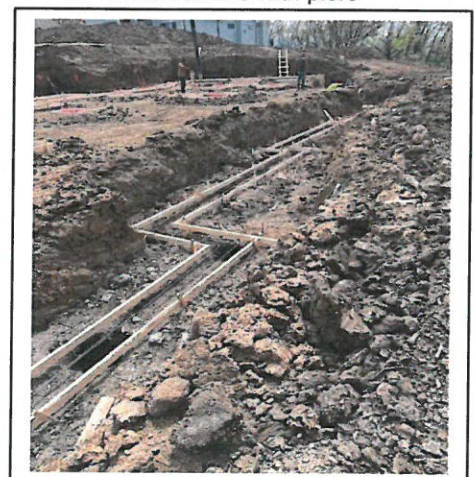
Upon arrival at the site all of the footing forms were in place. From a prior side visit, we knew that there was some soil bearing concerns on the west side and 18 piers were positioned along the west side as noted in the supplemental drawing. All the soils material tested greater were greater than 1,500 psf which is the minimum requirement soil bearing pressure.

West wall line with piers
