Stormwater Pollution Prevention Plan Inspection Report

Project Name and Location: Blackwell

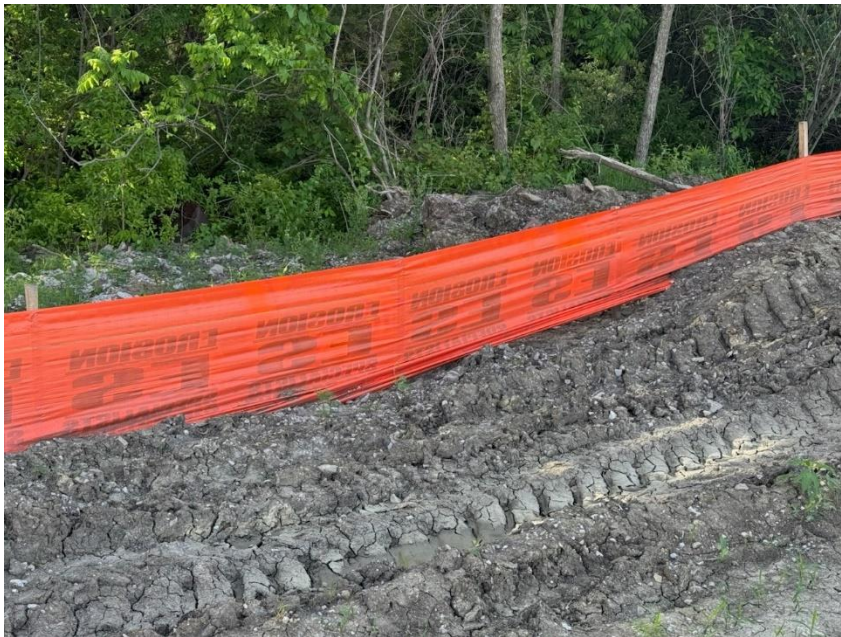
BMP	Location	Observation, Effectiveness, & Corrective Actions Ordered
Silt fence	Along curb	Repair a few areas where the fence has been damaged
Stabilize	In-active	Stabilize all areas that have been inactive for 14+ days- Weeds are not considered vegetation.
Stabilize	Swale	Stabilize swale on North end as soon as possible if work is done
Stabilize	Detention Ponds	Stabilize detention ponds asap- weeds are not considered vegetation
Silt fence	Detention Pond	Reset silt fence along detention pond behind Residences
Silt fence	Perimeter	Orange silt fence is not trenched in on East side of pond behind Residences- See picture below

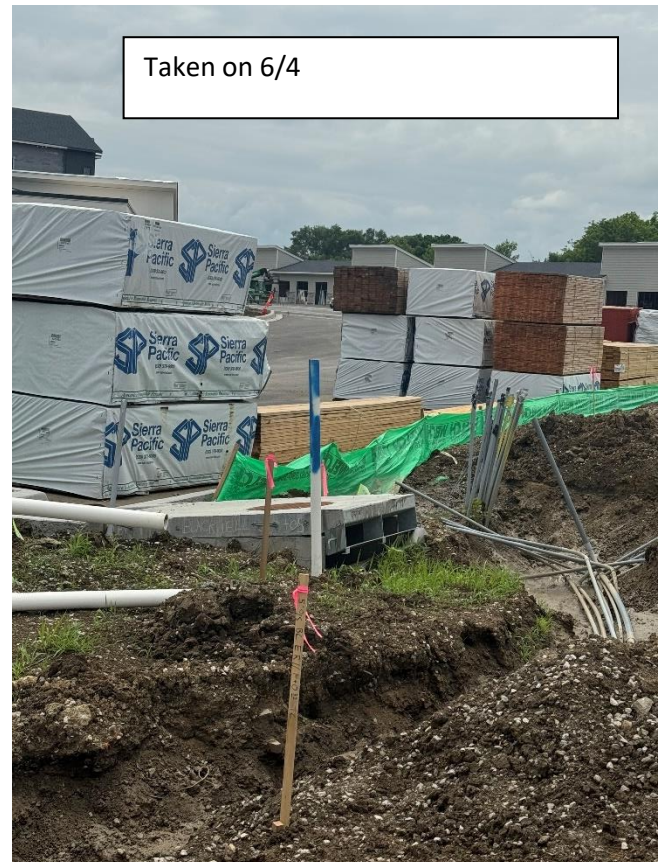
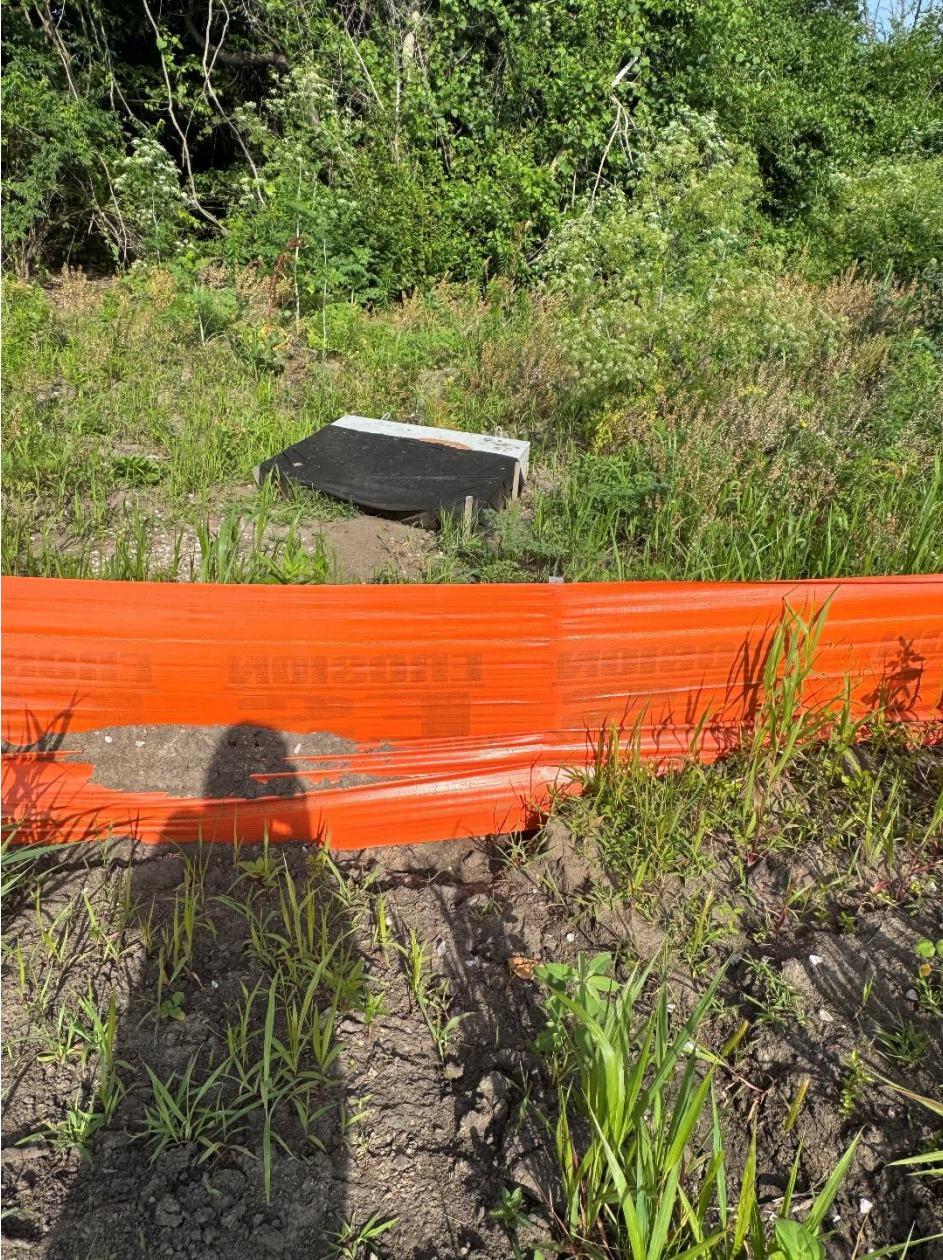
Taken on 6/16/25

BMP	Location	Observation, Effectiveness, & Corrective Actions Ordered
Field Inlet	NW corner	Remove built up silt around box and reset silt fence if needed
Concrete Washout	Throughout Site	Need more concrete washouts installed. Saw trucks cleaning out along curbs on 6/2
Grate Inlets	In soon to be alley	Need to protect grate inlets- install silt fence inside grate
Silt fence	Along backfilled curb	Install silt fence along backfilled curb throughout site
Inlet	Parking lot	Back side of inlet needs wrapped in silt fence. Parking lot of Residences- picture below
Inlet/Street	Various	Clean out various inlets, curbs, and streets throughout entire site
