Stormwater Pollution Prevention Plan Inspection Report

Project Name and Location: Ascend

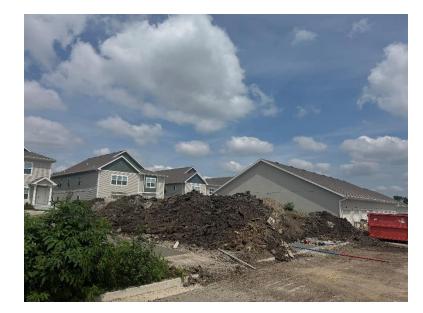
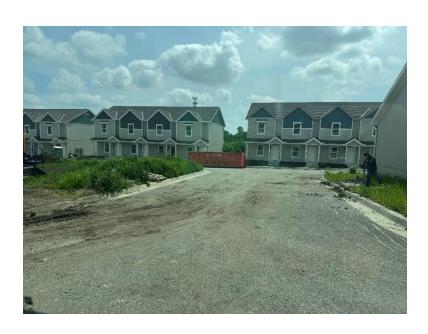
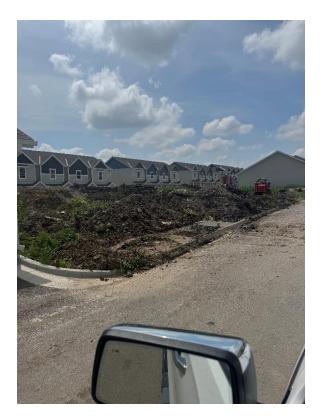
Taken on 6/16/25

ВМР	Location	Observation, Effectiveness, & Corrective Actions Ordered
Silt fence	East Perimeter	Replace silt fence
EC	Various	Install wattles along curbs
Streets	Various	Clean all streets and curbs- see pictures below
Stabilize	Sidewalk	Stabilize along upper detention pond/along sidewalk and reseed pond where silted in. Weeds do not count as stabilized
Inlets	Various	Clean inlets- see pictures below
Washout	Onsite	Need concrete washout on site

Have items noted on the last inspection been corrected? \boxtimes Yes \boxtimes No (if no explain): Welch was onsite cleaning streets, curbs, and inlets. Everything written up is new. Need to stabilize along sidewalks
