Stormwater Pollution Prevention Plan Inspection Report

Project Name and Location: Blackwell

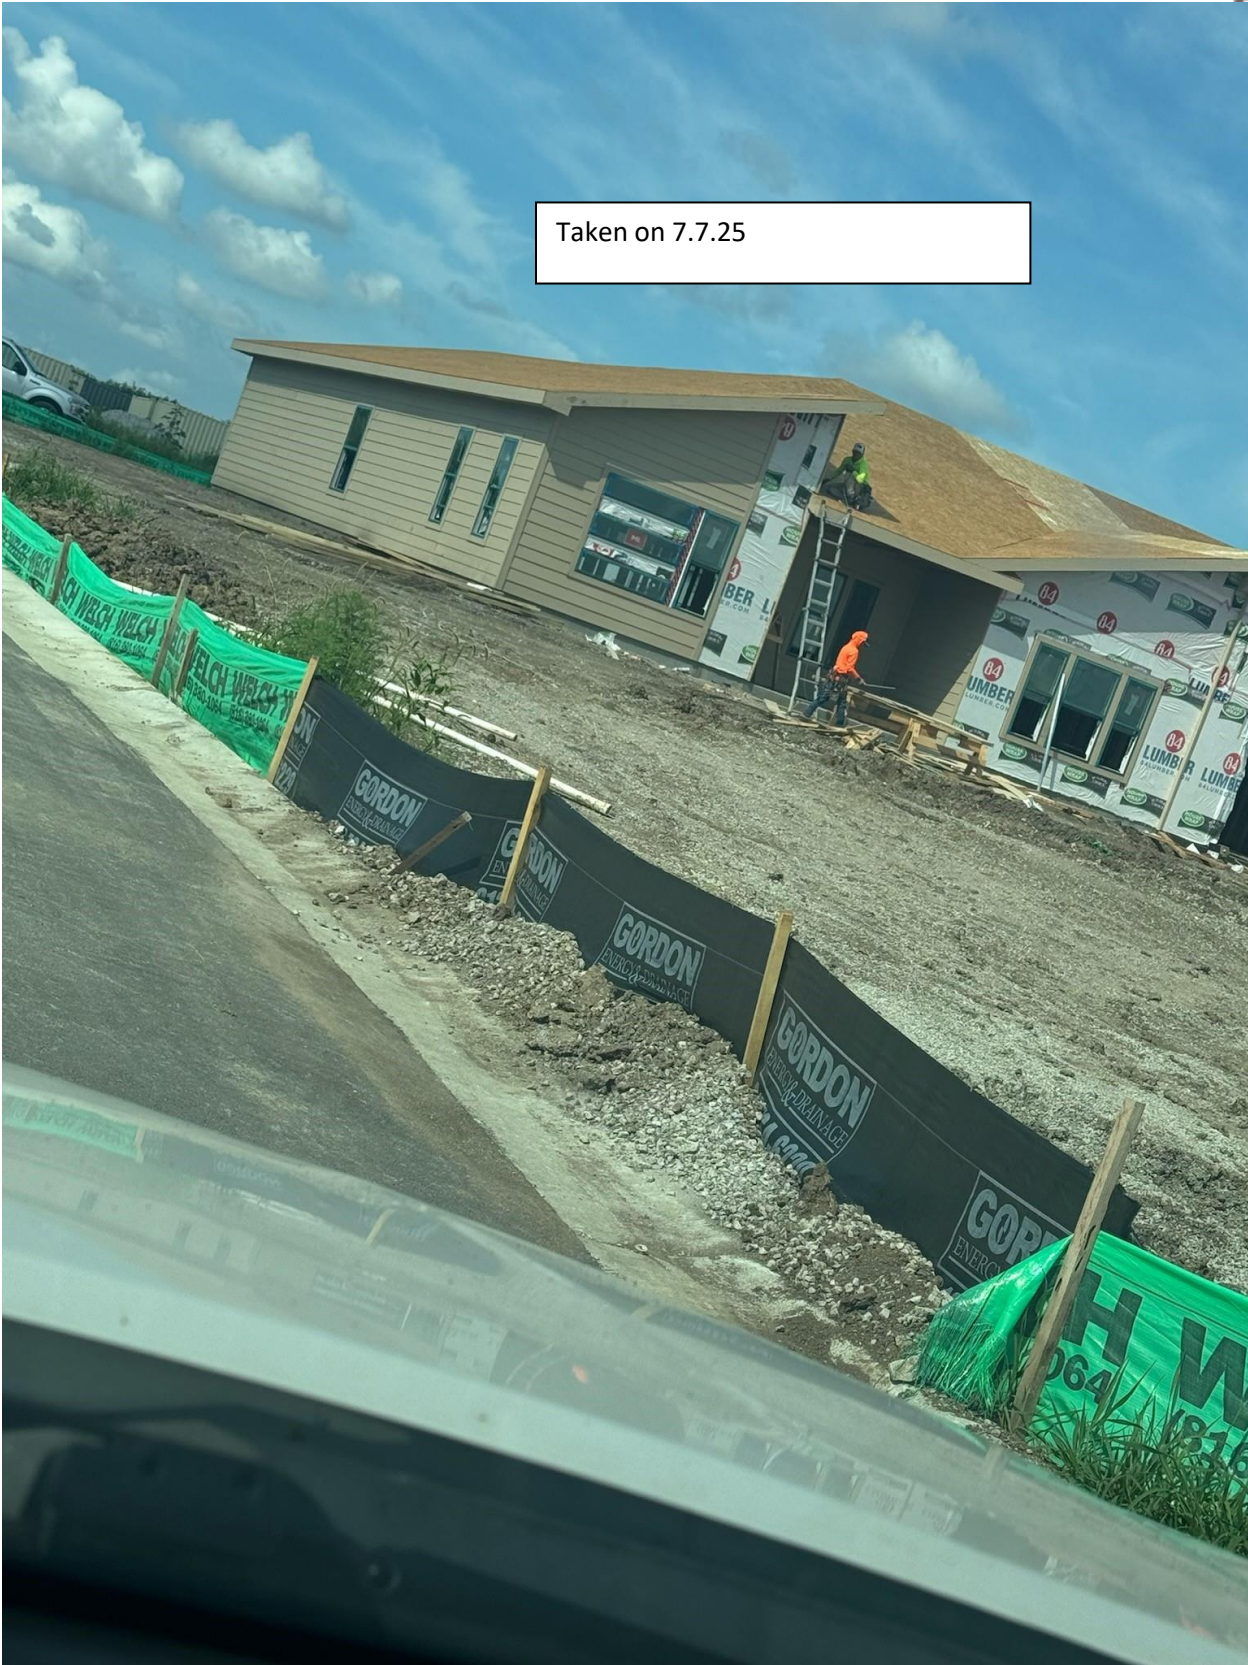
Taken on 7.7.25

BMP	Location	Observation, Effectiveness, & Corrective Actions Ordered
Stabilize	In-active	Stabilize all areas that have been inactive for 14+ days- Weeds are not considered vegetation.
Stabilize	Swale	Stabilize swale on North end as soon as possible if work is done
Stabilize	Detention Ponds	Stabilize detention ponds asap- weeds are not considered vegetation
Silt fence	Detention Pond	Reset silt fence along detention pond behind Residences
Silt fence	Perimeter	Orange silt fence is not trenched in on East side of pond behind Residences- See picture below

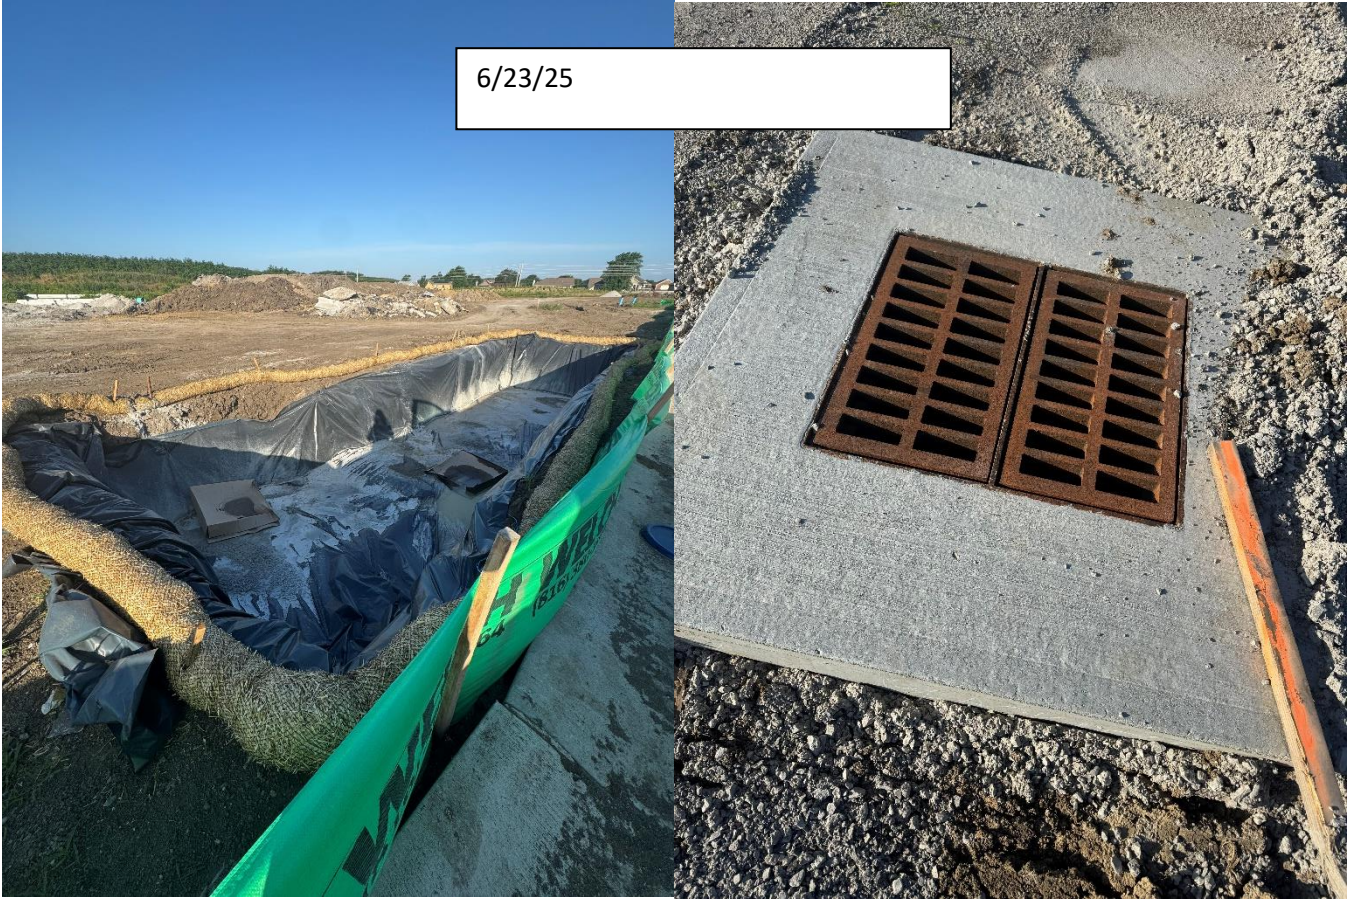
6/23/25

BMP	Location	Observation, Effectiveness, & Corrective Actions Ordered
Field Inlet	NW corner	Remove built up silt around box and reset silt fence if needed
Grate Inlets	In soon to be alley	Need to protect grate inlets- install silt fence inside grat- see picture below
Silt fence	Along backfilled curb	Install silt fence along backfilled curb throughout site
Inlet/Street	Various	Clean out various inlets, curbs, and streets throughout entire site
Silt fence	Along curb	New Gordon silt fence installed needs to either be closer to the curb or built up dirt from install needs to be lower than the curb- PER CITY—SEE PICTURE
Silt fence	Along curb	Repair various areas where fence has been ran over along curb
Trash	Whole Site	Remove trash dumped throughout site- Lots of tires
Silt fence	Detention Pond	Repair silt fence along detention pond- North end
Silt fence	Perimeter	Entire perimeter needs silt fence repaired/replaced in various areas
